FEASIBILITY REPORT

GOOSE LAKE PARKWAY AND ELM CREEK TRAIL AREA PROJECT

CHAMPLIN | HENNEPIN COUNTY | MINNESOTA

CITY PROJECT NO. 22502
SAP 193-121-001
WSB PROJECT NO. 026077-000

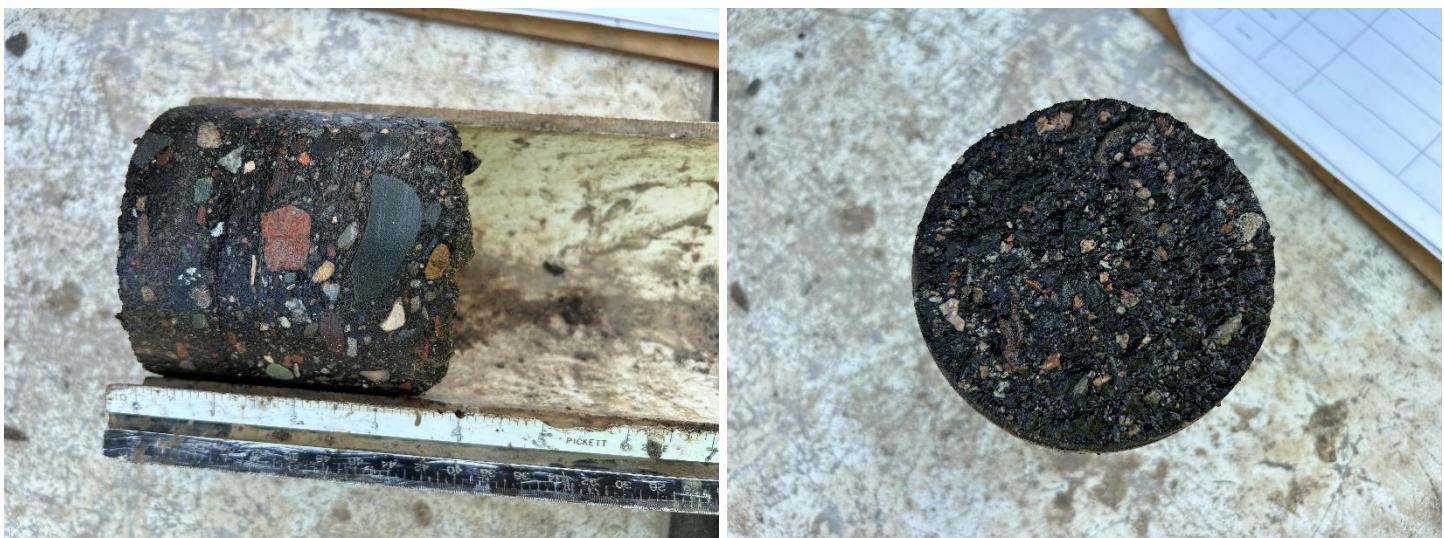
Core Photos

Location	Number of Lanes	Roadway Width (ft)	Curb and Gutter	Surface Distresses
Goose Lake Parkway East Bound	1	13	Yes	Surface stripping, Alligator, transverse cracking

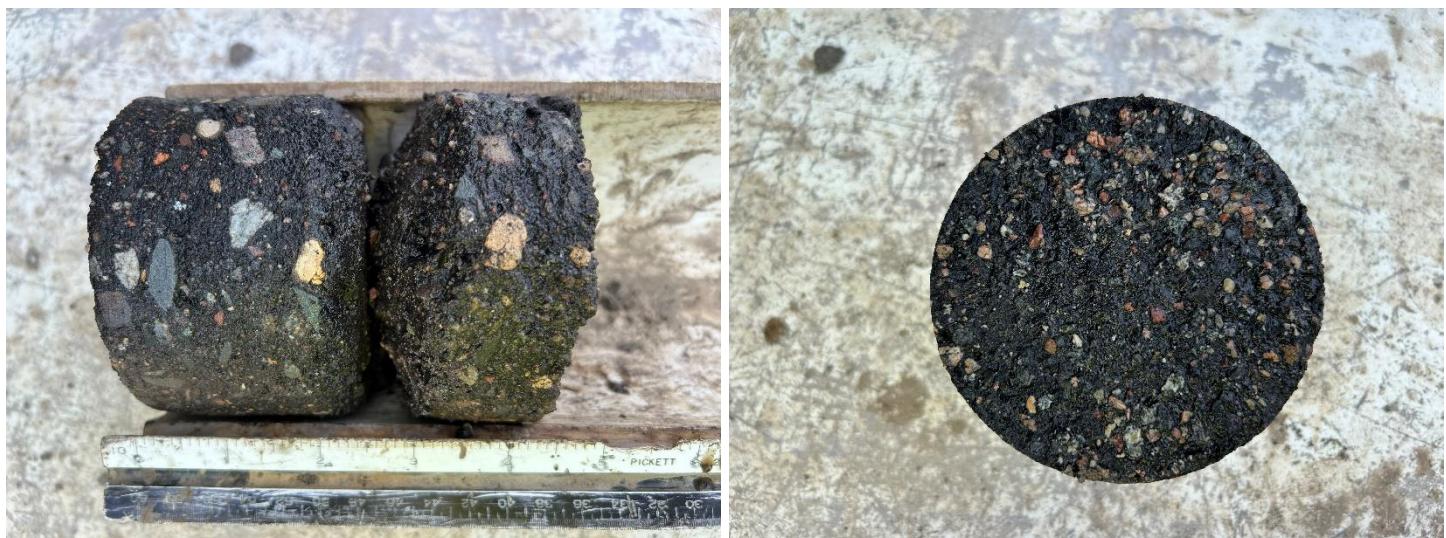
Core Photos

Location	Number of Lanes	Roadway Width (ft)	Curb and Gutter	Surface Distresses
Goose Lake Parkway East Bound	1	13	Yes	Surface stripping, Transverse, longitudinal cracking

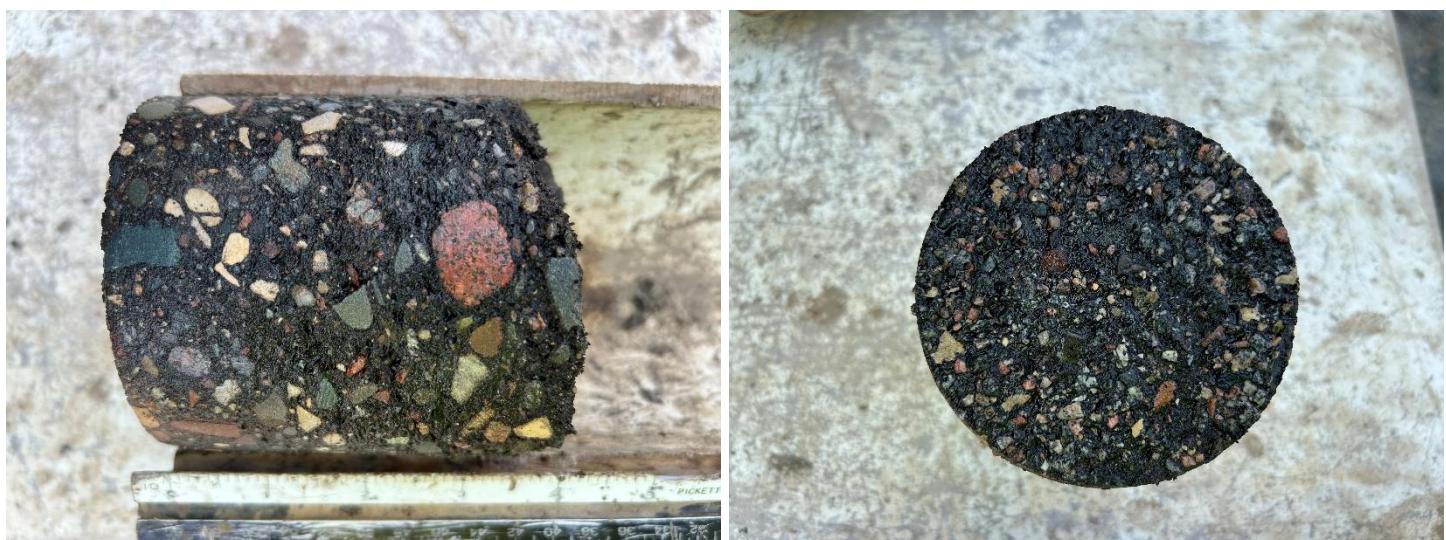
Core Photos

Location	Number of Lanes	Roadway Width (ft)	Curb and Gutter	Surface Distresses
Goose Lake Parkway East Bound	2	22	Yes	Surface stripping, Patching, Transverse cracking

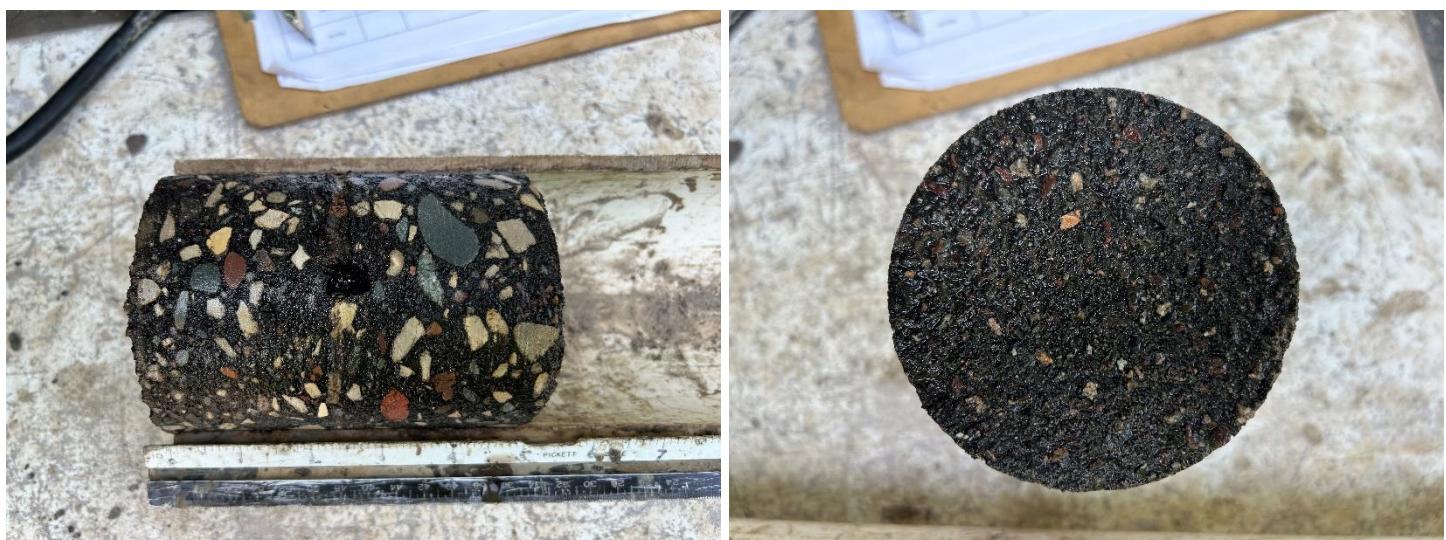
Core Photos

Location	Number of Lanes	Roadway Width (ft)	Curb and Gutter	Surface Distresses
Goose Lake Parkway East Bound	2	22	Yes	Surface stripping, Patching, Longitudinal cracking

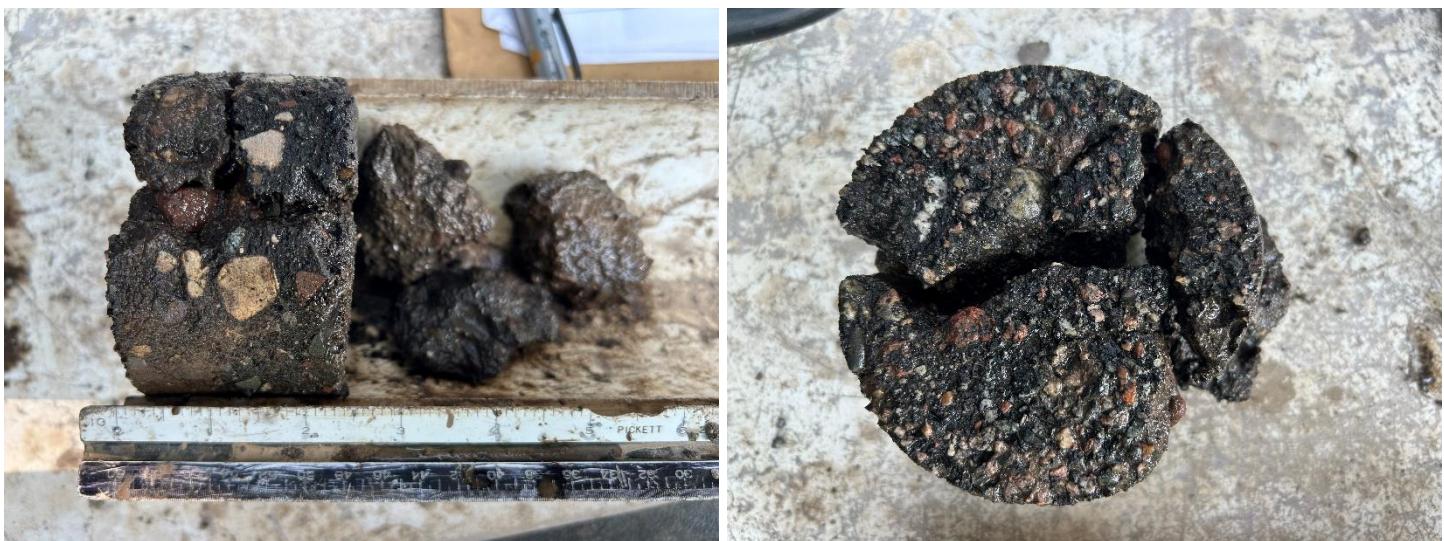
Core Photos

Location	Number of Lanes	Roadway Width (ft)	Curb and Gutter	Surface Distresses
Goose Lake Parkway West Bound	2	22	Yes	Surface stripping, Longitudinal cracking

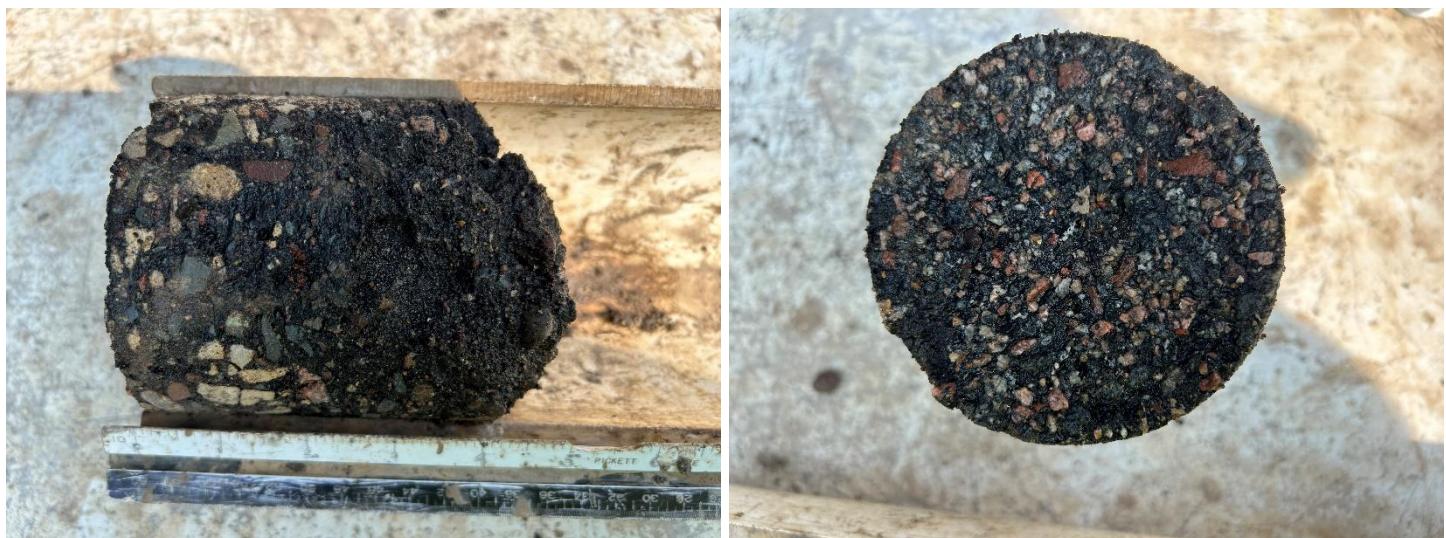
Core Photos

Location	Number of Lanes	Roadway Width (ft)	Curb and Gutter	Surface Distresses
Goose Lake Parkway West Bound	2	22	Yes	Surface stripping, Some transverse, longitudinal cracking

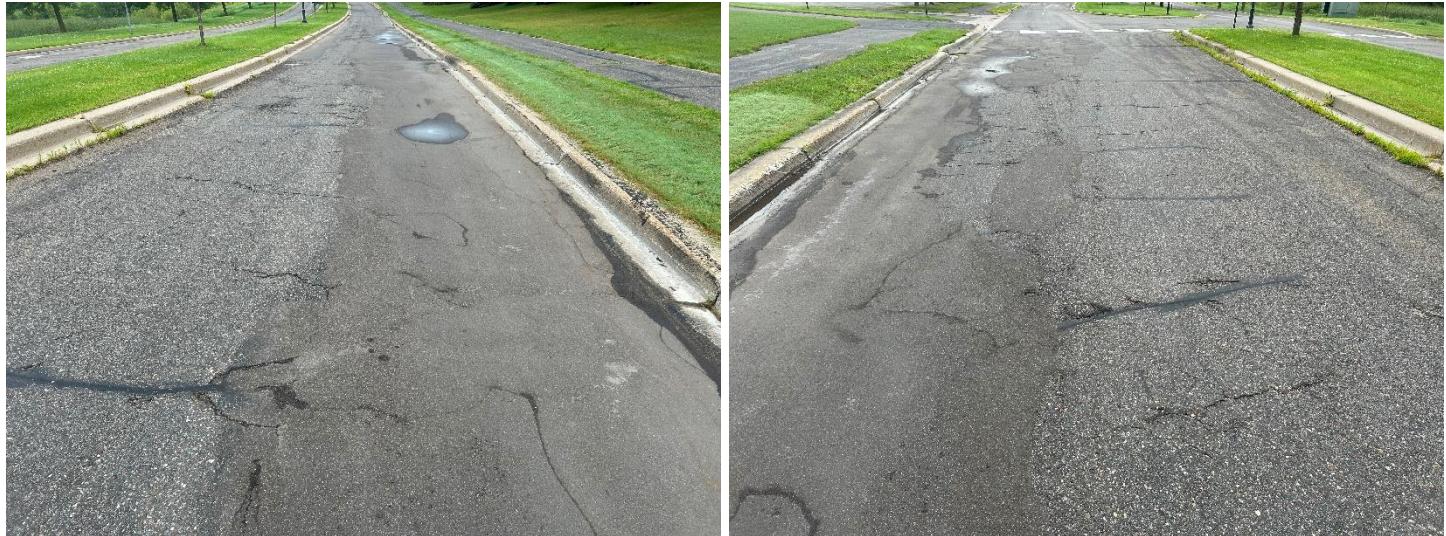
Street Photos

Location	Number of Lanes	Roadway Width (ft)	Curb and Gutter	Surface Distresses
Goose Lake Parkway West Bound	1	13	Yes	Surface stripping, Patching, Transverse cracking

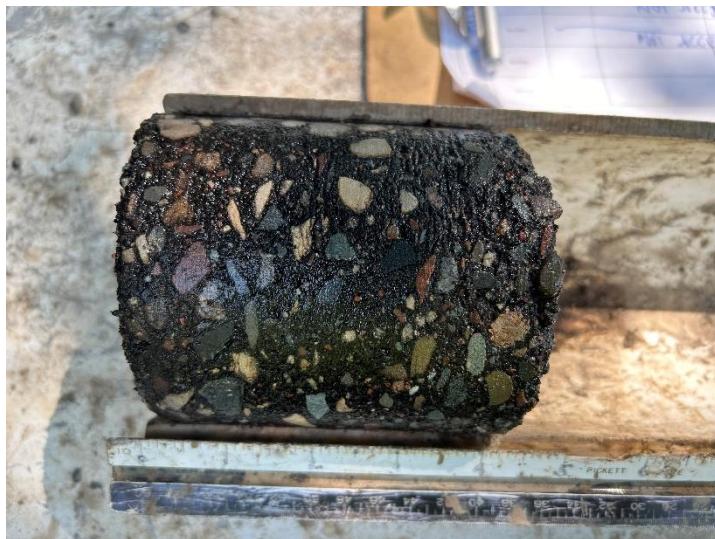
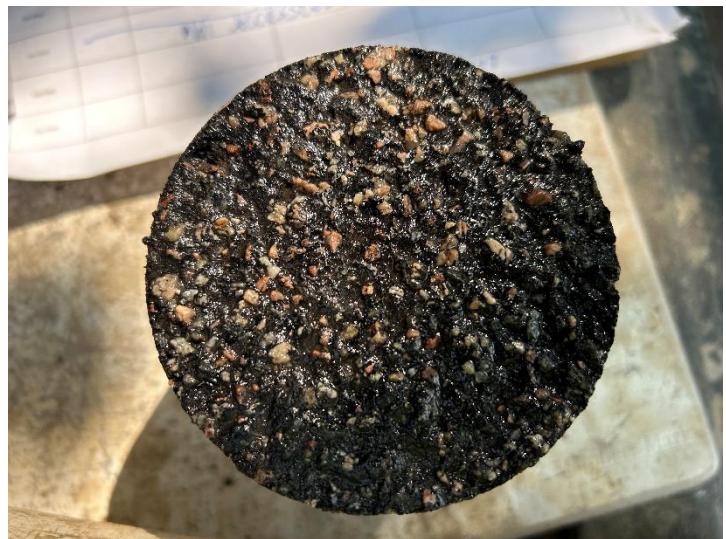
Core Photos

Location	Number of Lanes	Roadway Width (ft)	Curb and Gutter	Surface Distresses
Elm Creek Trail	2	24	Yes	Surface stripping

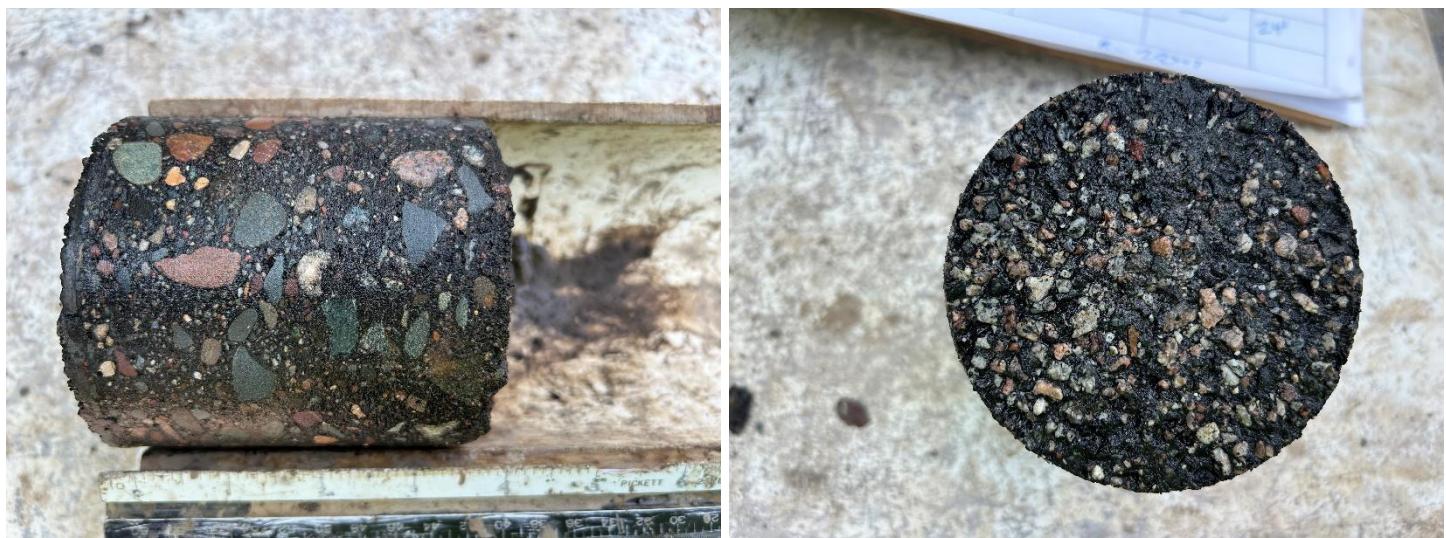
Core Photos

Location	Number of Lanes	Roadway Width (ft)	Curb and Gutter	Surface Distresses
Highview Ct	2	22	Yes	Surface stripping, some transverse cracking

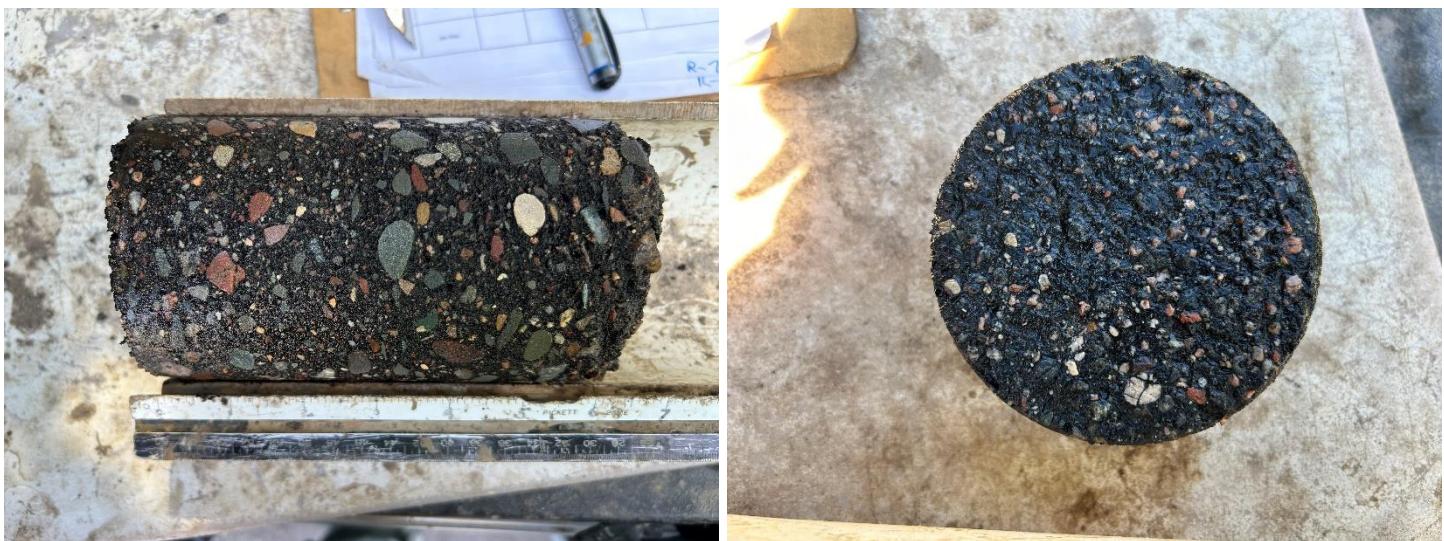
Core Photos

Location	Number of Lanes	Roadway Width (ft)	Curb and Gutter	Surface Distresses
Elm Creek Trail	2	25	Yes	Surface stripping, transverse cracking

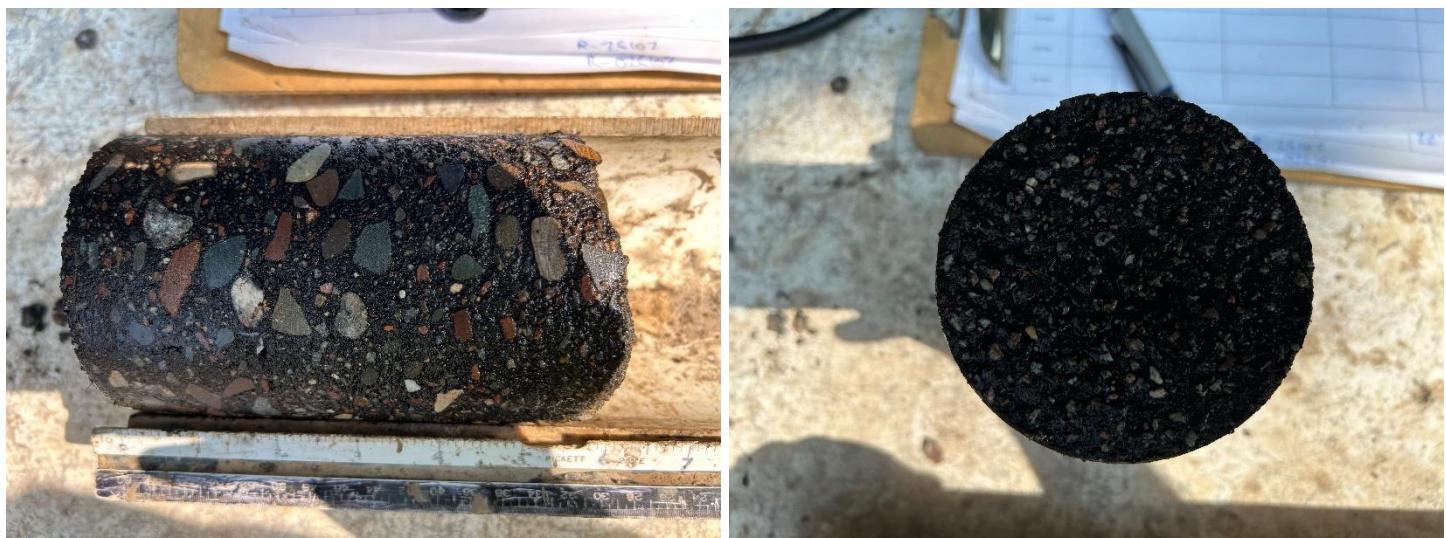
Core Photos

Location	Number of Lanes	Roadway Width (ft)	Curb and Gutter	Surface Distresses
Hilltop Ct	2	21	Yes	Surface stripping, transverse cracking

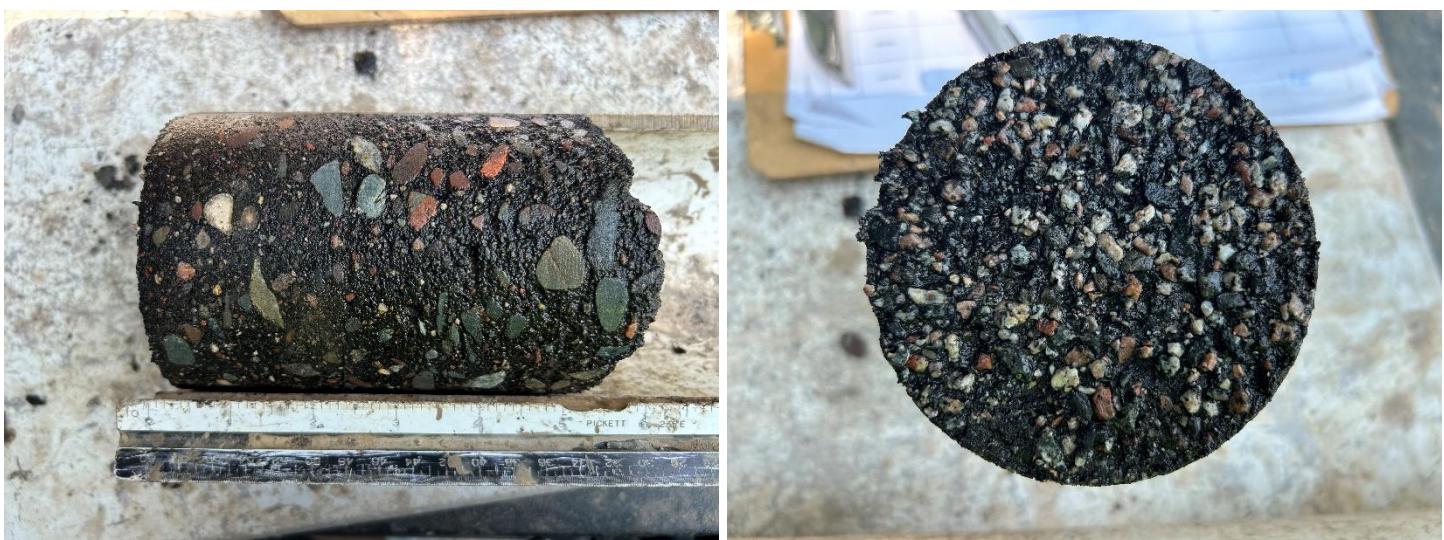
Core Photos

Location	Number of Lanes	Roadway Width (ft)	Curb and Gutter	Surface Distresses
Hilltop Ct	2	21	Yes	Surface stripping, transverse cracking

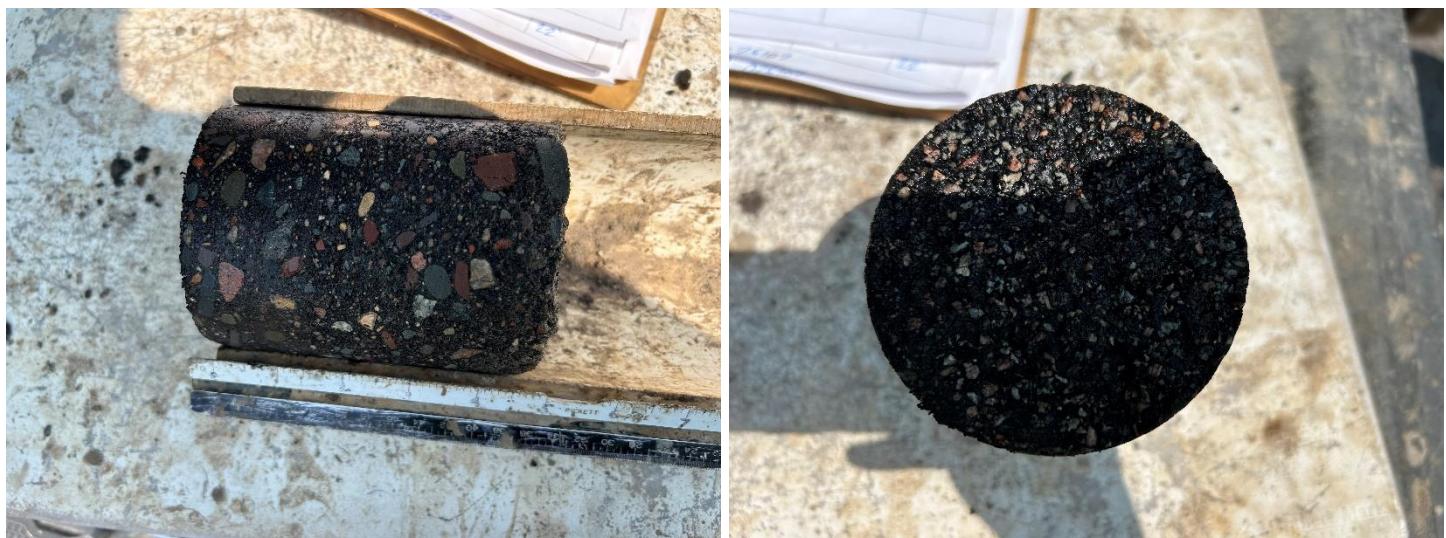
Core Photos

Location	Number of Lanes	Roadway Width (ft)	Curb and Gutter	Surface Distresses
Hilltop Ct	2	32	Yes	Surface stripping, Some transverse cracking

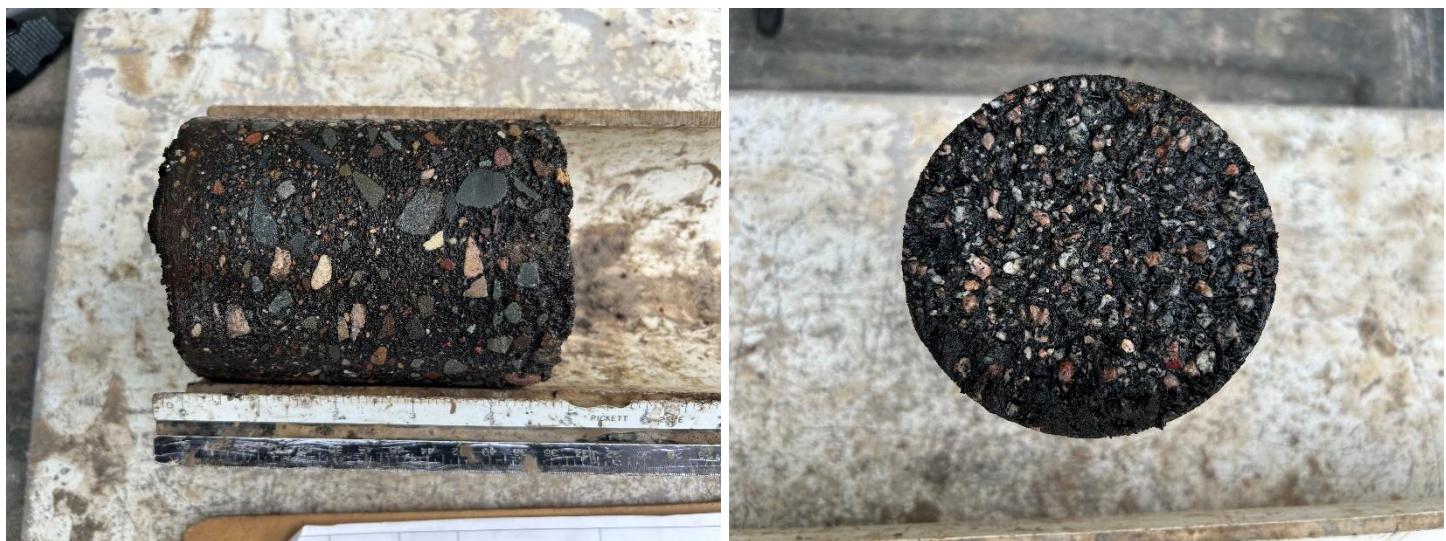
Core Photos

Location	Number of Lanes	Roadway Width (ft)	Curb and Gutter	Surface Distresses
Elm Creek Trail	2	24	Yes	Surface stripping, transverse cracking

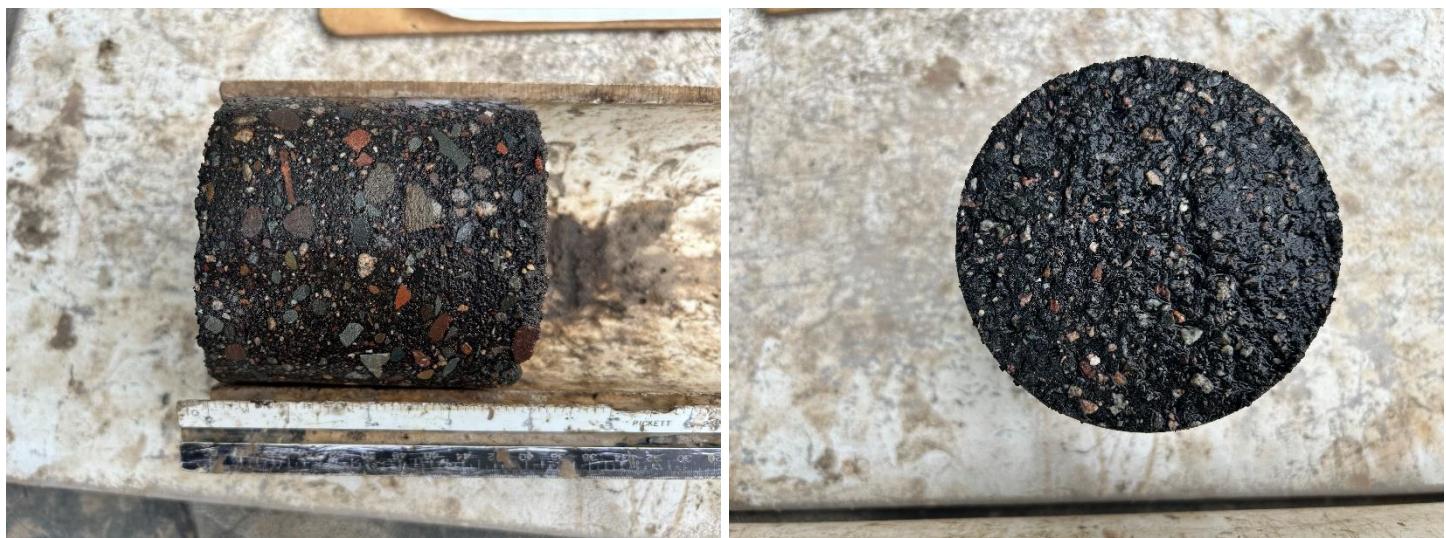
Core Photos

Location	Number of Lanes	Roadway Width (ft)	Curb and Gutter	Surface Distresses
Pondview Circle	2	22	Yes	Surface stripping, transverse cracking

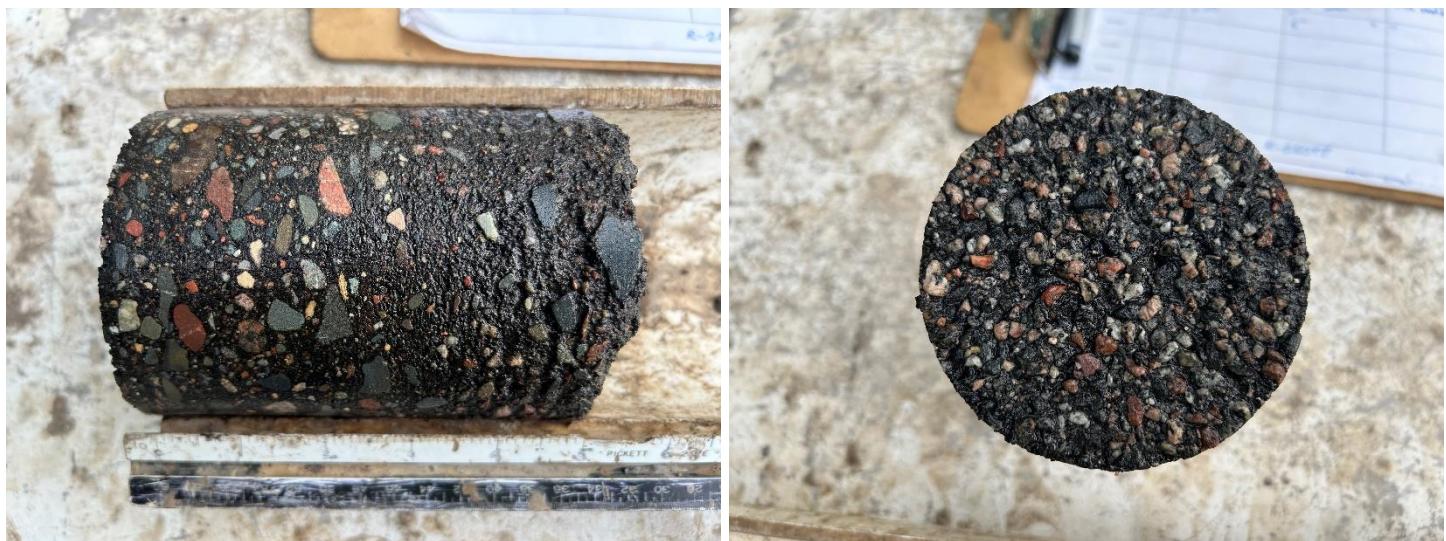
Core Photos

Location	Number of Lanes	Roadway Width (ft)	Curb and Gutter	Surface Distresses
Pondview Ct	2	21	Yes	Surface stripping, Some alligator, transverse cracking

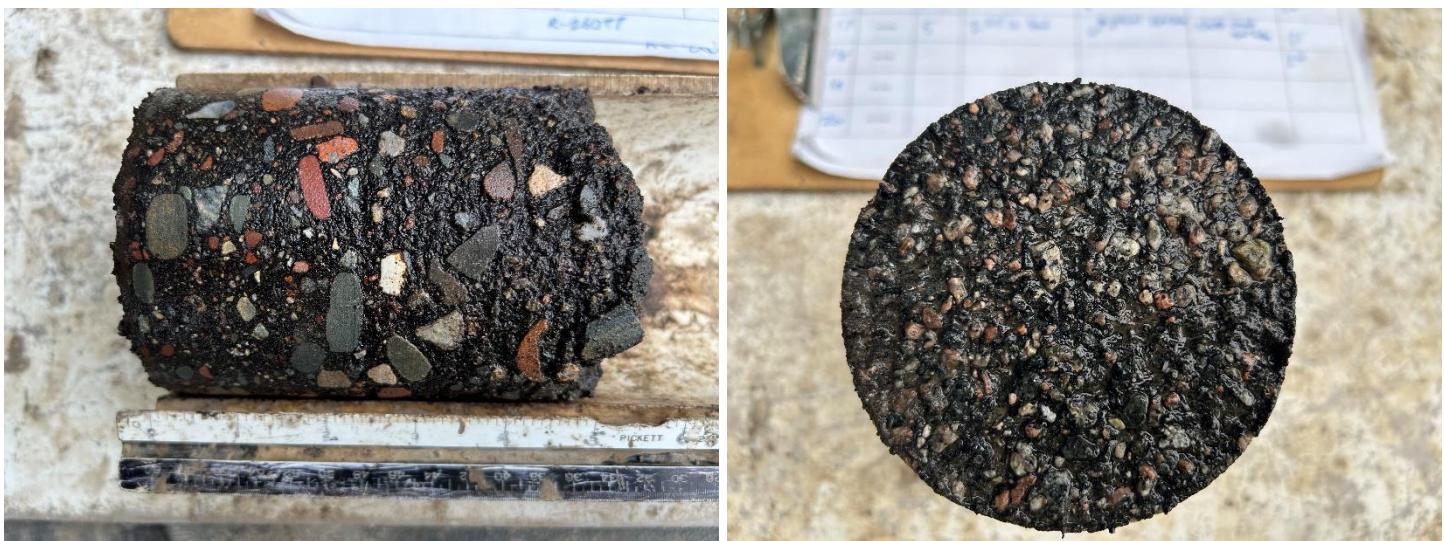
Core Photos

Location	Number of Lanes	Roadway Width (ft)	Curb and Gutter	Surface Distresses
Pondview Ct	2	24	Yes	Surface stripping, patching, transverse cracking

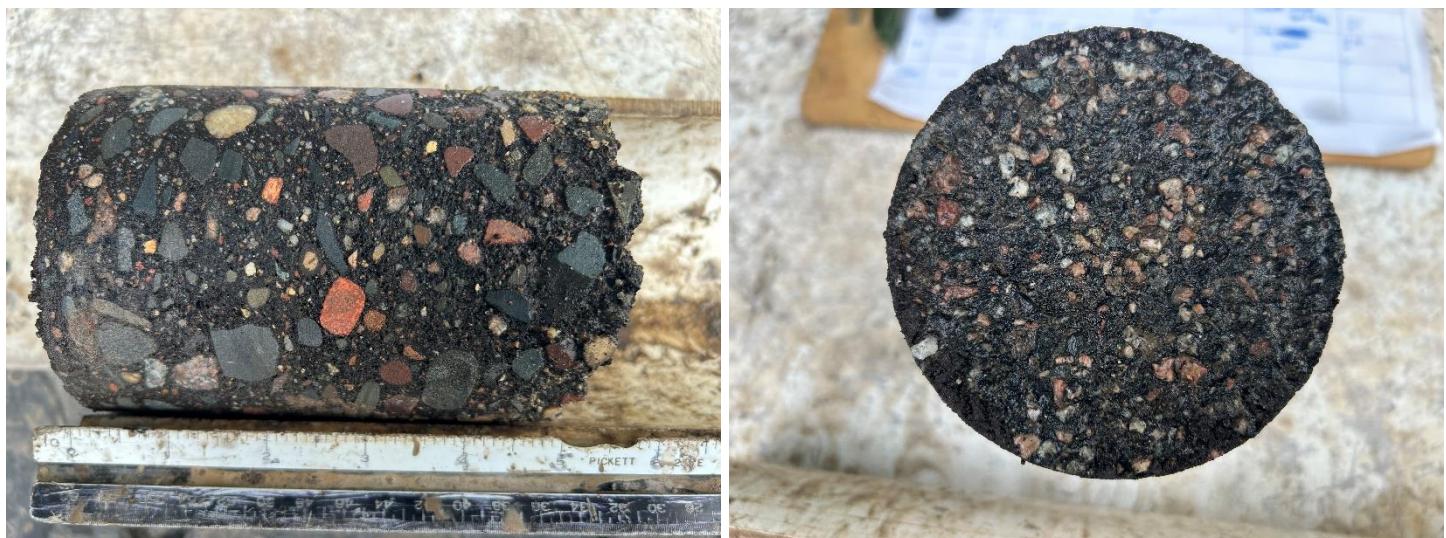
Core Photos

Location	Number of Lanes	Roadway Width (ft)	Curb and Gutter	Surface Distresses
Pondview Ct	2	24	Yes	Surface stripping, transverse, longitudinal cracking

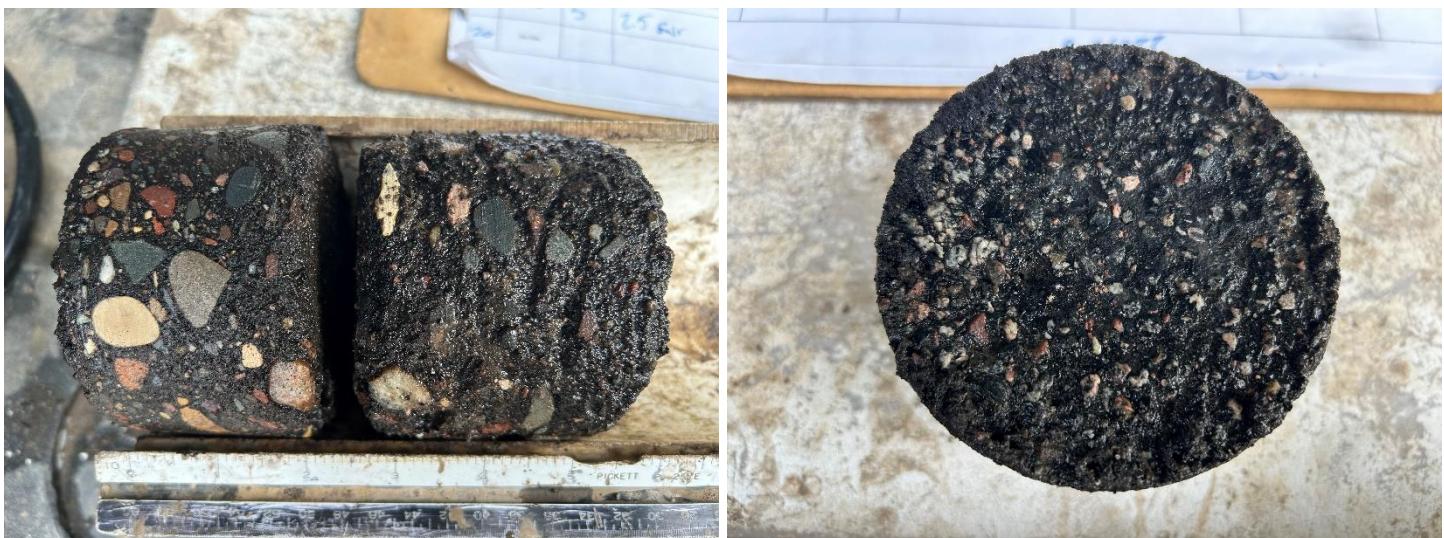
Core Photos

Location	Number of Lanes	Roadway Width (ft)	Curb and Gutter	Surface Distresses
Pondview Ct	2	24	Yes	Surface stripping, Some transverse cracking

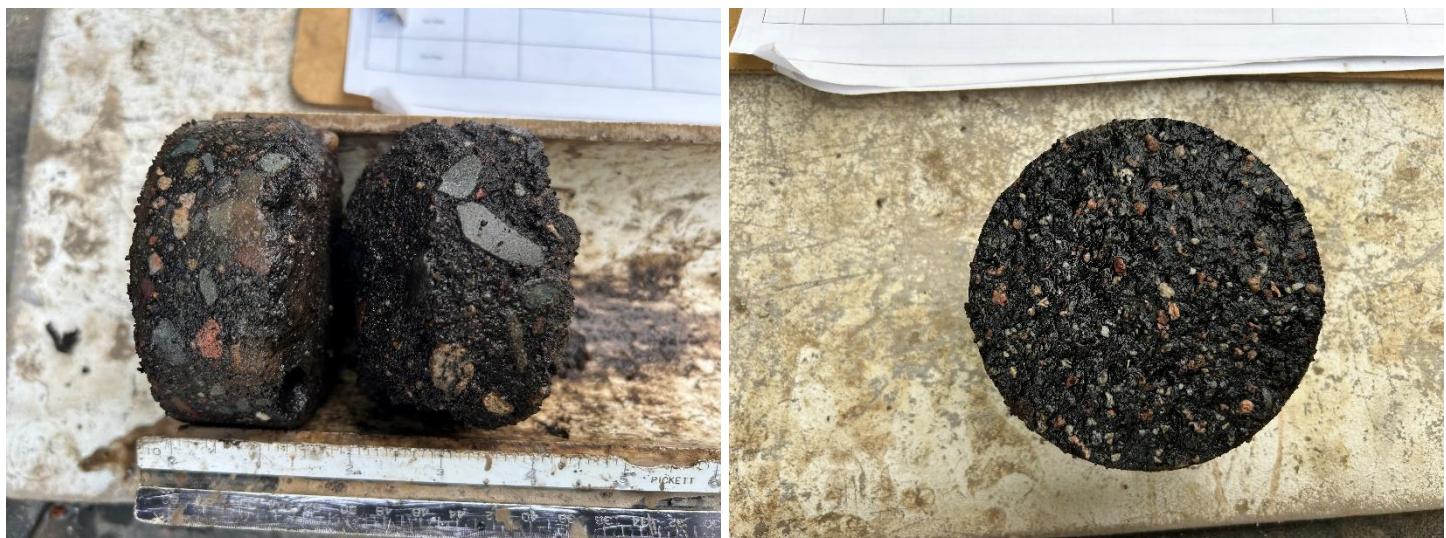
Core Photos

Location	Number of Lanes	Roadway Width (ft)	Curb and Gutter	Surface Distresses
Oakview Ct	2	22	Yes	Surface stripping, transverse cracking

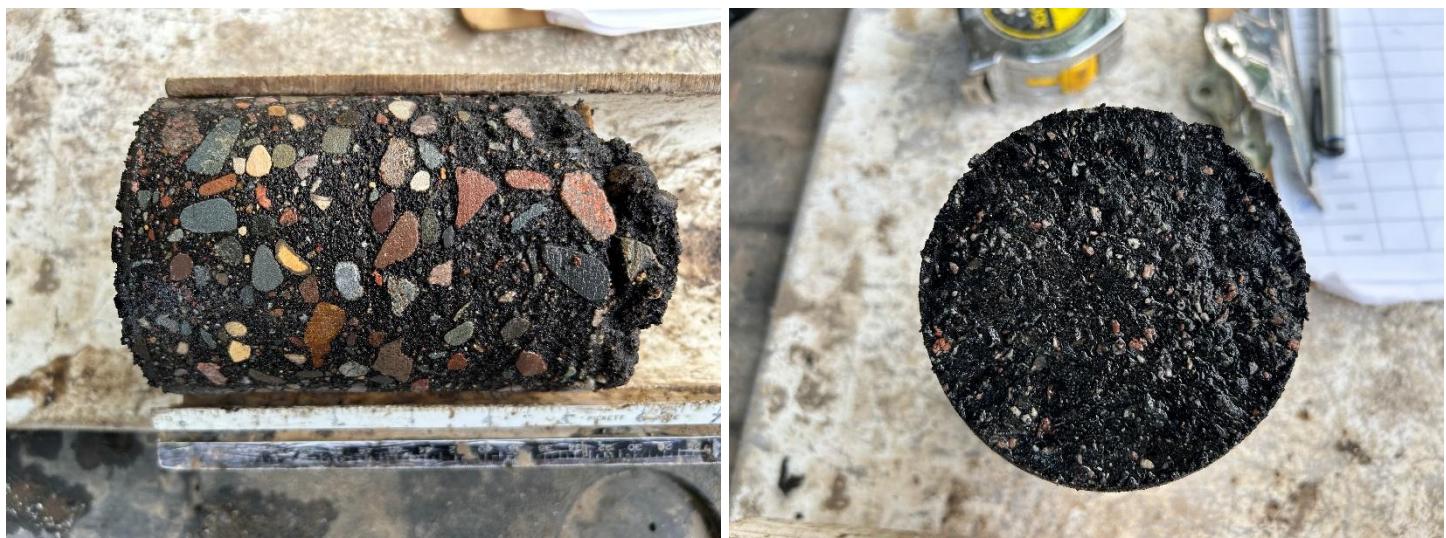
Core Photos

Location	Number of Lanes	Roadway Width (ft)	Curb and Gutter	Surface Distresses
Oakview Ct	2	24	Yes	Surface stripping, transverse cracking

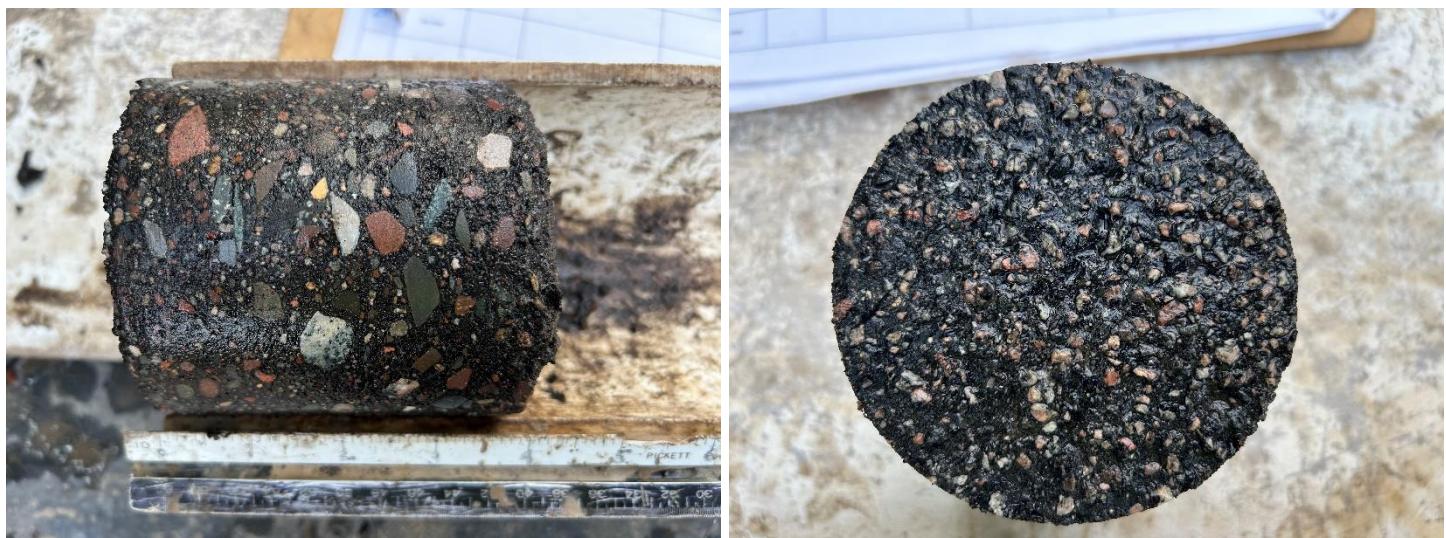
Core Photos

Location	Number of Lanes	Roadway Width (ft)	Curb and Gutter	Surface Distresses
Elm Creek Trail	2	24	Yes	Surface stripping, transverse, longitudinal cracking

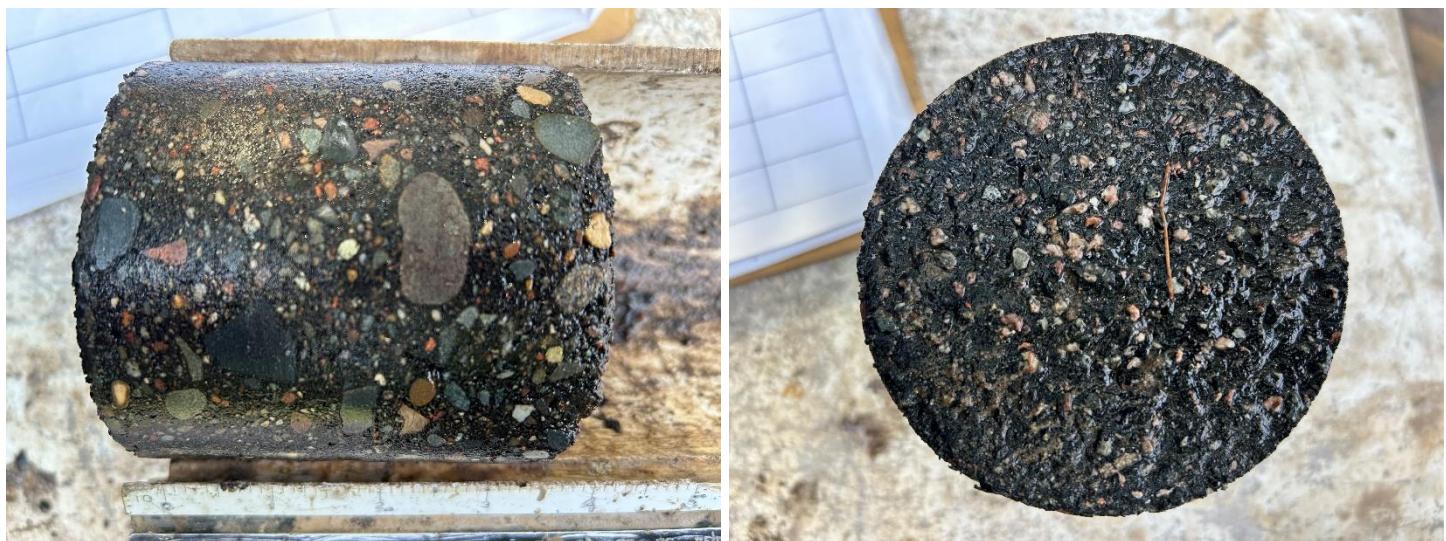
Core Photos

Location	Number of Lanes	Roadway Width (ft)	Curb and Gutter	Surface Distresses
Norway Ct	2	24	Yes	Surface stripping, transverse cracking

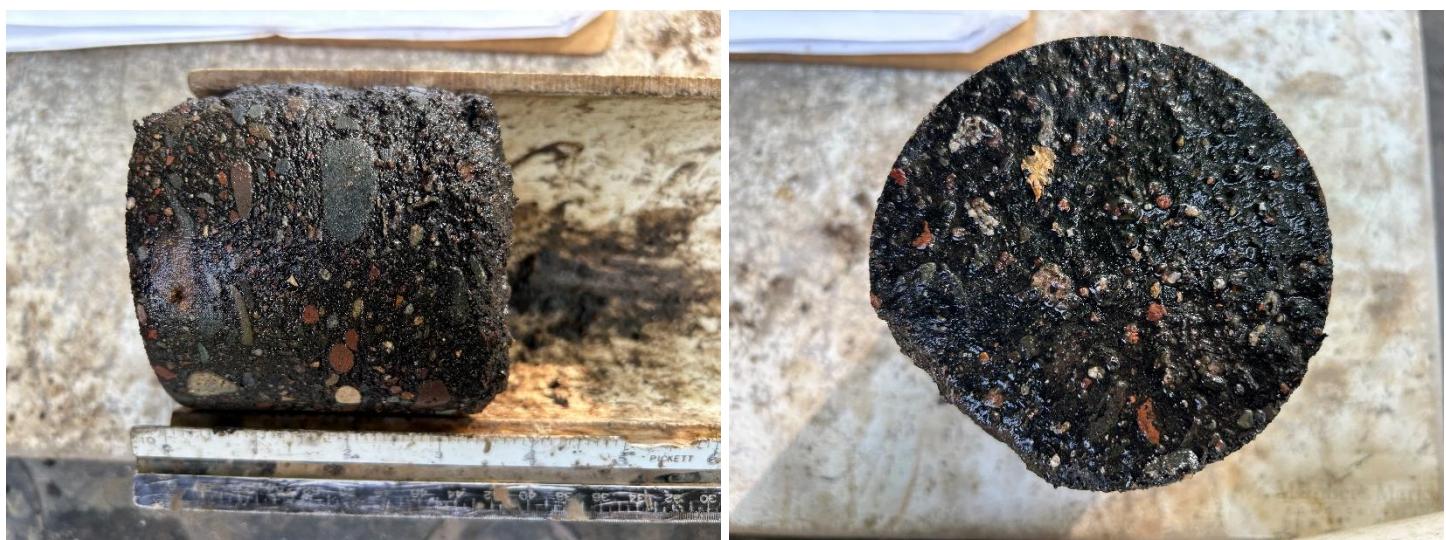
Core Photos

Location	Number of Lanes	Roadway Width (ft)	Curb and Gutter	Surface Distresses
Norway Ct	2	24	Yes	Surface stripping, alligator, transverse cracking

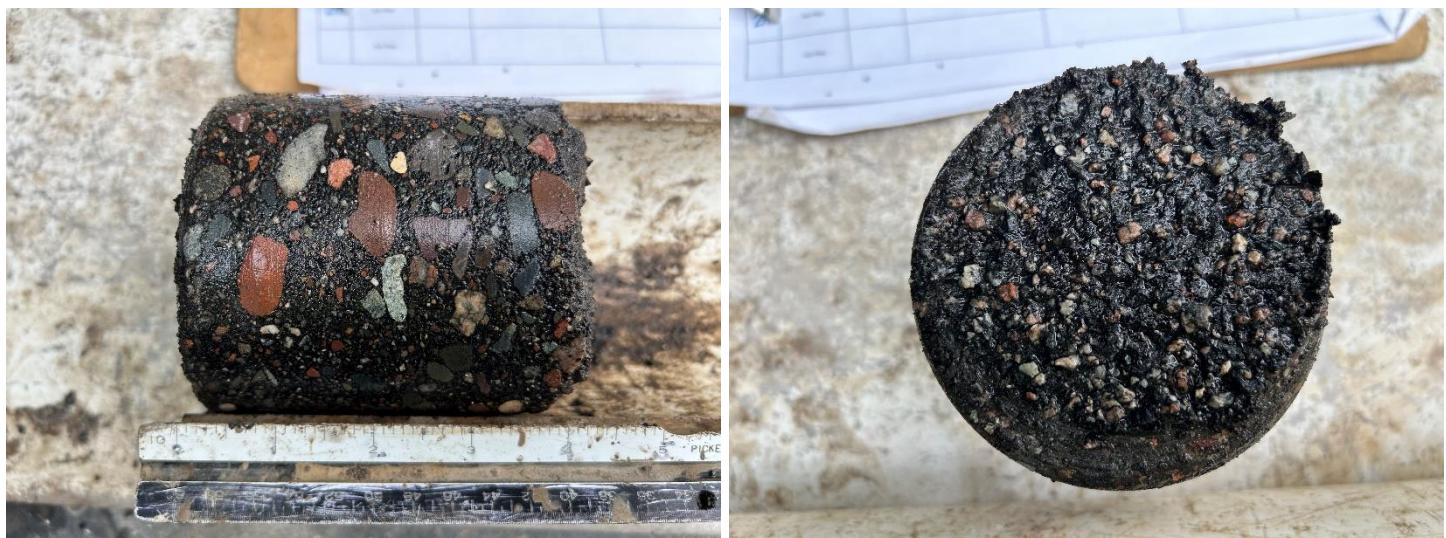
Core Photos

Location	Number of Lanes	Roadway Width (ft)	Curb and Gutter	Surface Distresses
Elm Creek Trail	2	24	Yes	Surface stripping, patching, transverse cracking

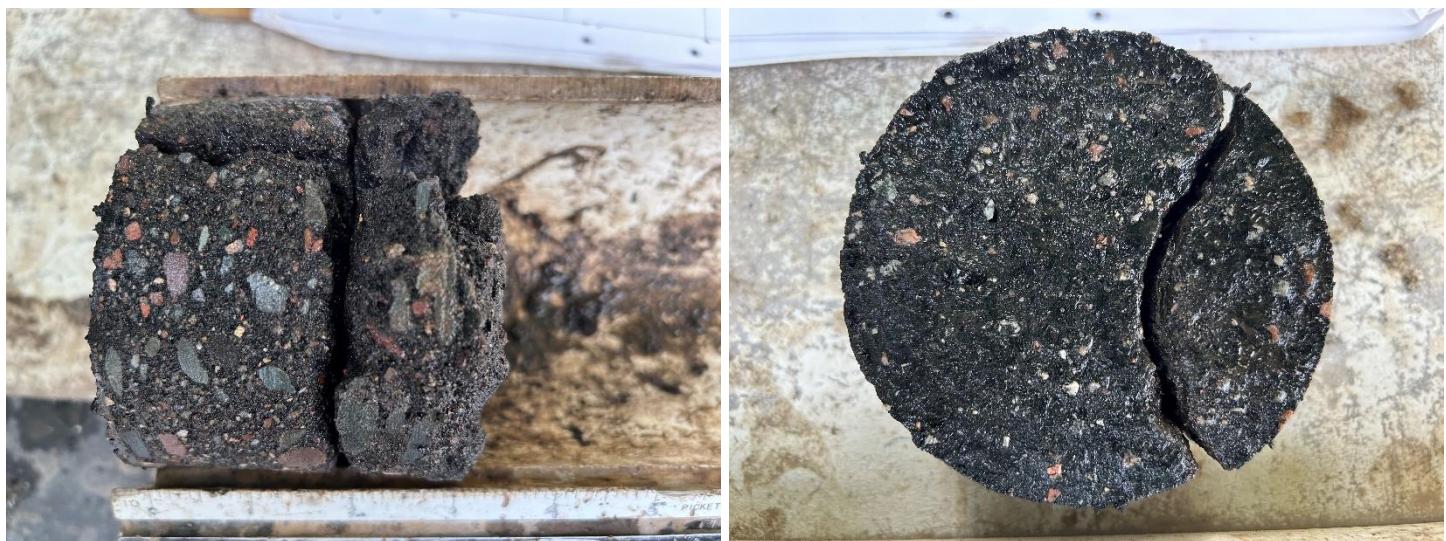
Core Photos

Location	Number of Lanes	Roadway Width (ft)	Curb and Gutter	Surface Distresses
Magnolia Ct	2	24	Yes	Surface stripping, transverse cracking

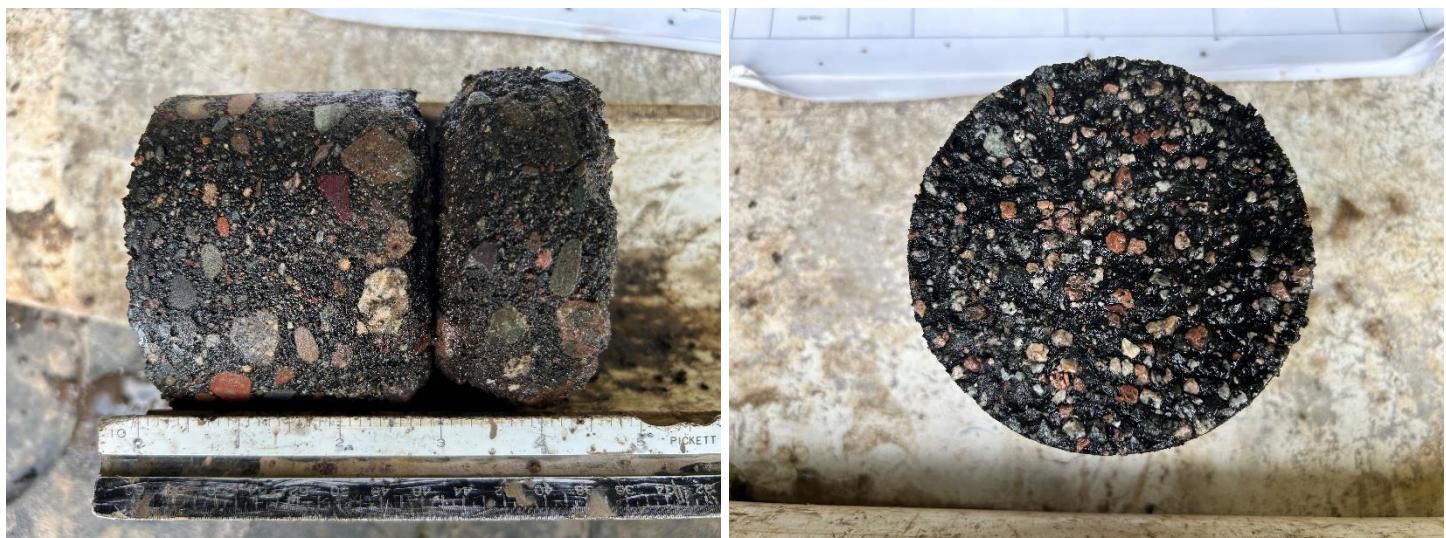
Core Photos

Location	Number of Lanes	Roadway Width (ft)	Curb and Gutter	Surface Distresses
Magnolia Ct	2	24	Yes	Surface stripping, transverse cracking

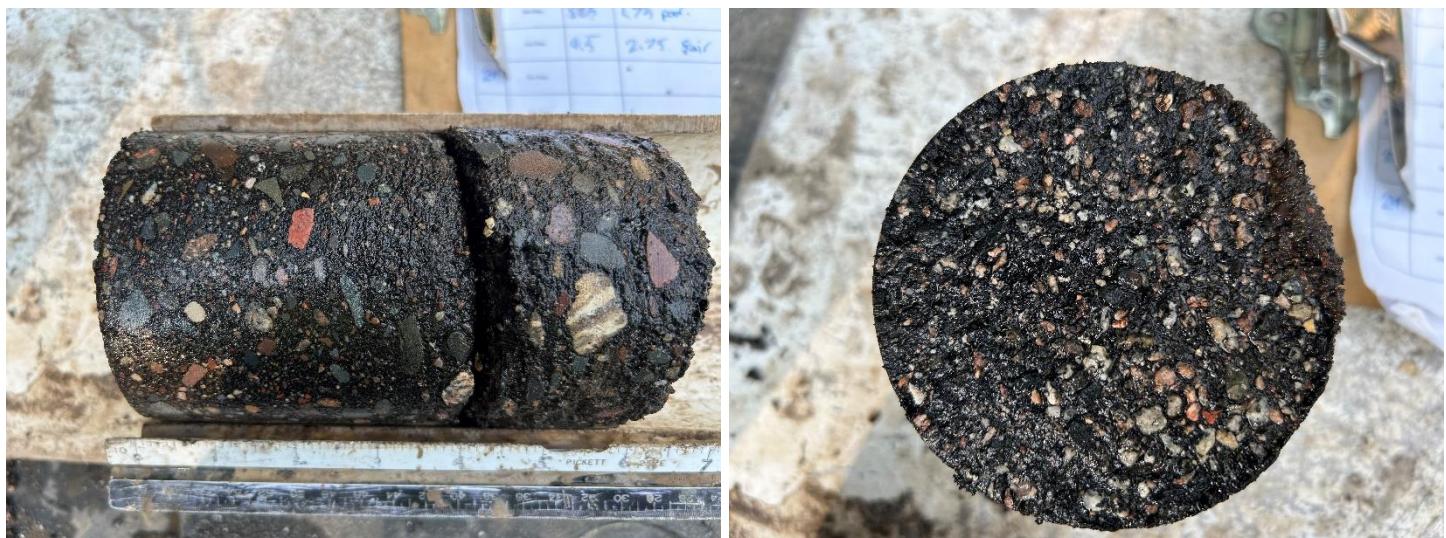
Core Photos

Location	Number of Lanes	Roadway Width (ft)	Curb and Gutter	Surface Distresses
Elm Creek Trail	2	28	Yes	Surface stripping, patching, transverse cracking

Bituminous Depth (in)	Lift Thickness and Condition	Base Depth and Description	Subbase or Subgrade Description
6.25	2.25" - Wear (3+ Lifts of material) Poor - Base layer raveling	4" - Sand trace gravel, brown	f-m Sand, brown
