FEASIBILITY REPORT

GOOSE LAKE PARKWAY AND ELM CREEK TRAIL AREA PROJECT

CHAMPLIN | HENNEPIN COUNTY | MINNESOTA

CITY PROJECT NO. 22502
SAP 193-121-001
WSB PROJECT NO. 026077-000

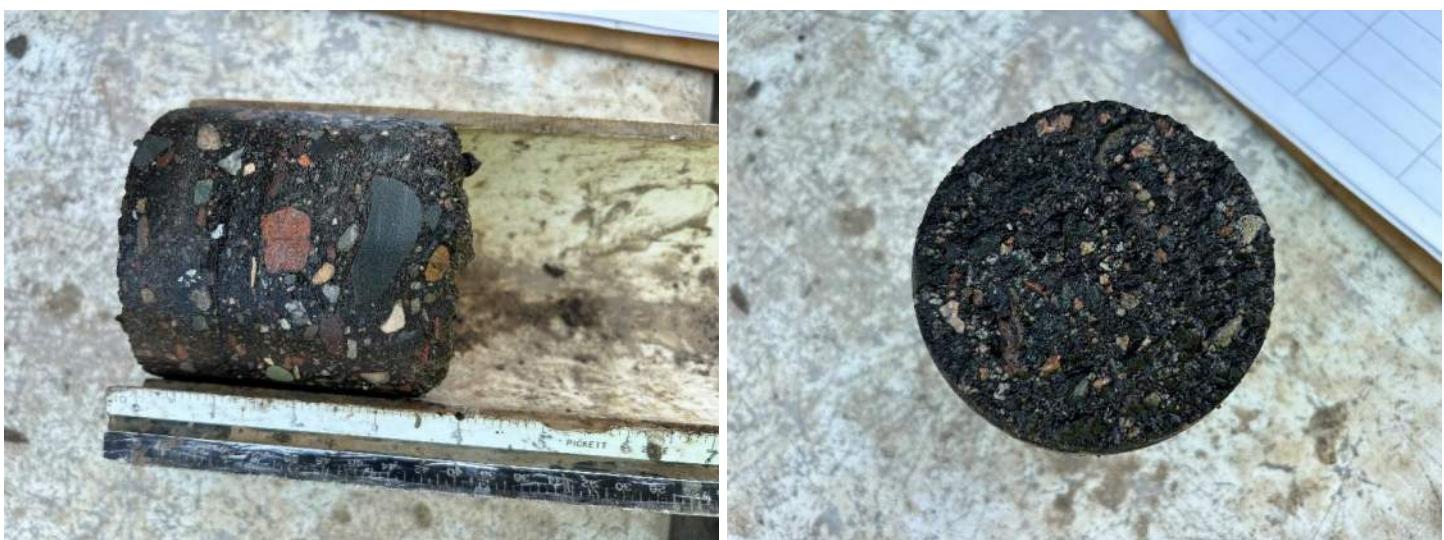
Core Photos

Location	Number of Lanes	Roadway Width (ft)	Curb and Gutter	Surface Distresses
Goose Lake Parkway East Bound	1	13	Yes	Surface stripping, Alligator, transverse cracking

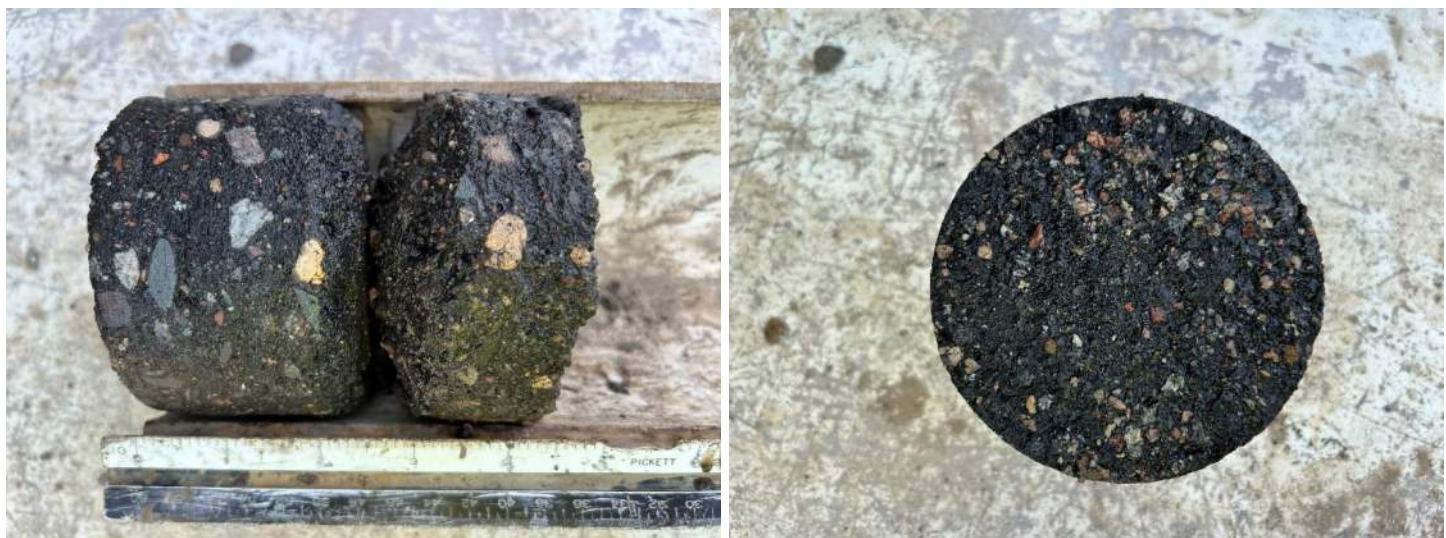
Core Photos

Location	Number of Lanes	Roadway Width (ft)	Curb and Gutter	Surface Distresses
Goose Lake Parkway East Bound	1	13	Yes	Surface stripping, Transverse, longitudinal cracking

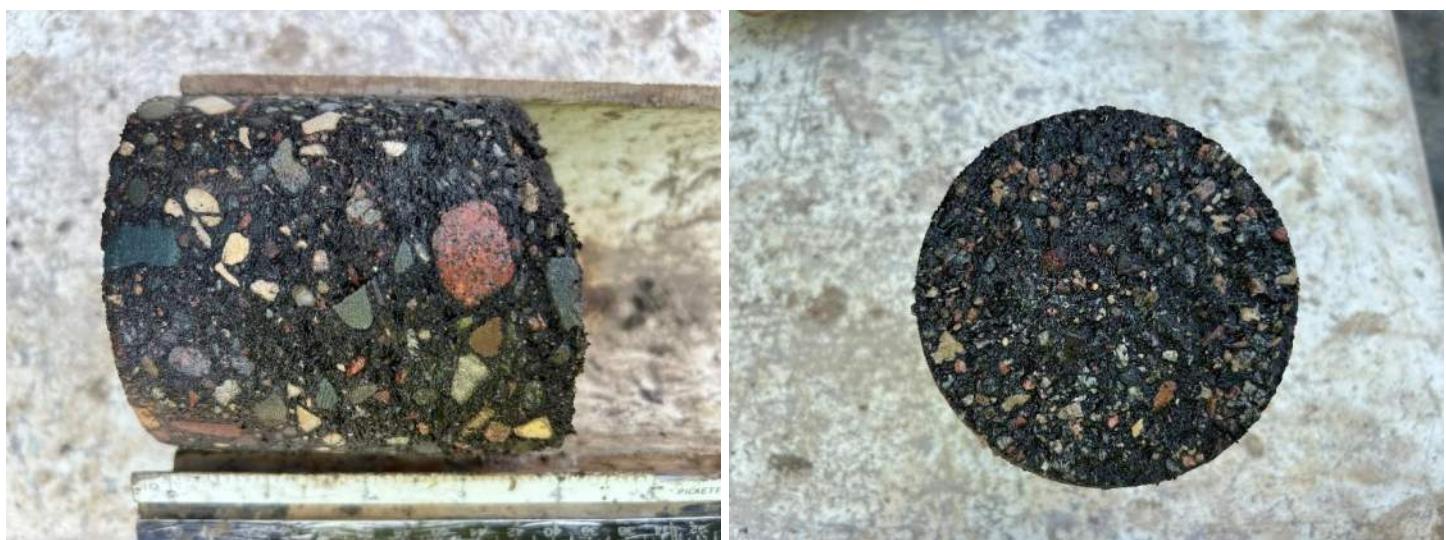
Core Photos

Location	Number of Lanes	Roadway Width (ft)	Curb and Gutter	Surface Distresses
Goose Lake Parkway East Bound	2	22	Yes	Surface stripping, Patching, Transverse cracking

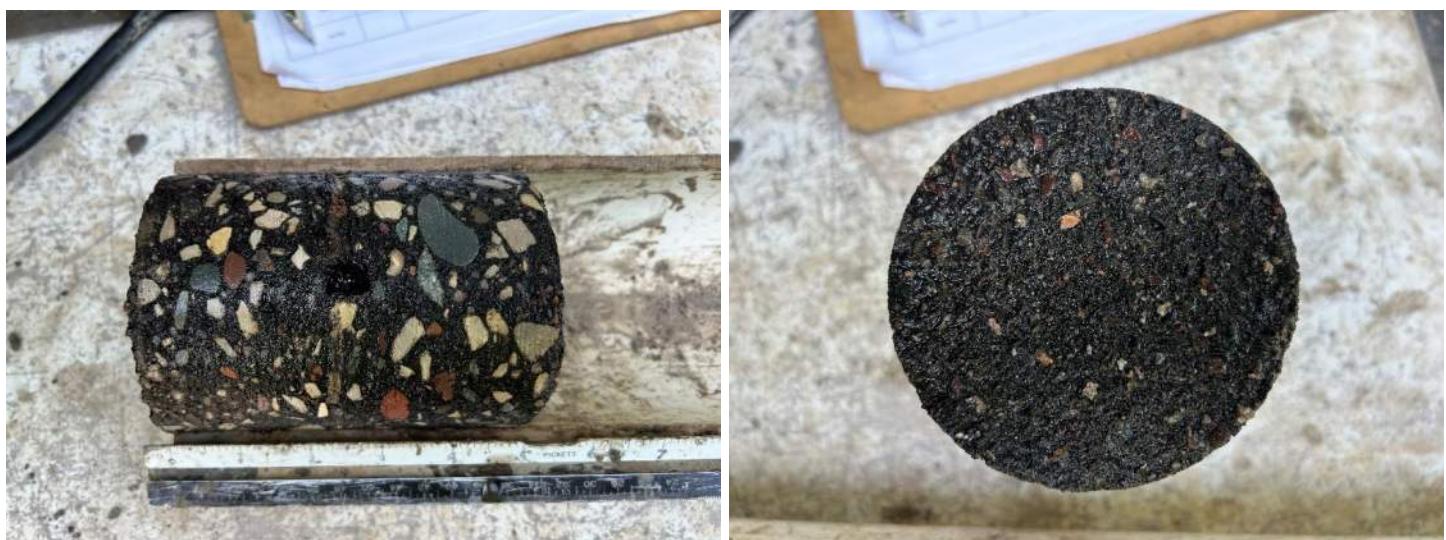
Core Photos

Location	Number of Lanes	Roadway Width (ft)	Curb and Gutter	Surface Distresses
Goose Lake Parkway East Bound	2	22	Yes	Surface stripping, Patching, Longitudinal cracking

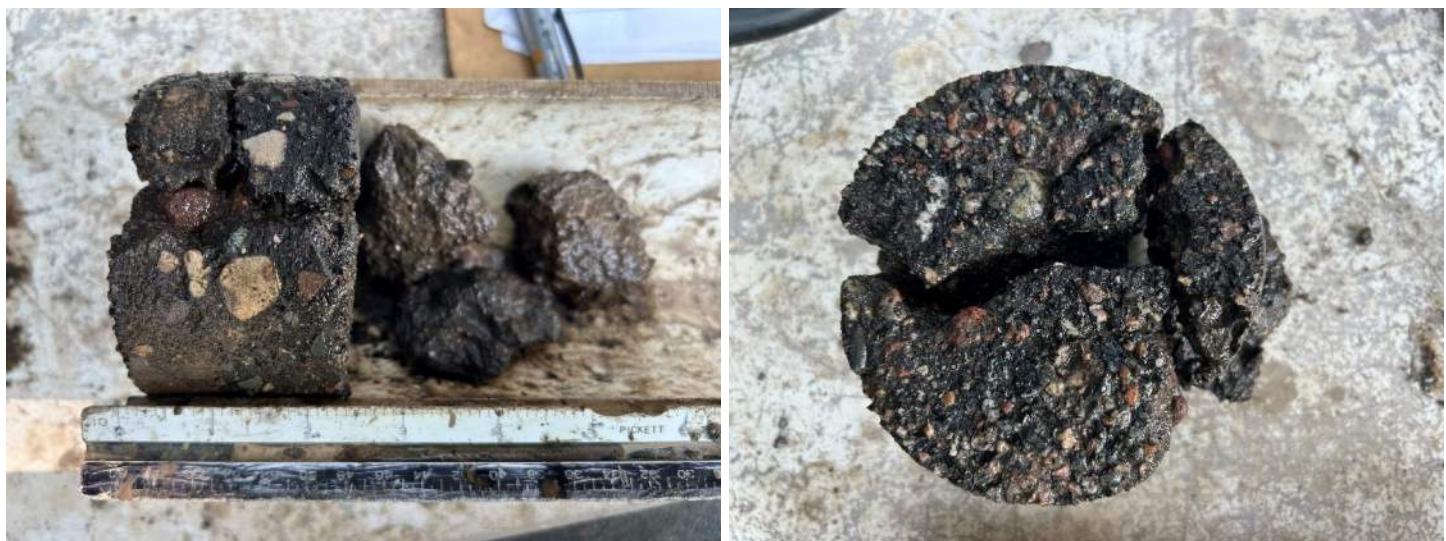
Core Photos

Location	Number of Lanes	Roadway Width (ft)	Curb and Gutter	Surface Distresses
Goose Lake Parkway West Bound	2	22	Yes	Surface stripping, Longitudinal cracking

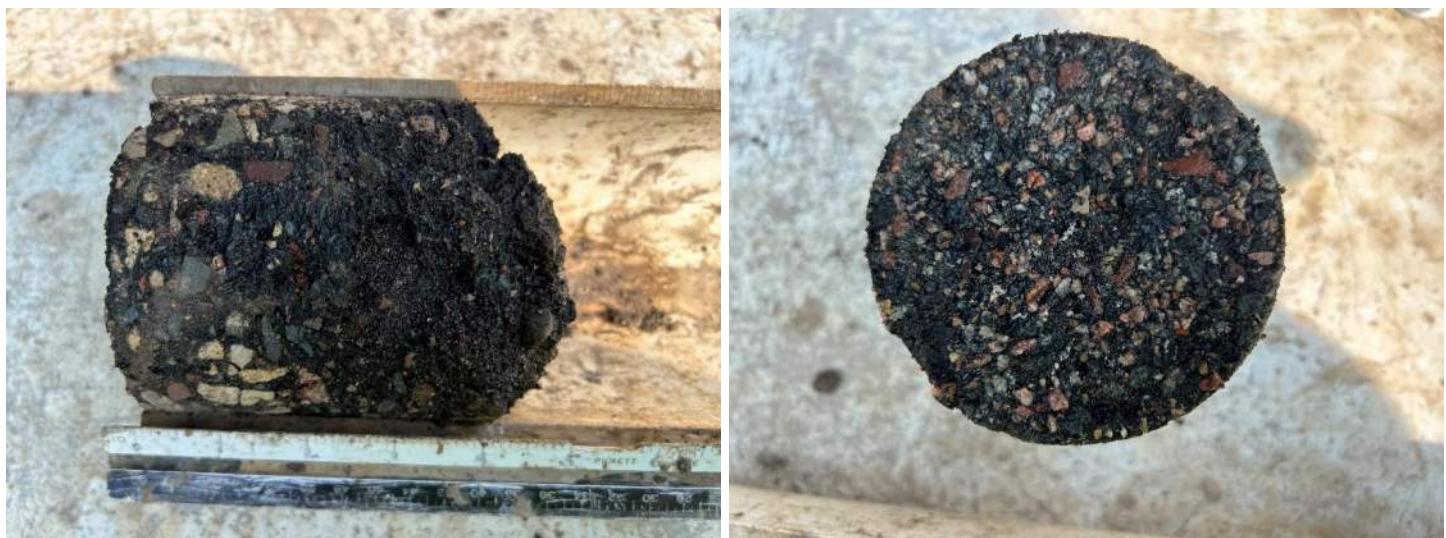
Core Photos

Location	Number of Lanes	Roadway Width (ft)	Curb and Gutter	Surface Distresses
Goose Lake Parkway West Bound	2	22	Yes	Surface stripping, Some transverse, longitudinal cracking

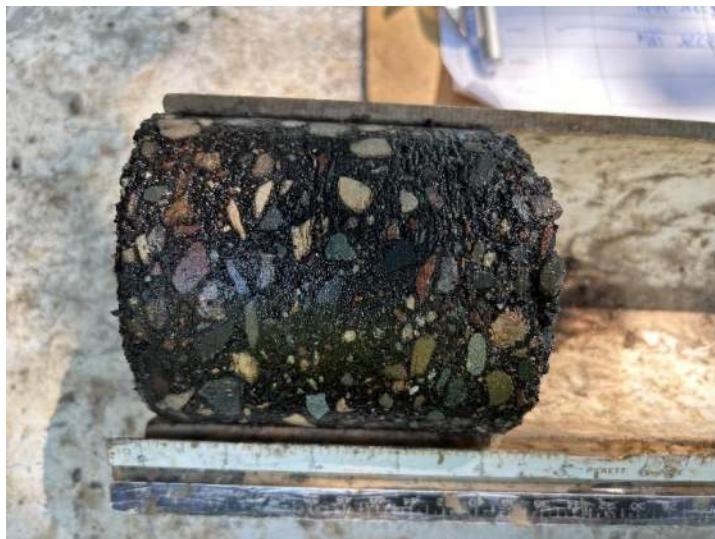
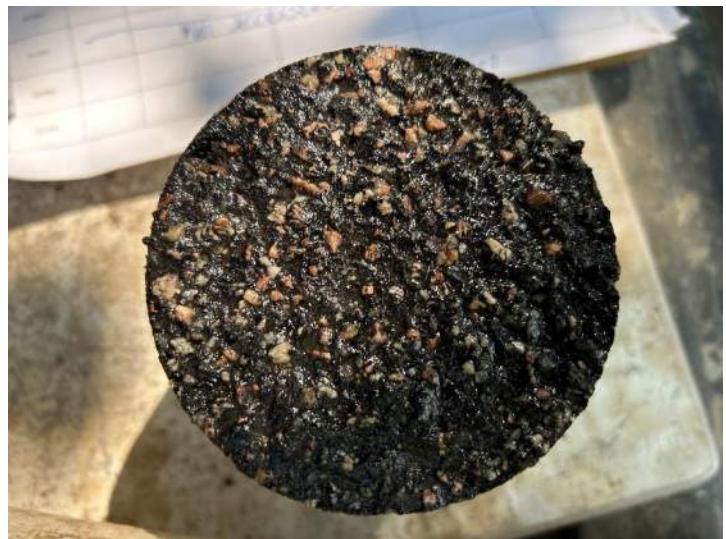
Core Photos

Location	Number of Lanes	Roadway Width (ft)	Curb and Gutter	Surface Distresses
Elm Creek Trail	2	24	Yes	Surface stripping

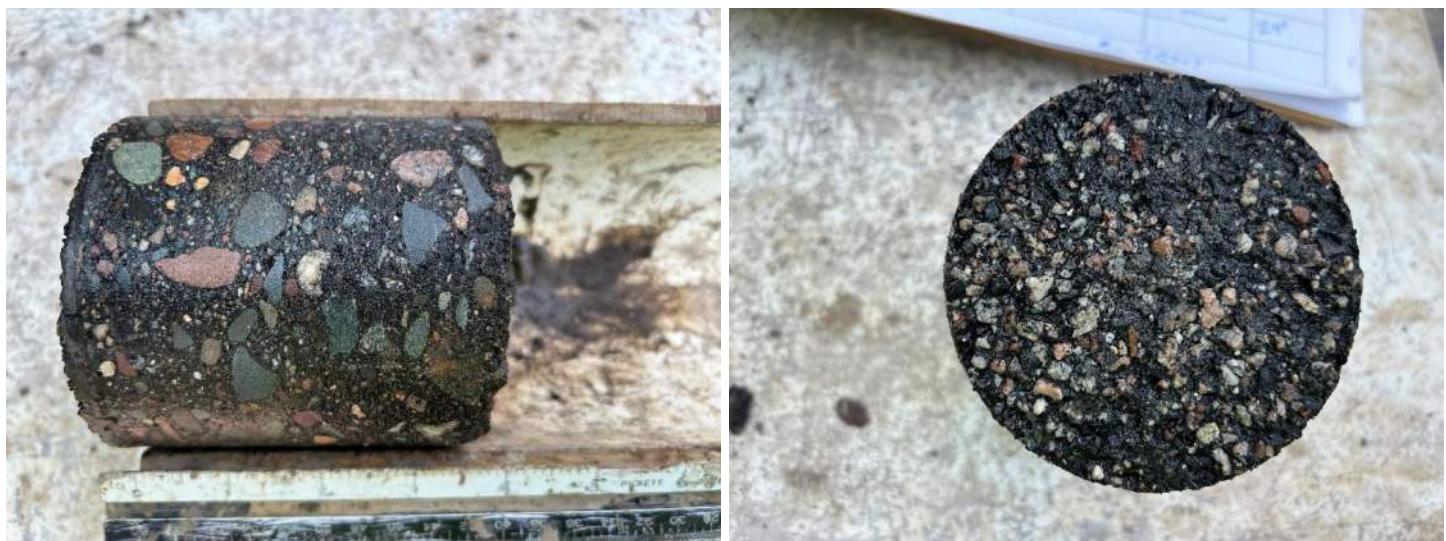
Core Photos

Location	Number of Lanes	Roadway Width (ft)	Curb and Gutter	Surface Distresses
Highview Ct	2	22	Yes	Surface stripping, some transverse cracking

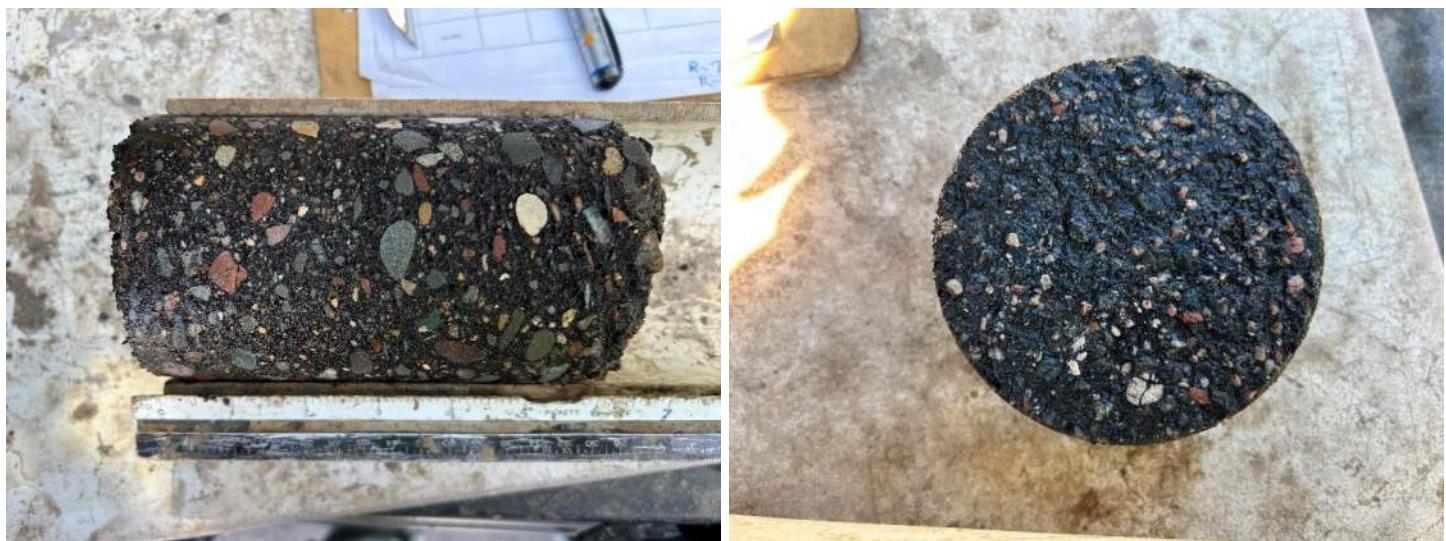
Core Photos

Location	Number of Lanes	Roadway Width (ft)	Curb and Gutter	Surface Distresses
Elm Creek Trail	2	25	Yes	Surface stripping, transverse cracking

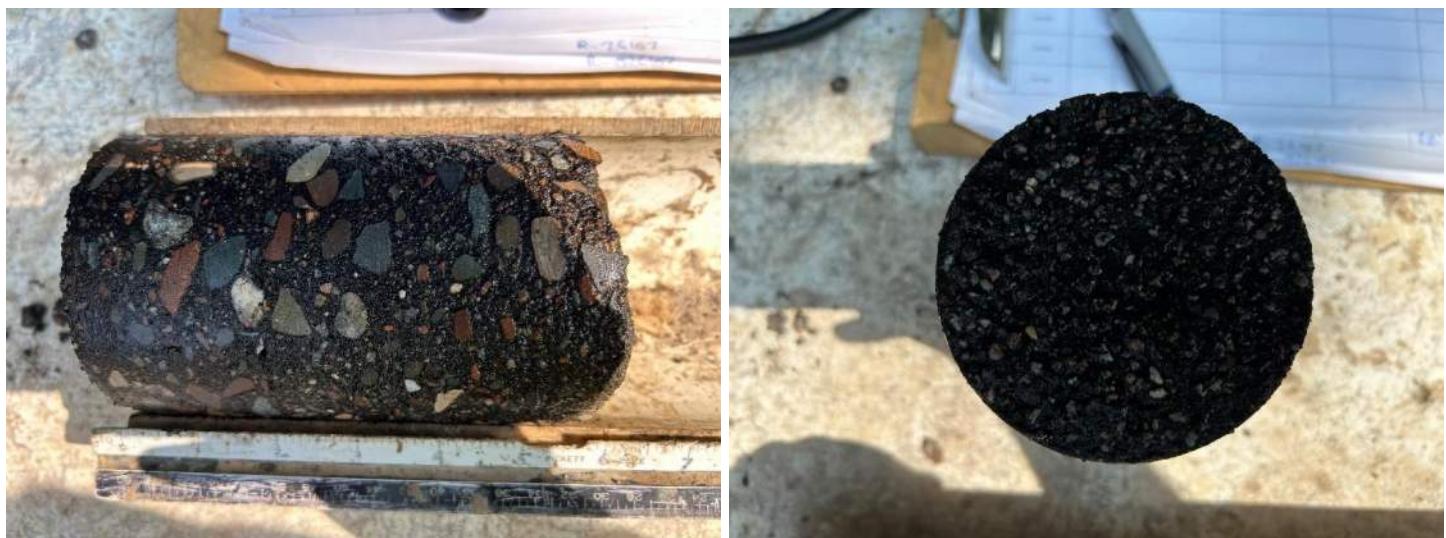
Core Photos

Location	Number of Lanes	Roadway Width (ft)	Curb and Gutter	Surface Distresses
Hilltop Ct	2	21	Yes	Surface stripping, transverse cracking

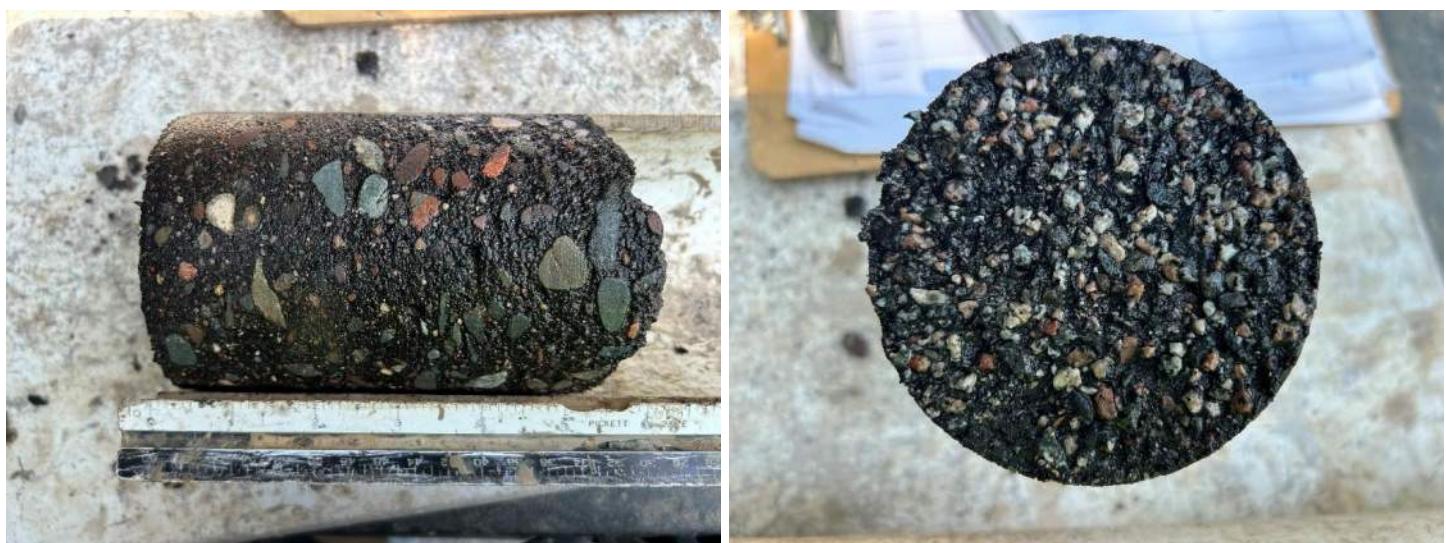
Core Photos

Location	Number of Lanes	Roadway Width (ft)	Curb and Gutter	Surface Distresses
Hilltop Ct	2	21	Yes	Surface stripping, transverse cracking

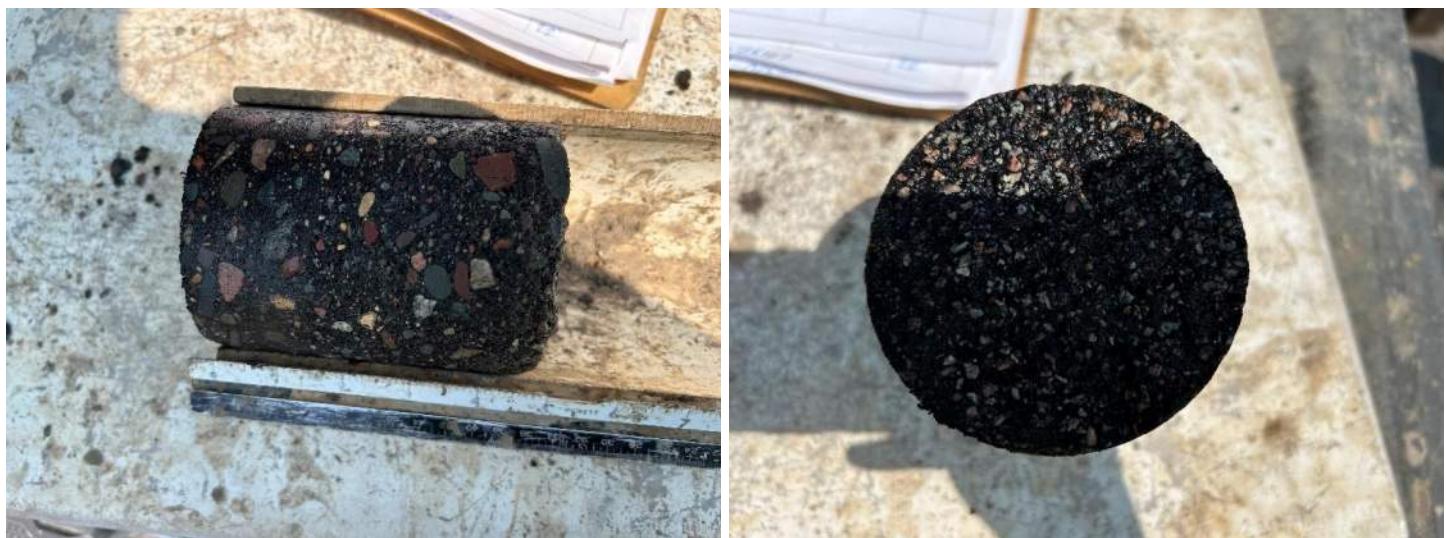
Core Photos

Location	Number of Lanes	Roadway Width (ft)	Curb and Gutter	Surface Distresses
Hilltop Ct	2	32	Yes	Surface stripping, Some transverse cracking

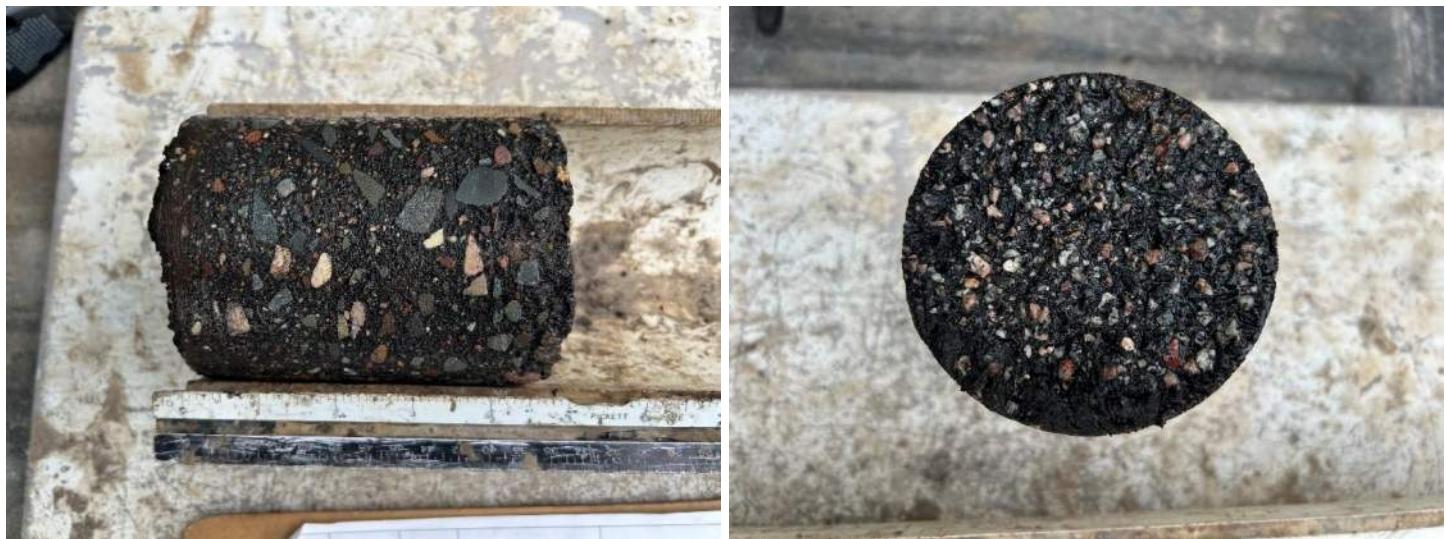
Core Photos

Location	Number of Lanes	Roadway Width (ft)	Curb and Gutter	Surface Distresses
Elm Creek Trail	2	24	Yes	Surface stripping, transverse cracking

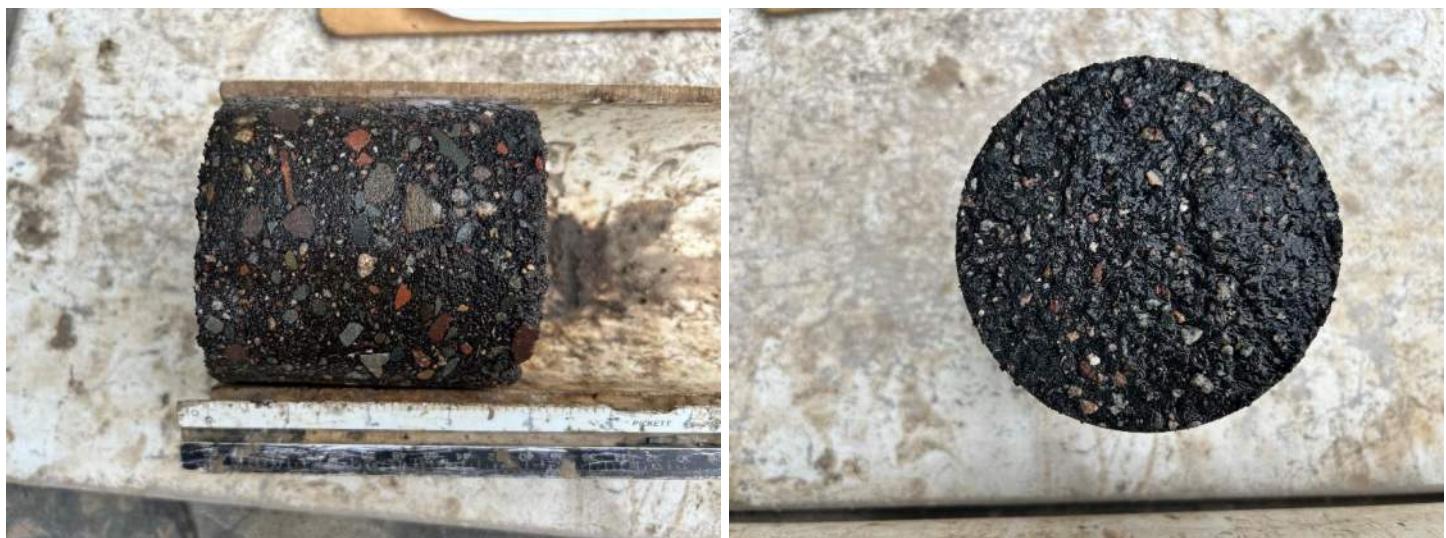
Core Photos

Location	Number of Lanes	Roadway Width (ft)	Curb and Gutter	Surface Distresses
Pondview Circle	2	22	Yes	Surface stripping, transverse cracking

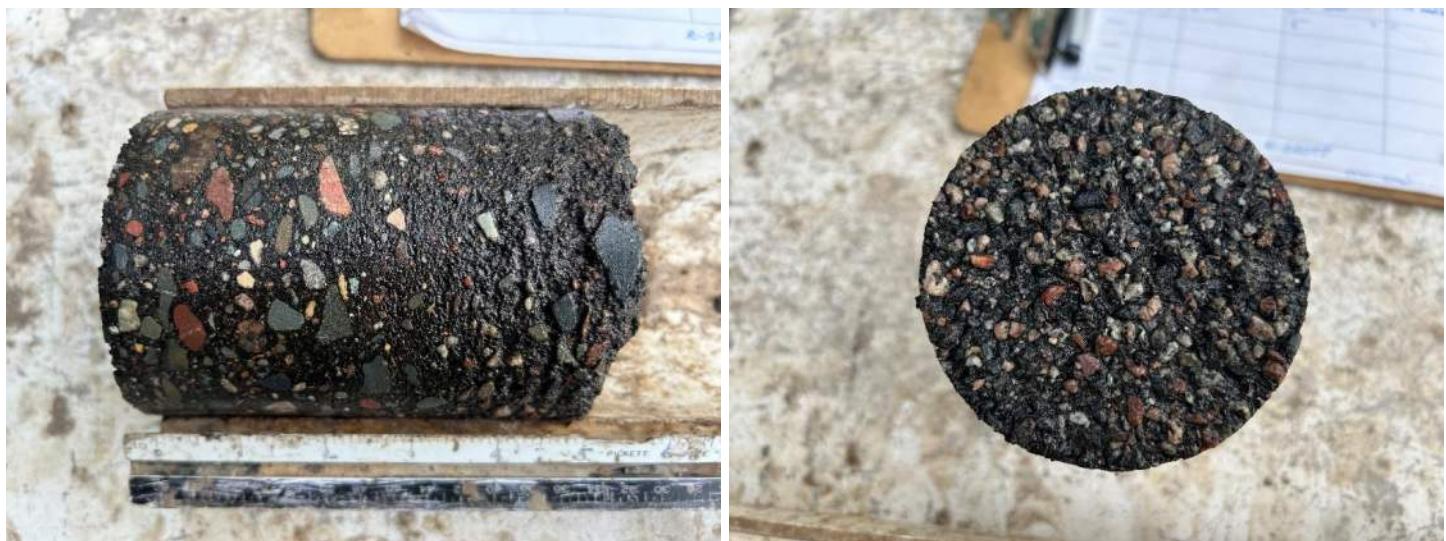
Core Photos

Location	Number of Lanes	Roadway Width (ft)	Curb and Gutter	Surface Distresses
Pondview Ct	2	21	Yes	Surface stripping, Some alligator, transverse cracking

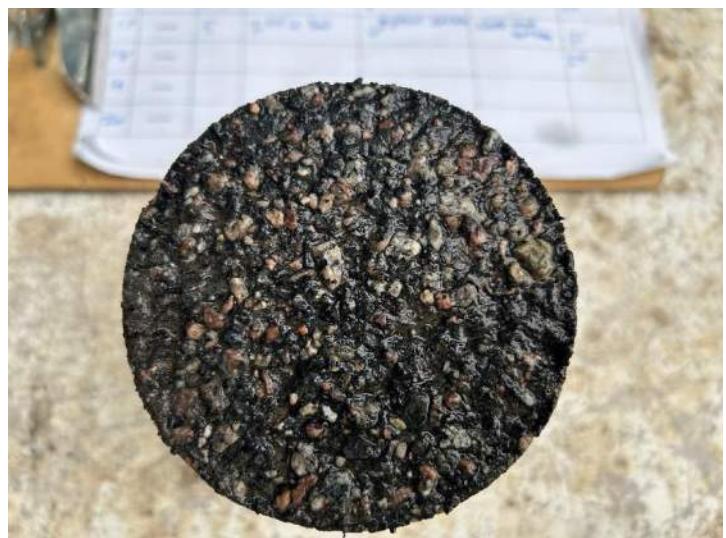
Core Photos

Location	Number of Lanes	Roadway Width (ft)	Curb and Gutter	Surface Distresses
Pondview Ct	2	24	Yes	Surface stripping, patching, transverse cracking

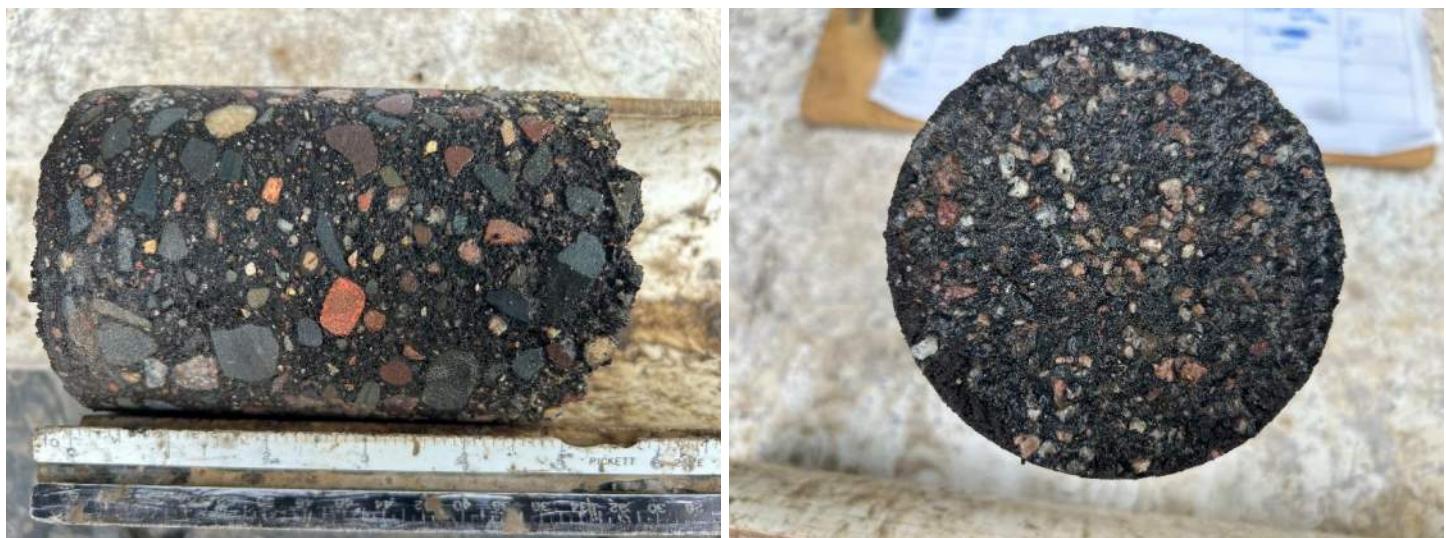
Core Photos

Location	Number of Lanes	Roadway Width (ft)	Curb and Gutter	Surface Distresses
Pondview Ct	2	24	Yes	Surface stripping, transverse, longitudinal cracking

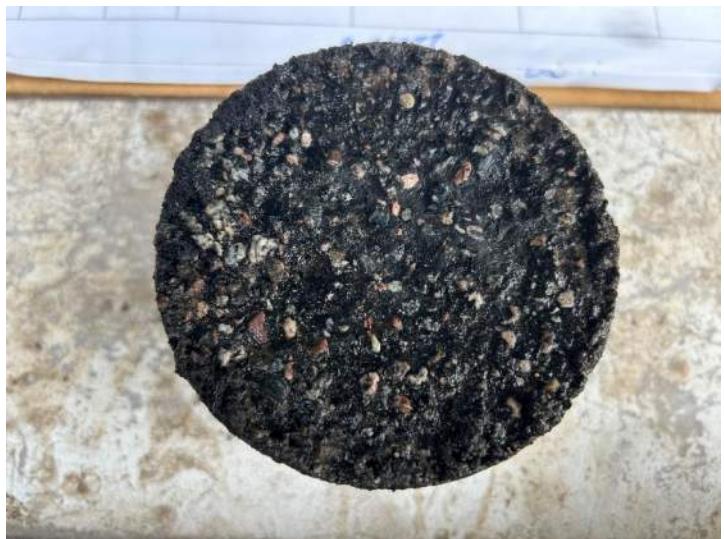
Core Photos

Location	Number of Lanes	Roadway Width (ft)	Curb and Gutter	Surface Distresses
Pondview Ct	2	24	Yes	Surface stripping, Some transverse cracking

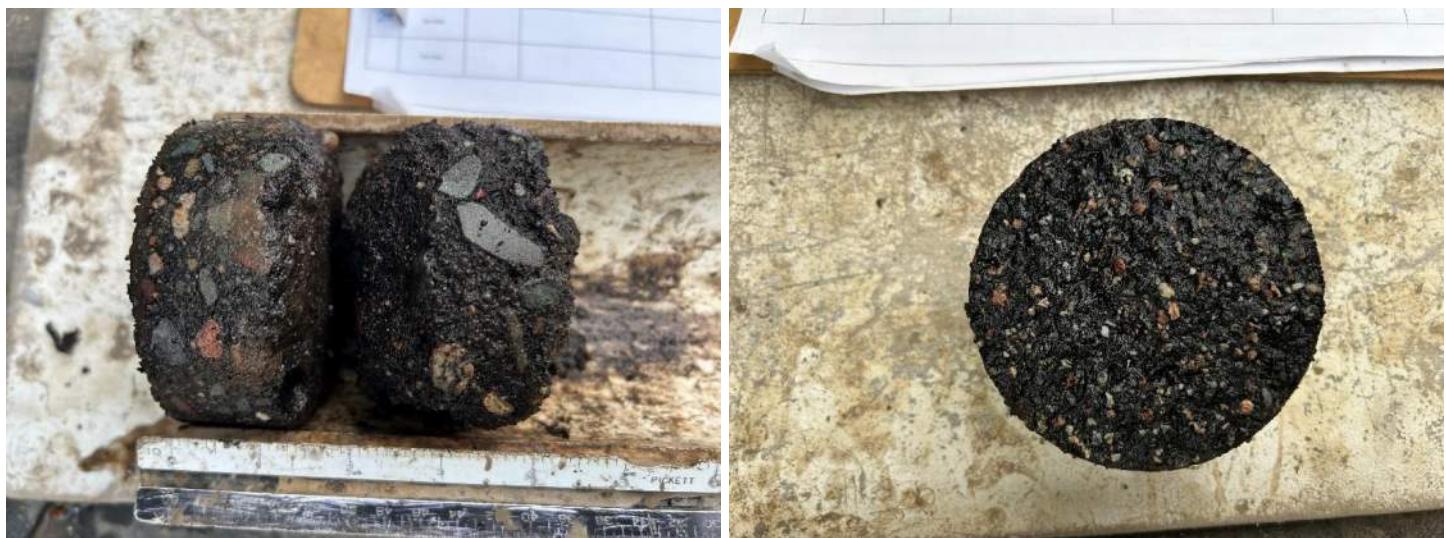
Core Photos

Location	Number of Lanes	Roadway Width (ft)	Curb and Gutter	Surface Distresses
Oakview Ct	2	22	Yes	Surface stripping, transverse cracking

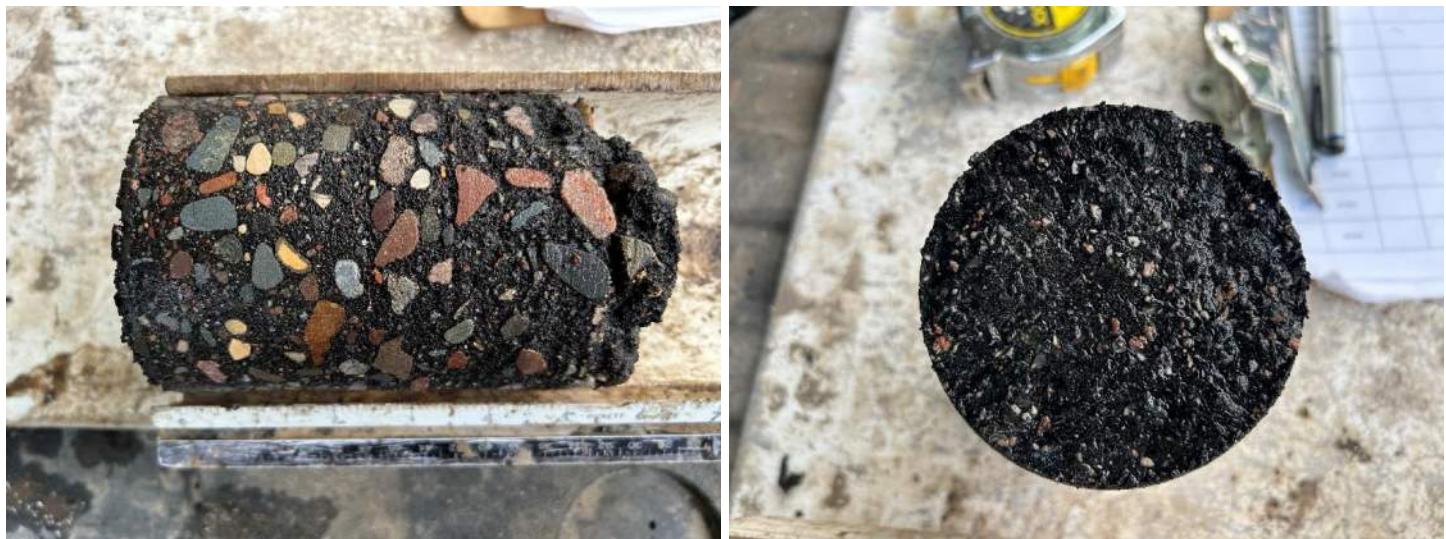
Core Photos

Location	Number of Lanes	Roadway Width (ft)	Curb and Gutter	Surface Distresses
Oakview Ct	2	24	Yes	Surface stripping, transverse cracking

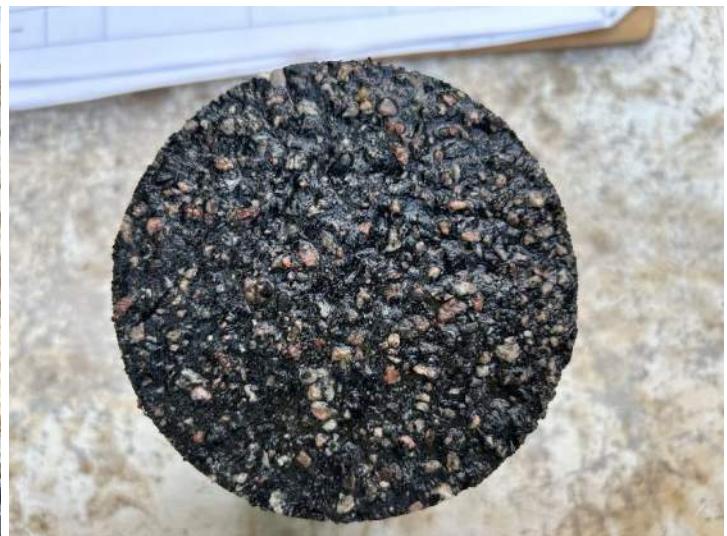
Core Photos

Location	Number of Lanes	Roadway Width (ft)	Curb and Gutter	Surface Distresses
Elm Creek Trail	2	24	Yes	Surface stripping, transverse, longitudinal cracking

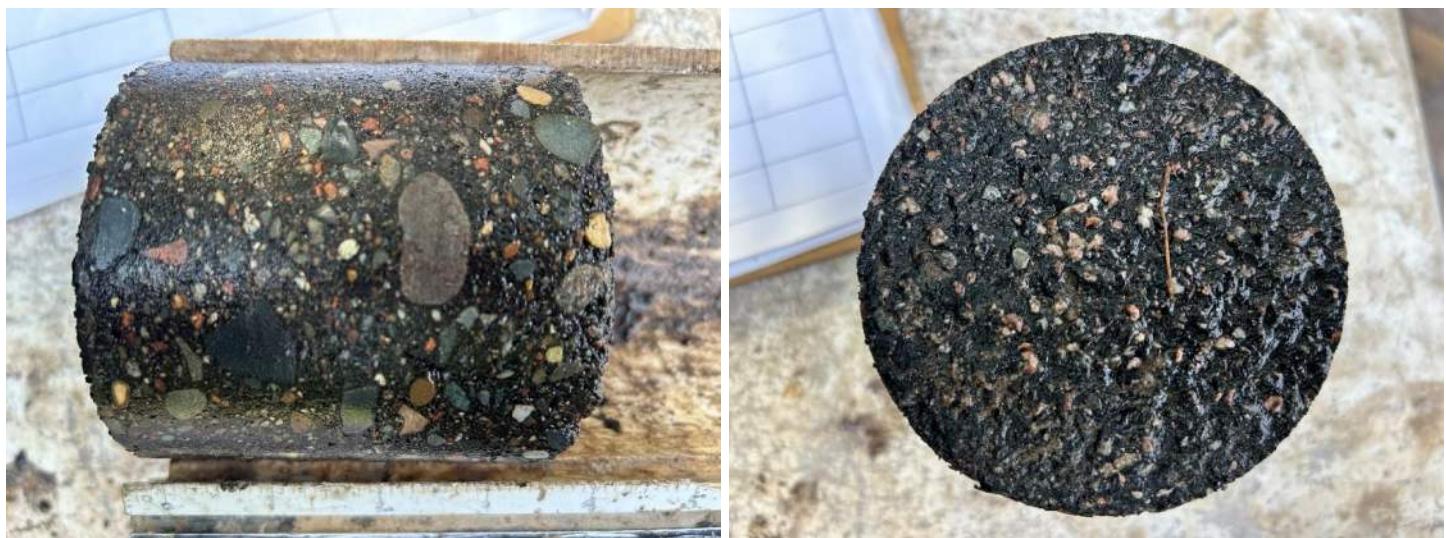
Core Photos

Location	Number of Lanes	Roadway Width (ft)	Curb and Gutter	Surface Distresses
Norway Ct	2	24	Yes	Surface stripping, transverse cracking

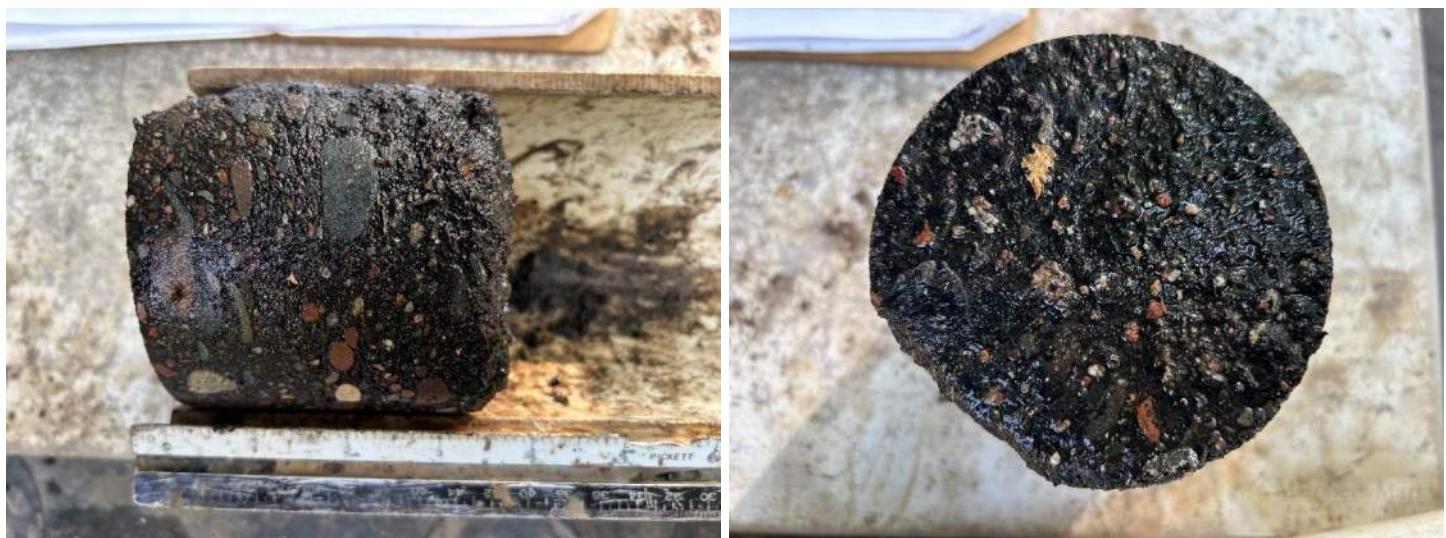
Core Photos

Location	Number of Lanes	Roadway Width (ft)	Curb and Gutter	Surface Distresses
Norway Ct	2	24	Yes	Surface stripping, alligator, transverse cracking

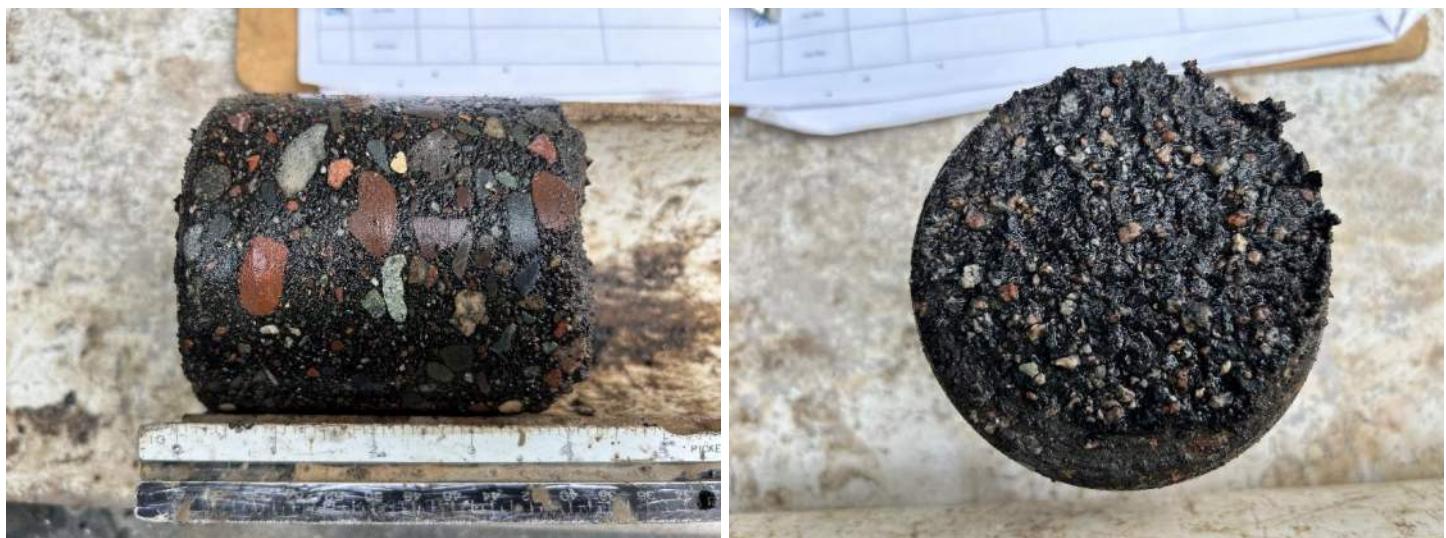
Core Photos

Location	Number of Lanes	Roadway Width (ft)	Curb and Gutter	Surface Distresses
Elm Creek Trail	2	24	Yes	Surface stripping, patching, transverse cracking

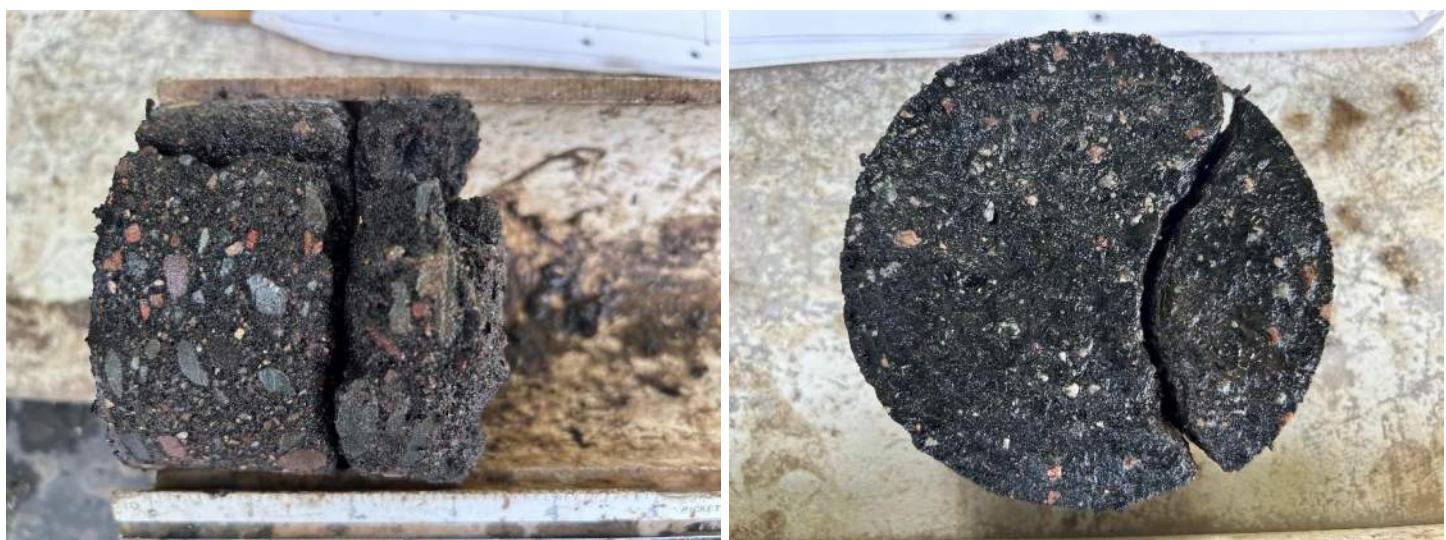
Core Photos

Location	Number of Lanes	Roadway Width (ft)	Curb and Gutter	Surface Distresses
Magnolia Ct	2	24	Yes	Surface stripping, transverse cracking

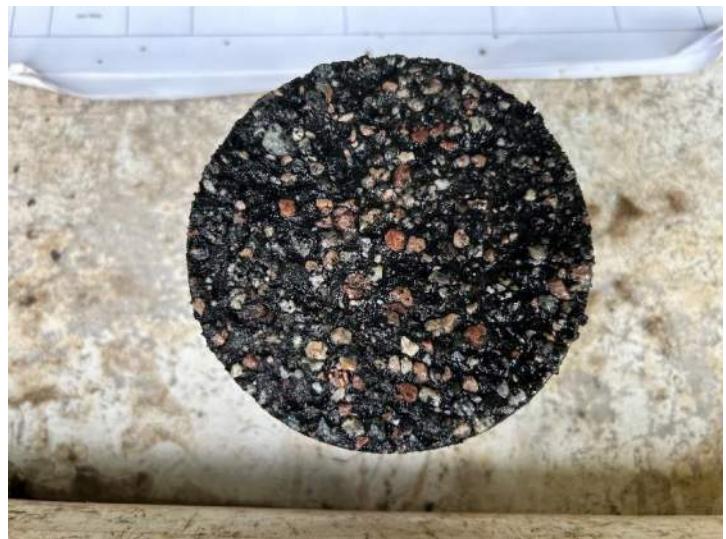
Core Photos

Location	Number of Lanes	Roadway Width (ft)	Curb and Gutter	Surface Distresses
Magnolia Ct	2	24	Yes	Surface stripping, transverse cracking

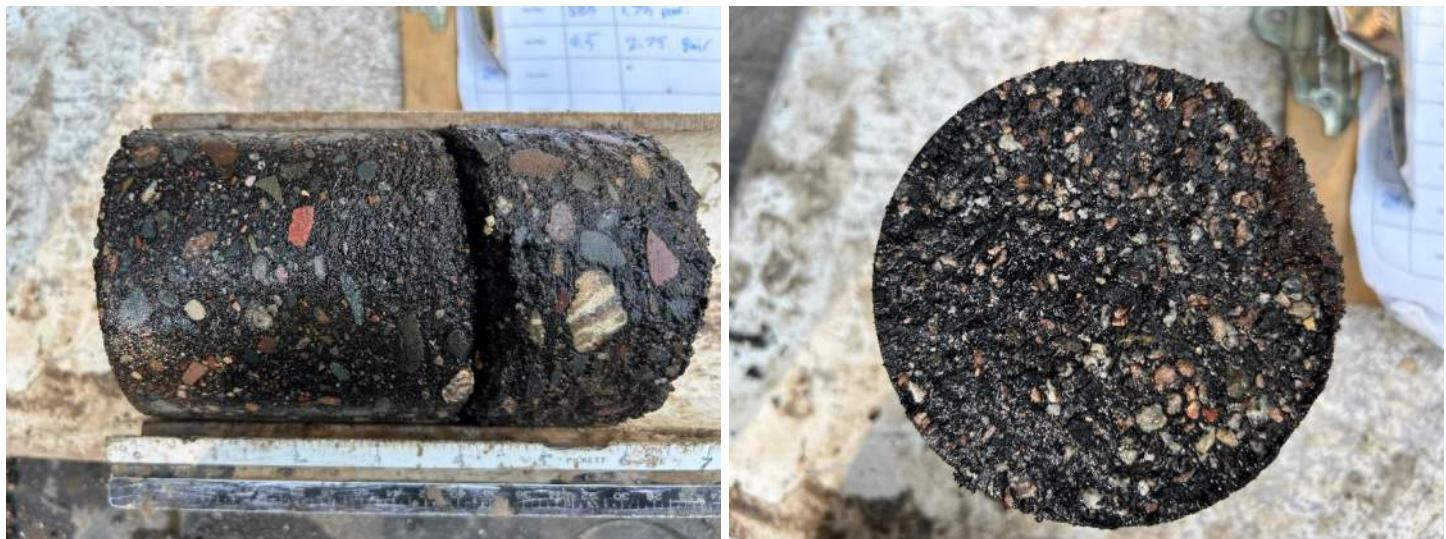
Core Photos

Location	Number of Lanes	Roadway Width (ft)	Curb and Gutter	Surface Distresses
Elm Creek Trail	2	28	Yes	Surface stripping, patching, transverse cracking
