FEASIBILITY REPORT

GOOSE LAKE PARKWAY AND ELM CREEK TRAIL AREA PROJECT

CHAMPLIN | HENNEPIN COUNTY | MINNESOTA

CITY PROJECT NO. 22502
SAP 193-121-001
WSB PROJECT NO. 026077-000

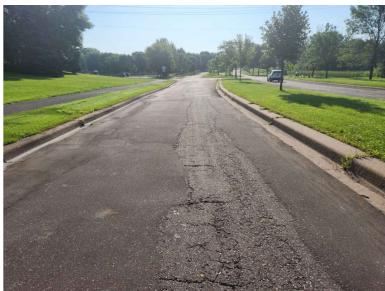
GOOSE LAKE PKWY

The existing bituminous surface conditions in general exhibit surface deterioration with significant cracking and settlement areas. It is becoming brittle due to age and general wear and tear and is showing signs of accelerated deterioration. Examples of the existing bituminous pavement are shown on **Figure 4** in **Appendix A**.

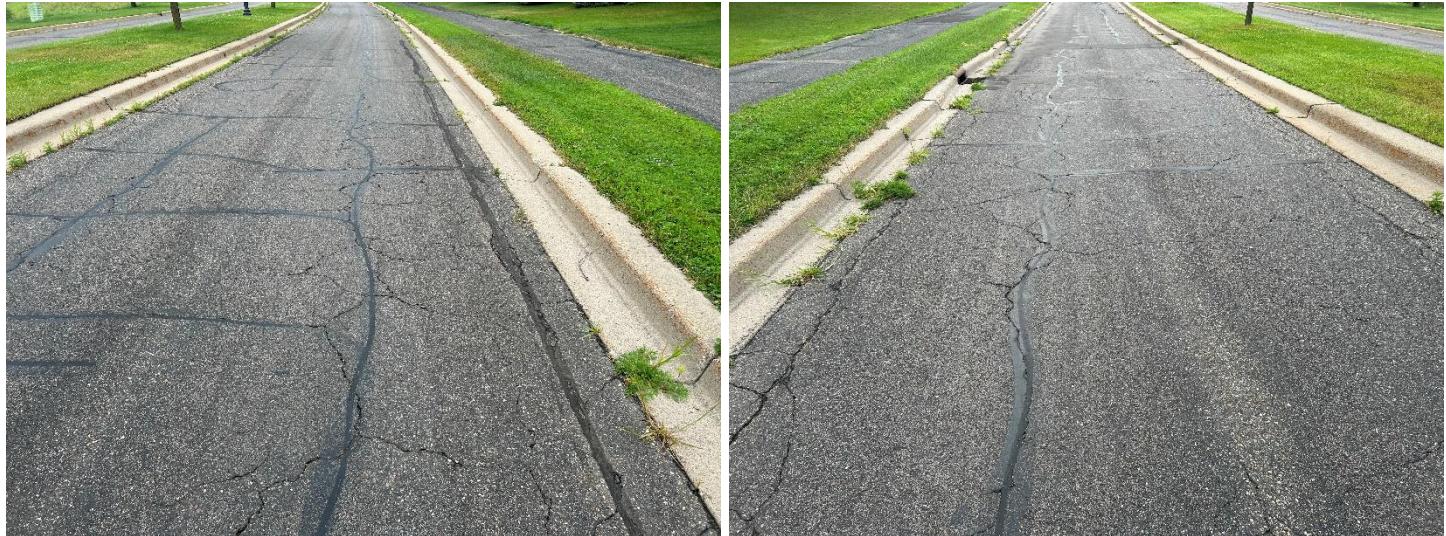
Core 8

Location	Number of Lanes	Roadway Width (ft)	Curb and Gutter	Surface Distresses
Goose Lake Parkway West Bound	1	13	Yes	Surface stripping, Longitudinal, transverse cracking

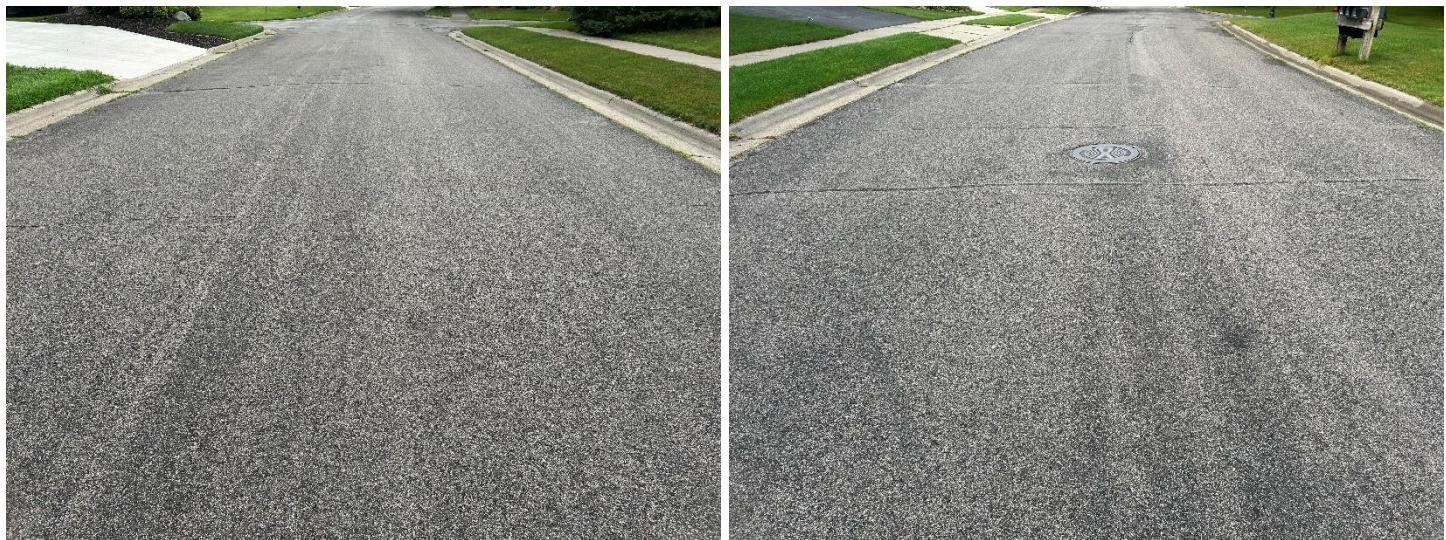
Core 15

Location	Number of Lanes	Roadway Width (ft)	Curb and Gutter	Surface Distresses
Elm Creek Trail	2	24	Yes	Surface stripping, transverse cracking

Bituminous Depth (in)	Lift Thickness and Condition	Base Depth and Description	Subbase or Subgrade Description
4.5	2" - Wear 2.5" - Base Fair - Some base layer raveling	4" - Sand trace gravel, brown	f-m Sand, brown

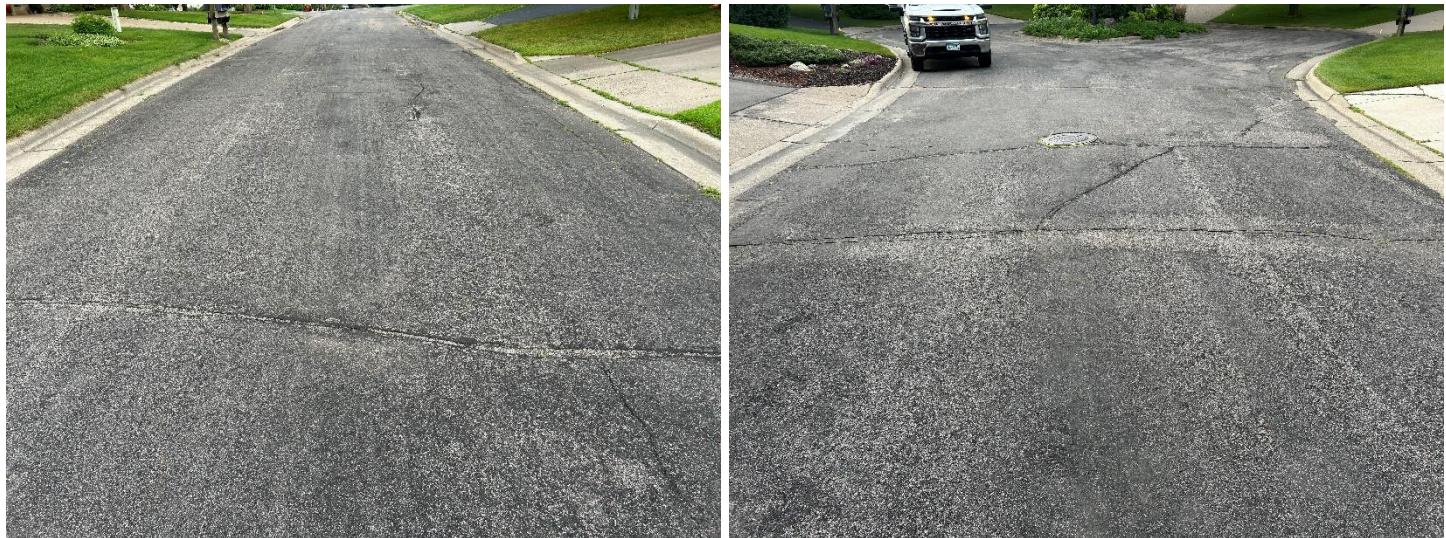
Core 16

Location	Number of Lanes	Roadway Width (ft)	Curb and Gutter	Surface Distresses
Pondview Circle	2	22	Yes	Surface stripping, transverse cracking

Bituminous Depth (in)	Lift Thickness and Condition	Base Depth and Description	Subbase or Subgrade Description
3.75	1.75" - Wear 2" - Base Fair - Some base layer raveling	6" - Sand trace gravel, brown	f-m Sand, brown

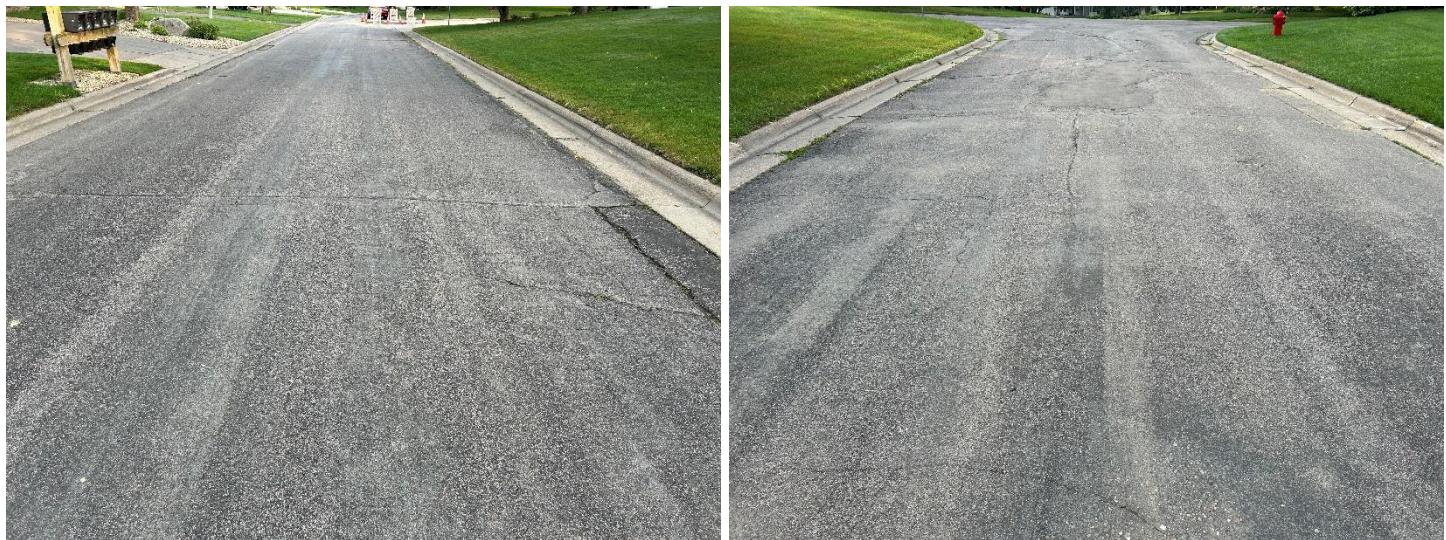
Core 17

Location	Number of Lanes	Roadway Width (ft)	Curb and Gutter	Surface Distresses
Pondview Ct	2	21	Yes	Surface stripping, Some alligator, transverse cracking

Bituminous Depth (in)	Lift Thickness and Condition	Base Depth and Description	Subbase or Subgrade Description
5	2.5" - Wear 2.5" - Base Poor - Base layer raveling	4" - Gravel, light brown	Clayey Sand, Light brown

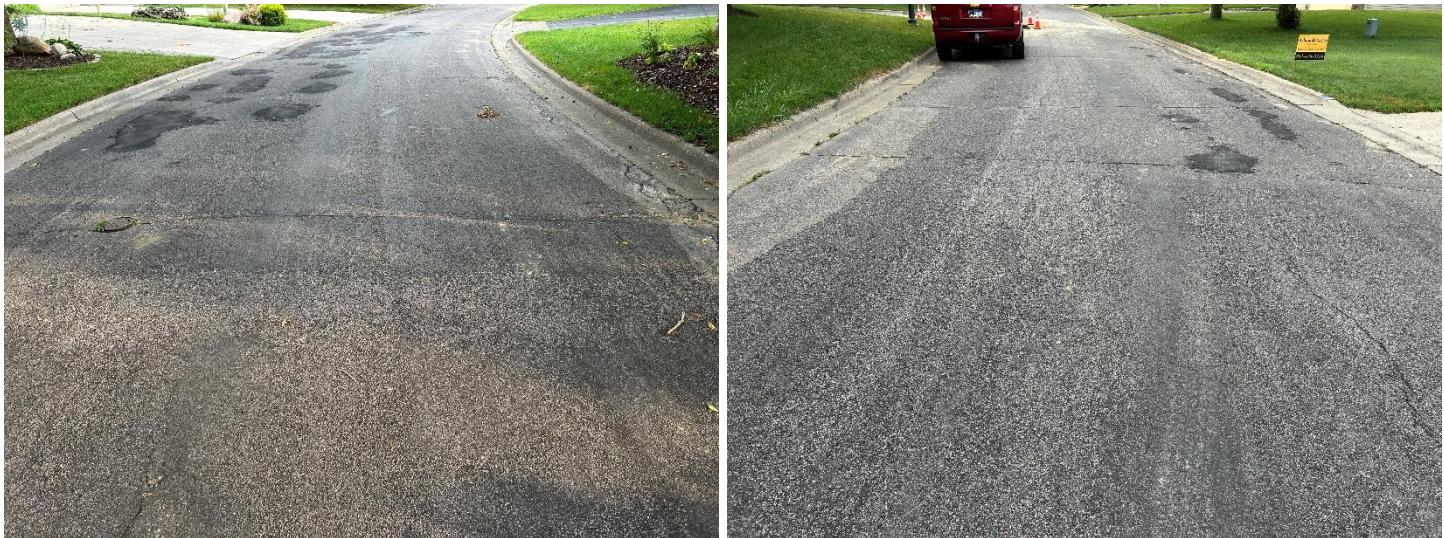
Core 18

Location	Number of Lanes	Roadway Width (ft)	Curb and Gutter	Surface Distresses
Pondview Ct	2	24	Yes	Surface stripping, patching, transverse cracking

Bituminous Depth (in)	Lift Thickness and Condition	Base Depth and Description	Subbase or Subgrade Description
5	2.5" - Wear 2.5" - Base Poor - Raveling	7" - Gravel, Light brown	Clay, brown

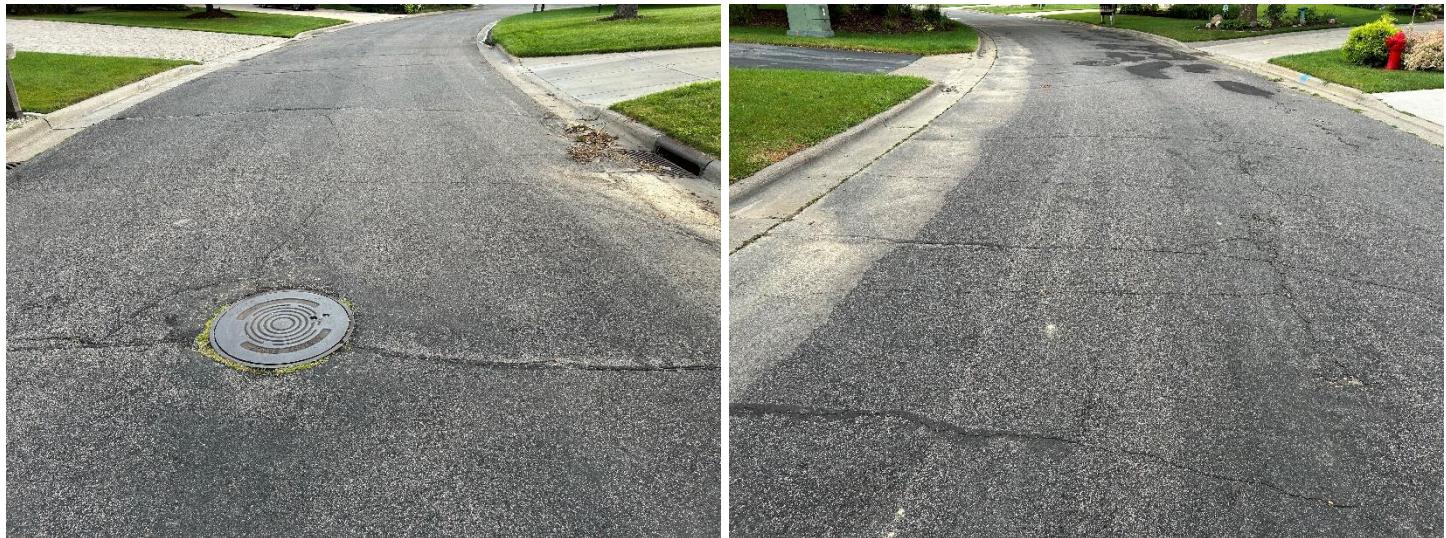
Core 19

Location	Number of Lanes	Roadway Width (ft)	Curb and Gutter	Surface Distresses
Pondview Ct	2	24	Yes	Surface stripping, transverse, longitudinal cracking

Bituminous Depth (in)	Lift Thickness and Condition	Base Depth and Description	Subbase or Subgrade Description
5	2.25" - Wear 2.75" - Base Fair - Some base layer raveling	8.5" - Sand with gravel, light brown	Clay, brown

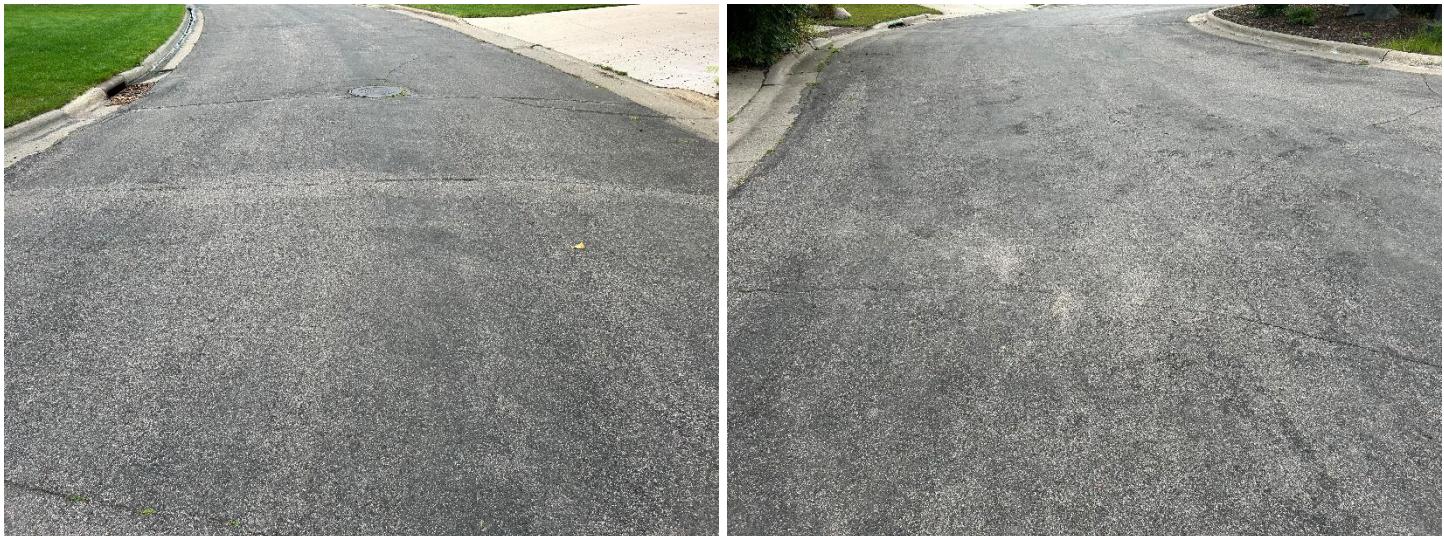
Core 20

Location	Number of Lanes	Roadway Width (ft)	Curb and Gutter	Surface Distresses
Pondview Ct	2	24	Yes	Surface stripping, Some transverse cracking

Bituminous Depth (in)	Lift Thickness and Condition	Base Depth and Description	Subbase or Subgrade Description
5	2.5" - Wear 2.5" - Base Poor - Raveling	5" - Sand with gravel, light brown	Clay, brown

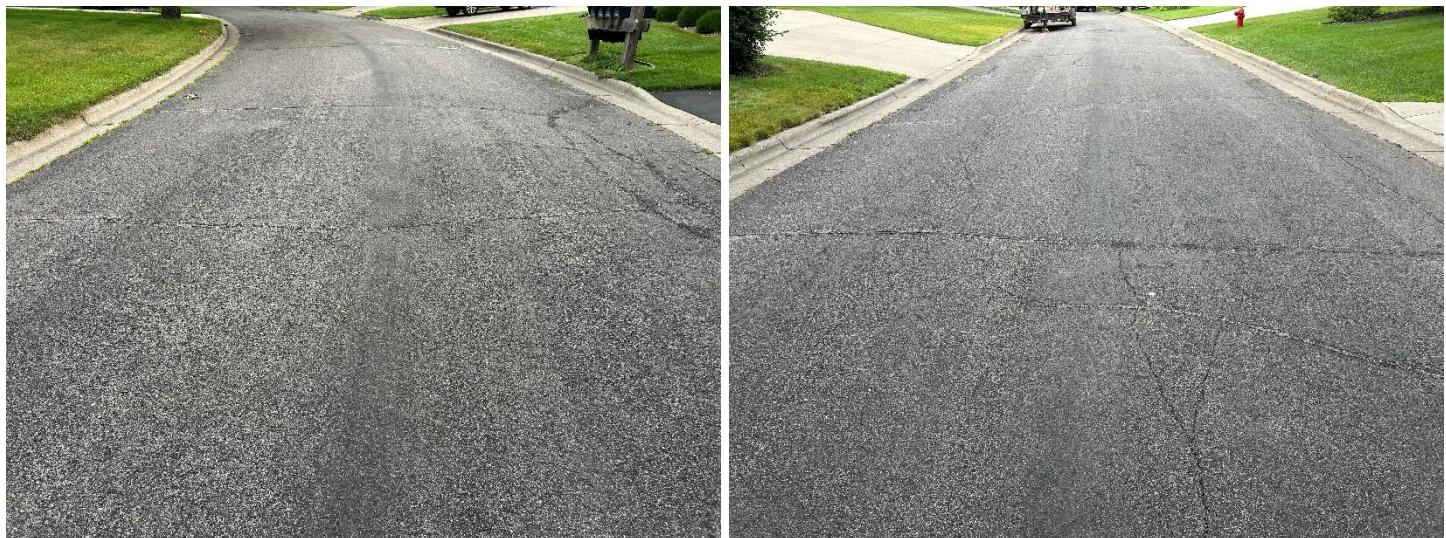
Core 21

Location	Number of Lanes	Roadway Width (ft)	Curb and Gutter	Surface Distresses
Oakview Ct	2	22	Yes	Surface stripping, transverse cracking

Bituminous Depth (in)	Lift Thickness and Condition	Base Depth and Description	Subbase or Subgrade Description
4	1.75" - Wear 2.25" - Base Poor - Raveling	6" - Sand with gravel, light brown	Clayey Sand, brown

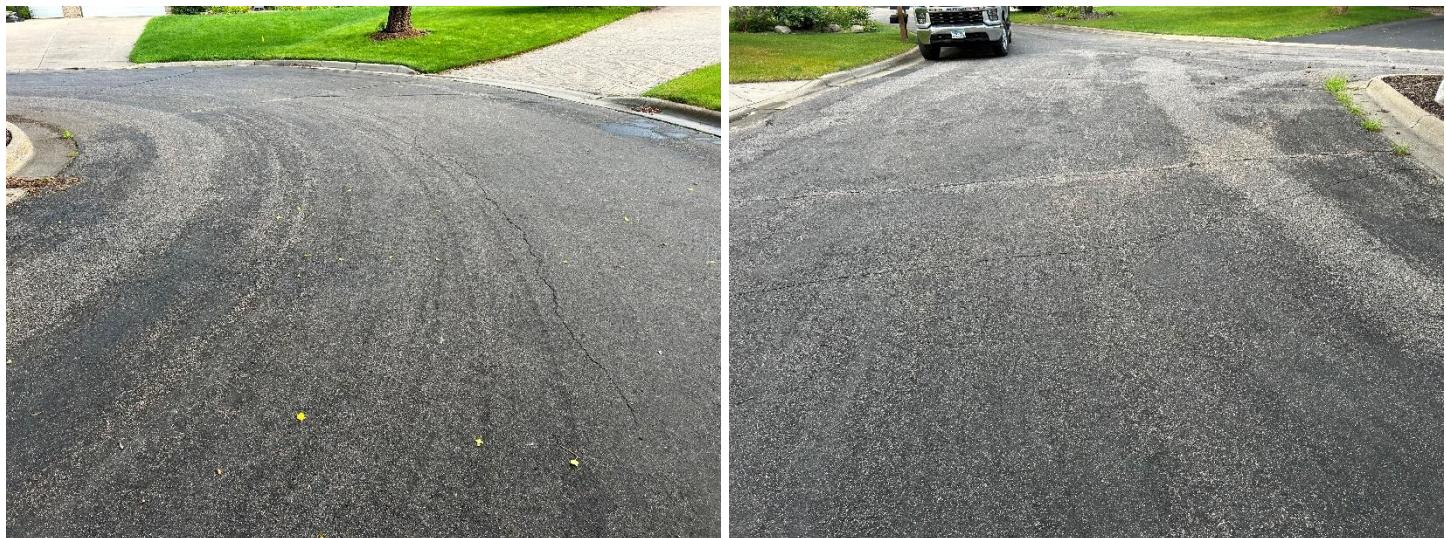
Core 22

Location	Number of Lanes	Roadway Width (ft)	Curb and Gutter	Surface Distresses
Oakview Ct	2	24	Yes	Surface stripping, transverse cracking

Bituminous Depth (in)	Lift Thickness and Condition	Base Depth and Description	Subbase or Subgrade Description
5.5	2.5" - Wear 3" - Base Poor - Raveling	5" - Sand with gravel, light brown	Clayey Sand, brown

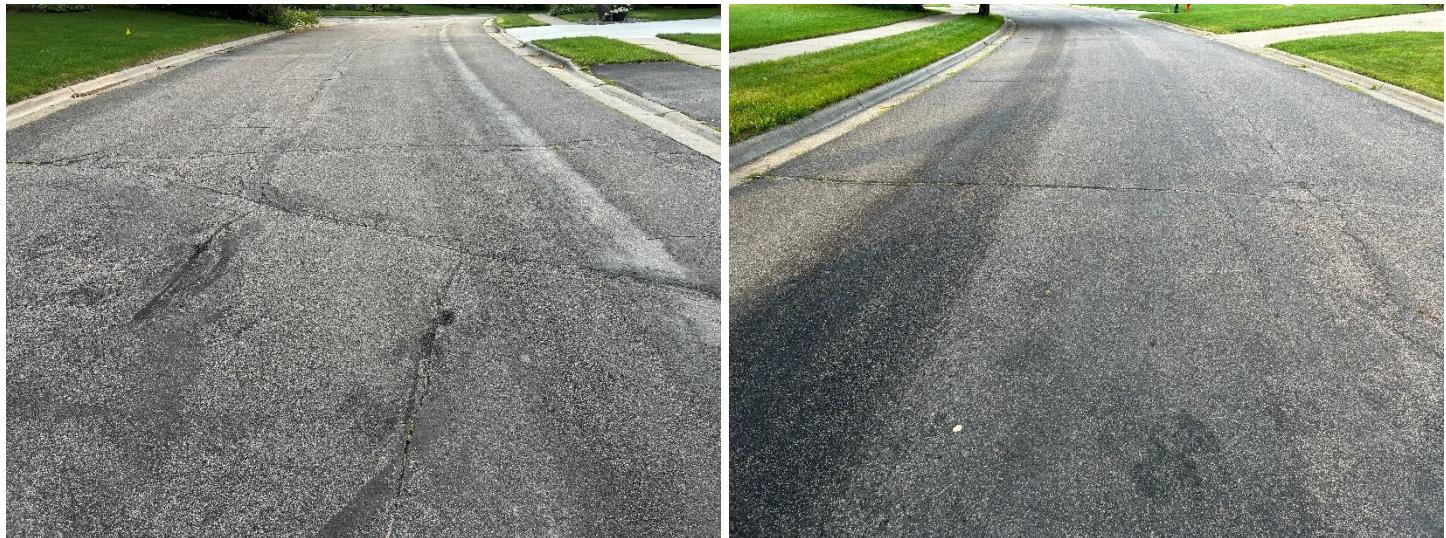
Core 23

Location	Number of Lanes	Roadway Width (ft)	Curb and Gutter	Surface Distresses
Elm Creek Trail	2	24	Yes	Surface stripping, transverse, longitudinal cracking

Bituminous Depth (in)	Lift Thickness and Condition	Base Depth and Description	Subbase or Subgrade Description
4	2.25" - Wear 1.75" - Base Fair - Some base layer raveling	4" - Sand trace gravel, brown	f-m Sand, brown

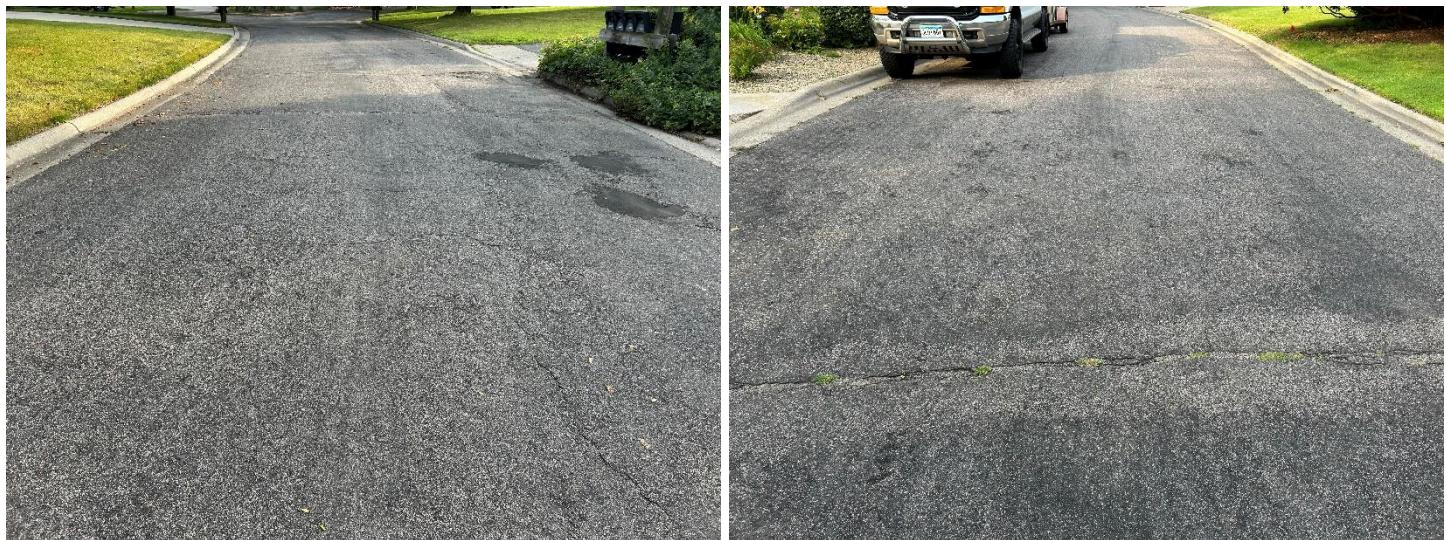
Core 24

Location	Number of Lanes	Roadway Width (ft)	Curb and Gutter	Surface Distresses
Norway Ct	2	24	Yes	Surface stripping, transverse cracking

Bituminous Depth (in)	Lift Thickness and Condition	Base Depth and Description	Subbase or Subgrade Description
3.5	2" - Wear 1.5" - Base Good Condition	4" - Sand trace gravel, brown	f-m Sand, brown

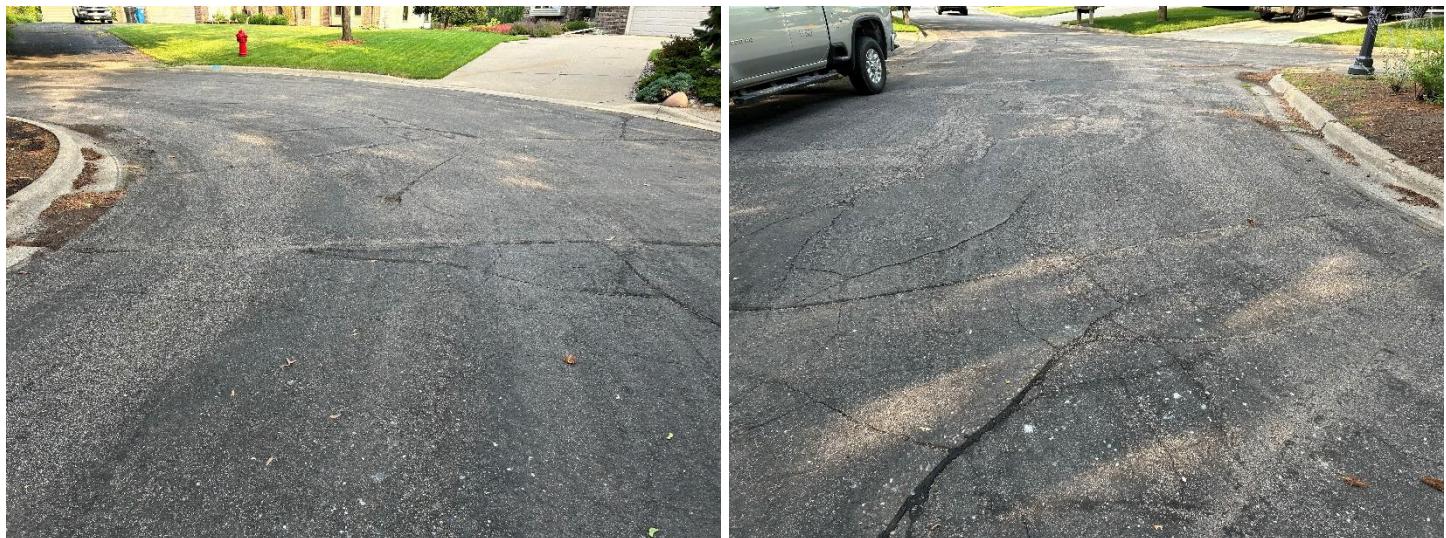
Core 25

Location	Number of Lanes	Roadway Width (ft)	Curb and Gutter	Surface Distresses
Norway Ct	2	24	Yes	Surface stripping, alligator, transverse cracking

Bituminous Depth (in)	Lift Thickness and Condition	Base Depth and Description	Subbase or Subgrade Description
3.5	1.75" - Wear 1.75" - Base Poor - Raveling	4" - Sand trace gravel, brown	f-m Sand, brown

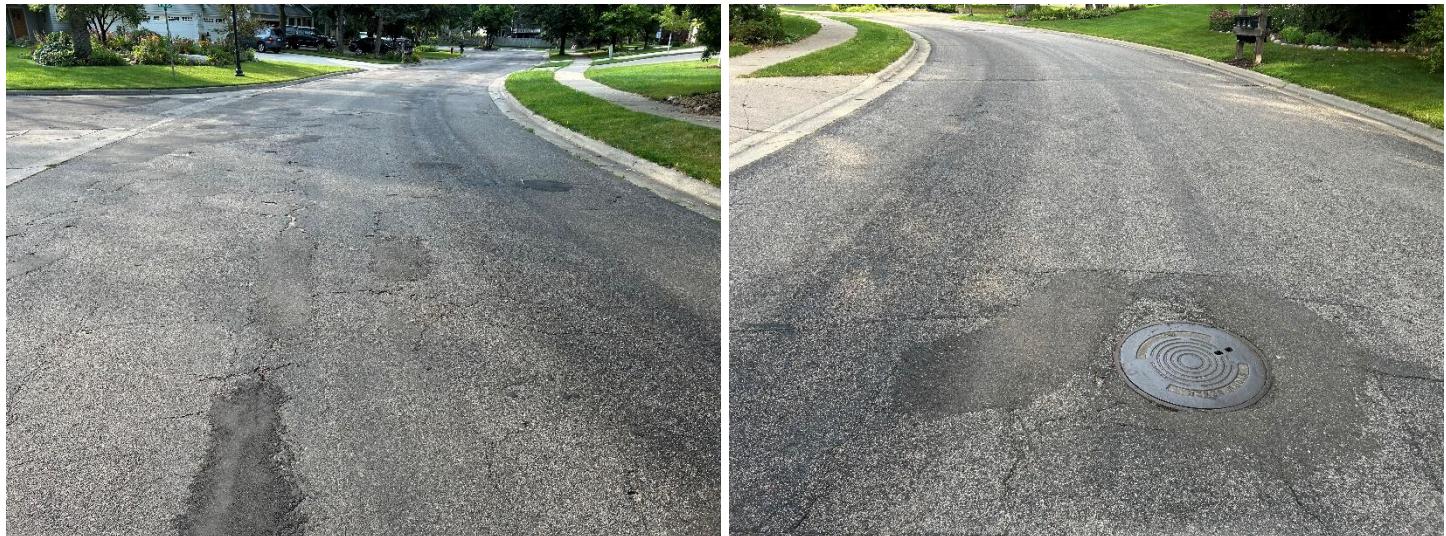
Core 26

Location	Number of Lanes	Roadway Width (ft)	Curb and Gutter	Surface Distresses
Elm Creek Trail	2	24	Yes	Surface stripping, patching, transverse cracking

Bituminous Depth (in)	Lift Thickness and Condition	Base Depth and Description	Subbase or Subgrade Description
4	2.25" Wear 1.75" - Base Fair - Some base layer raveling	4" - Sand trace gravel, brown	Sand trace gravel, brown

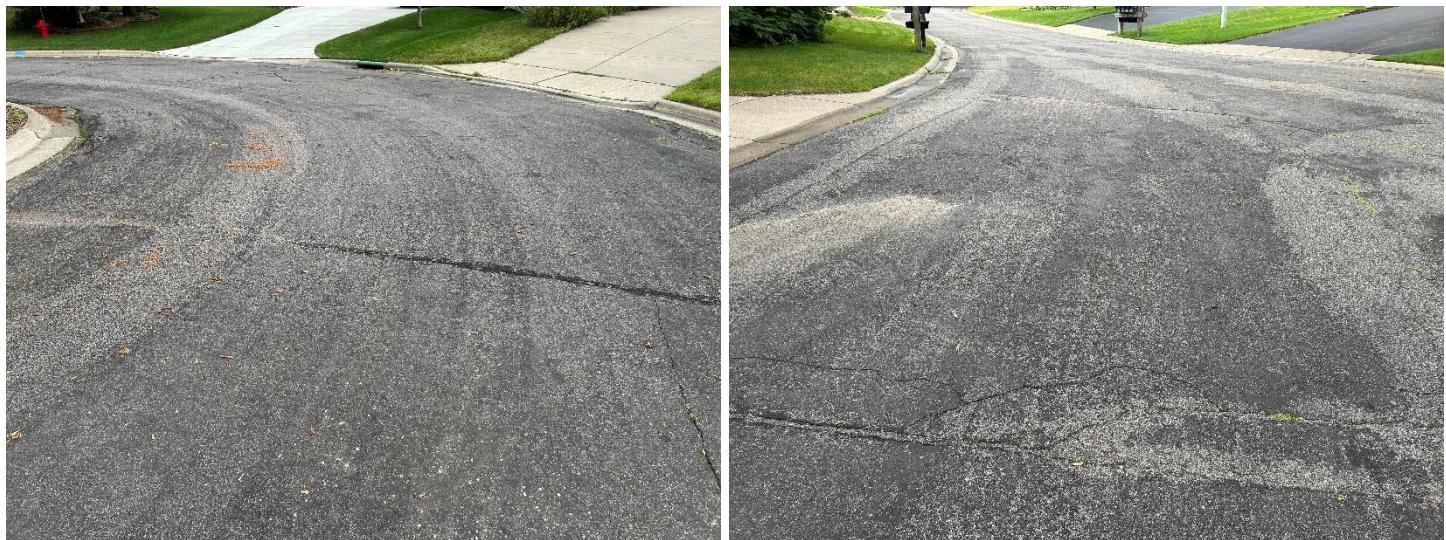
Core 27

Location	Number of Lanes	Roadway Width (ft)	Curb and Gutter	Surface Distresses
Magnolia Ct	2	24	Yes	Surface stripping, transverse cracking

Bituminous Depth (in)	Lift Thickness and Condition	Base Depth and Description	Subbase or Subgrade Description
3.25	2" - Wear 1.25" - Base Poor - Raveling	5" - Sand trace gravel, brown	f-m Sand, brown

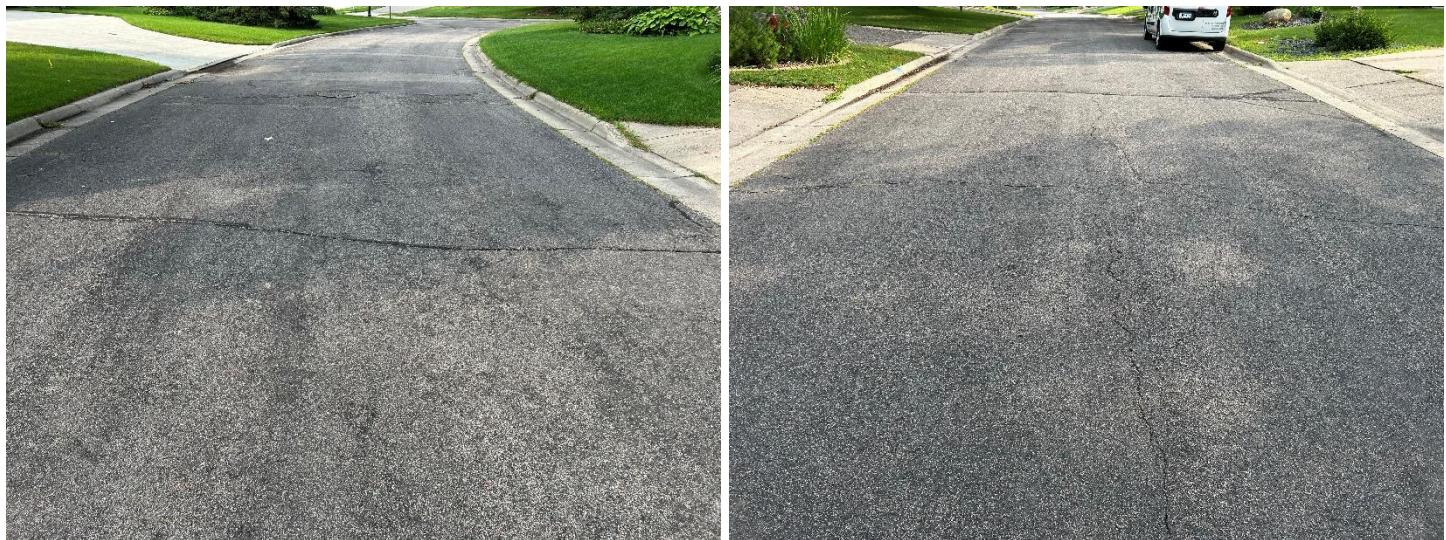
Core 28

Location	Number of Lanes	Roadway Width (ft)	Curb and Gutter	Surface Distresses
Magnolia Ct	2	24	Yes	Surface stripping, transverse cracking

Bituminous Depth (in)	Lift Thickness and Condition	Base Depth and Description	Subbase or Subgrade Description
4.5	3" - Wear 1.5" - Base Poor - Raveling	4" - Sand trace gravel, brown	f-m Sand, brown

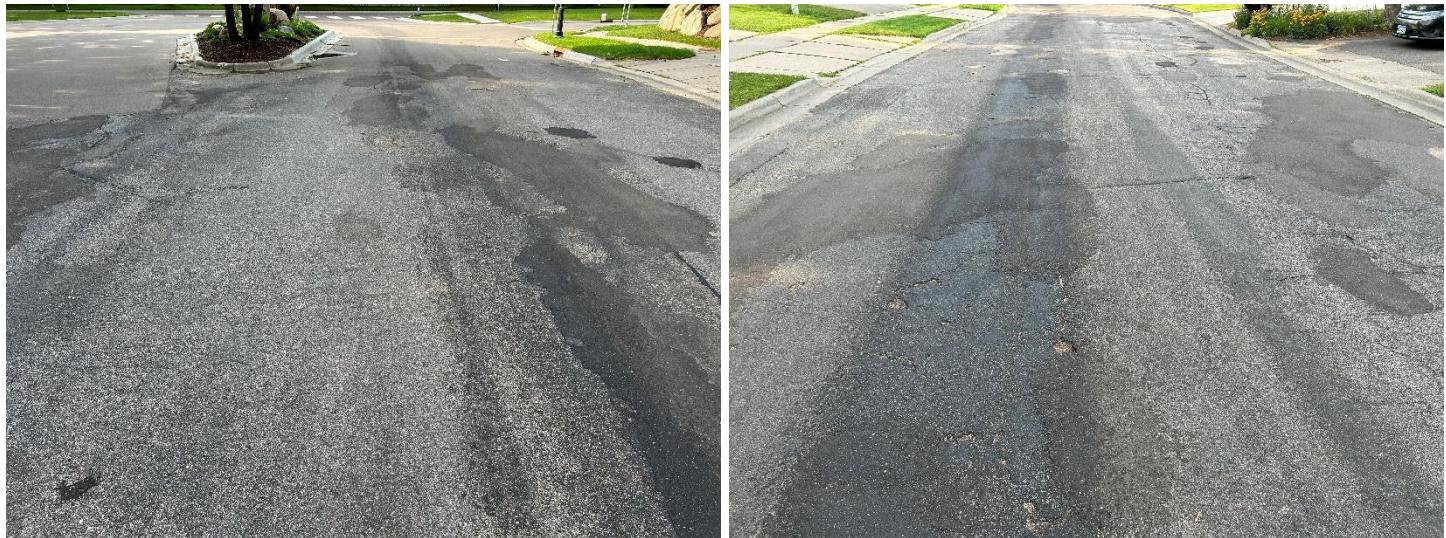
Core 29

Location	Number of Lanes	Roadway Width (ft)	Curb and Gutter	Surface Distresses
Elm Creek Trail	2	28	Yes	Surface stripping, patching, transverse cracking

Bituminous Depth (in)	Lift Thickness and Condition	Base Depth and Description	Subbase or Subgrade Description
6.25	2.25" - Wear (3+ Lifts of material) Poor - Base layer raveling	4" - Sand trace gravel, brown	f-m Sand, brown

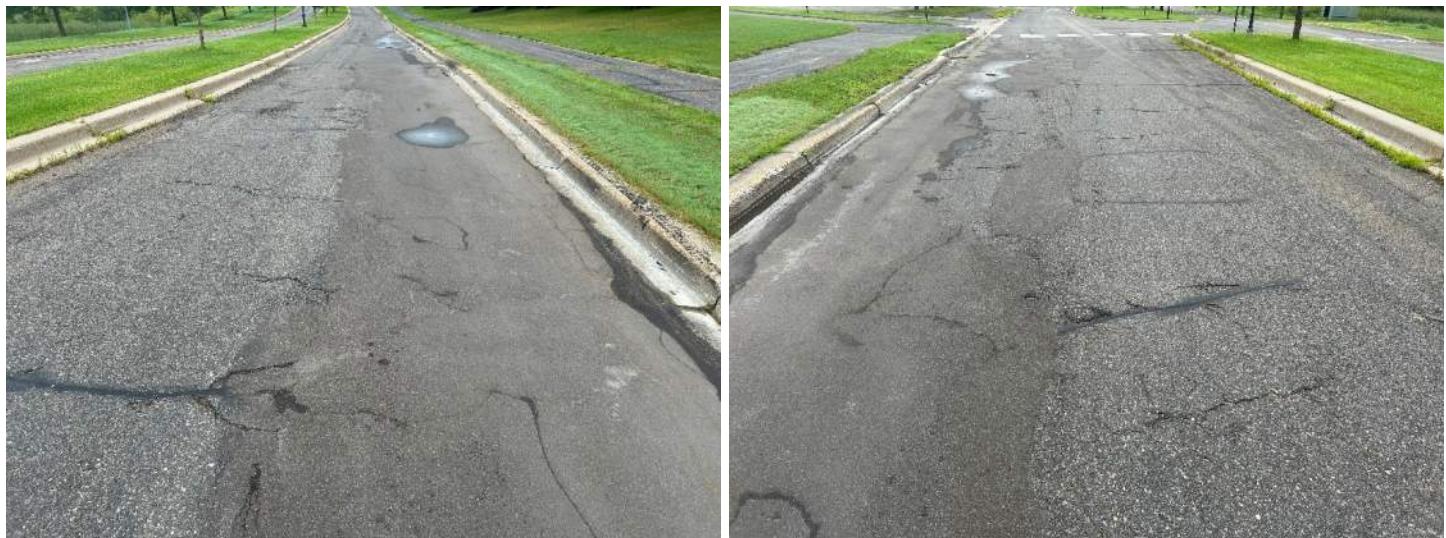
Core 7

Location	Number of Lanes	Roadway Width (ft)	Curb and Gutter	Surface Distresses
Goose Lake Parkway West Bound	1	13	Yes	Surface stripping, Patching, Transverse cracking

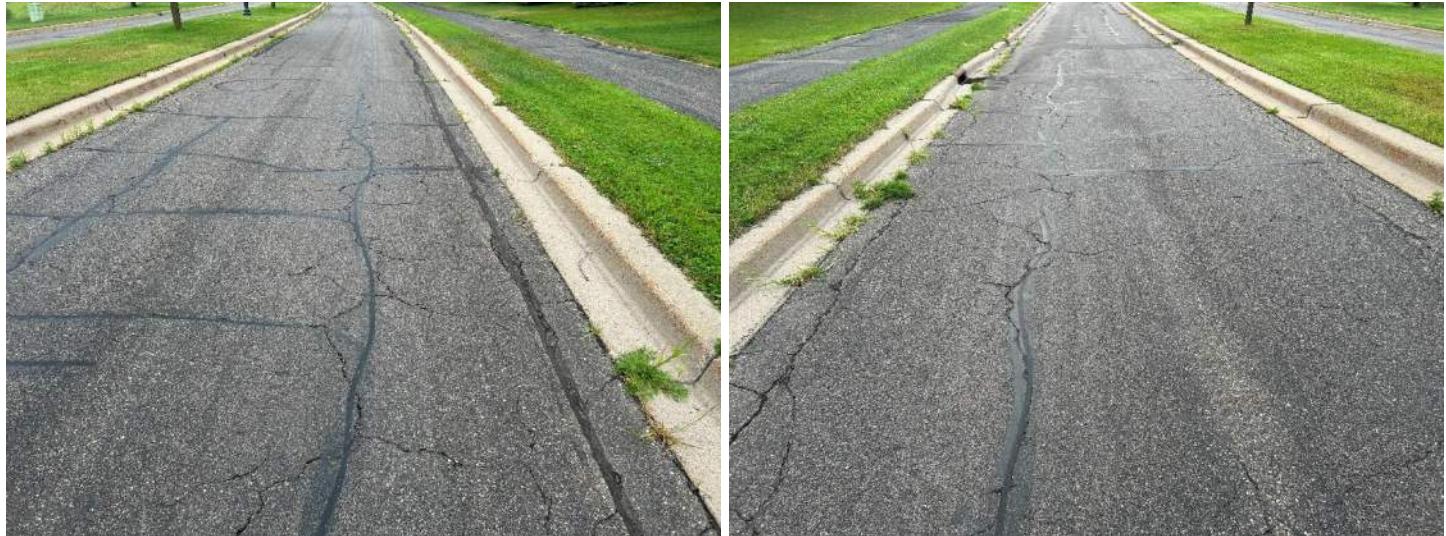
Core 8

Location	Number of Lanes	Roadway Width (ft)	Curb and Gutter	Surface Distresses
Goose Lake Parkway West Bound	1	13	Yes	Surface stripping, Longitudinal, transverse cracking

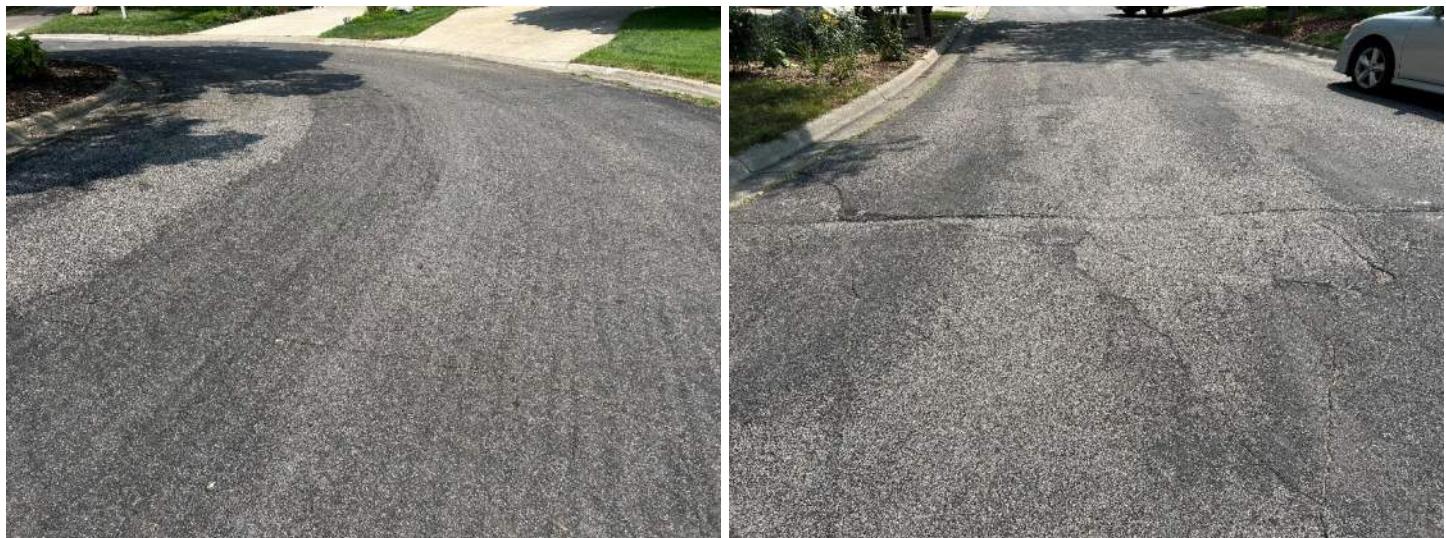
Core 14

Location	Number of Lanes	Roadway Width (ft)	Curb and Gutter	Surface Distresses
Hilltop Ct	2	32	Yes	Surface stripping, Some transverse cracking

Bituminous Depth (in)	Lift Thickness and Condition	Base Depth and Description	Subbase or Subgrade Description
4.5	1.5" - Wear 3" - Base Fair - Some raveling	5" - Sand with gravel, light brown	Clay, light brown

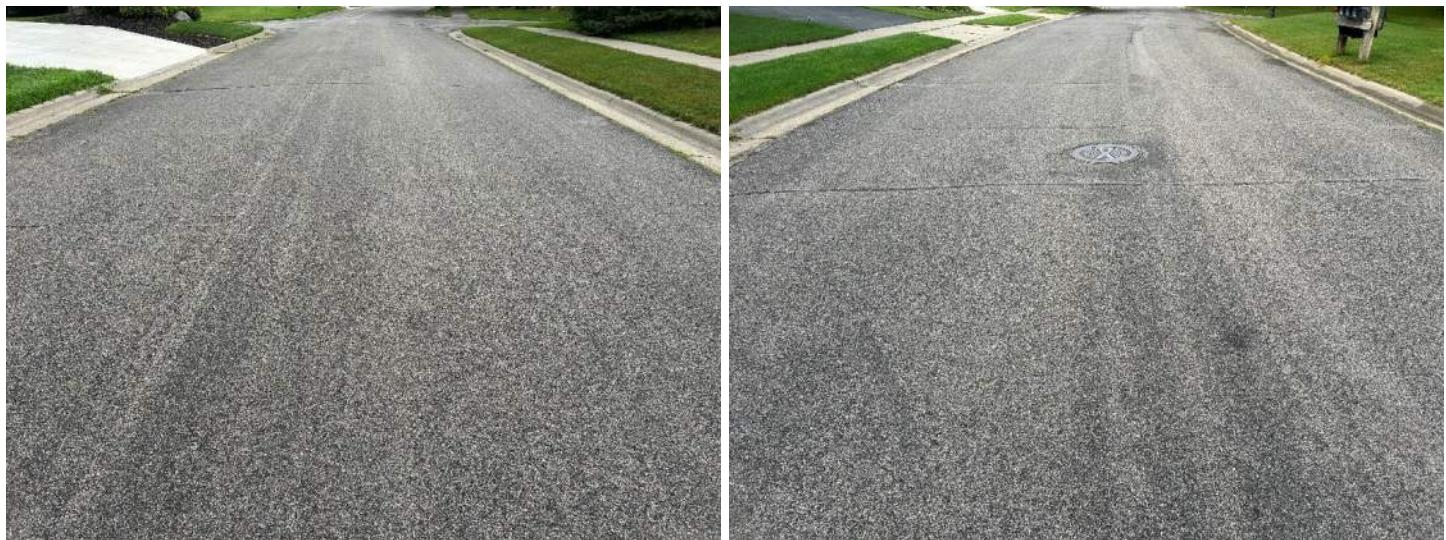
Core 15

Location	Number of Lanes	Roadway Width (ft)	Curb and Gutter	Surface Distresses
Elm Creek Trail	2	24	Yes	Surface stripping, transverse cracking

Bituminous Depth (in)	Lift Thickness and Condition	Base Depth and Description	Subbase or Subgrade Description
4.5	2" - Wear 2.5" - Base Fair - Some base layer raveling	4" - Sand trace gravel, brown	f-m Sand, brown

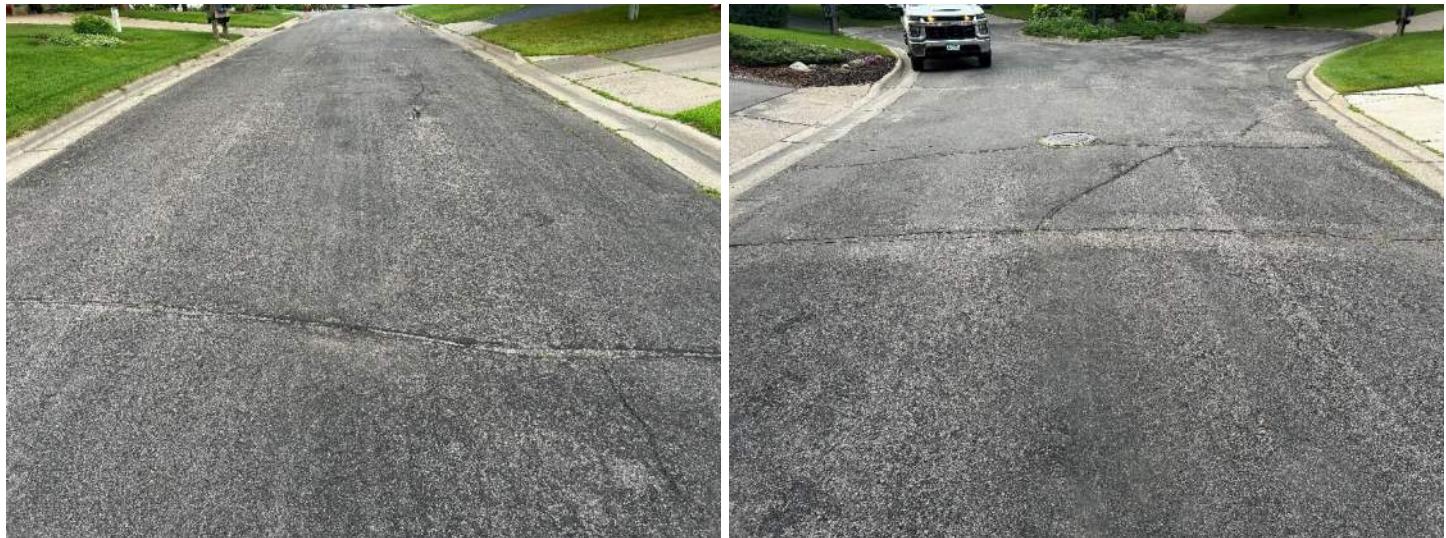
Core 16

Location	Number of Lanes	Roadway Width (ft)	Curb and Gutter	Surface Distresses
Pondview Circle	2	22	Yes	Surface stripping, transverse cracking

Bituminous Depth (in)	Lift Thickness and Condition	Base Depth and Description	Subbase or Subgrade Description
3.75	1.75" - Wear 2" - Base Fair - Some base layer raveling	6" - Sand trace gravel, brown	f-m Sand, brown

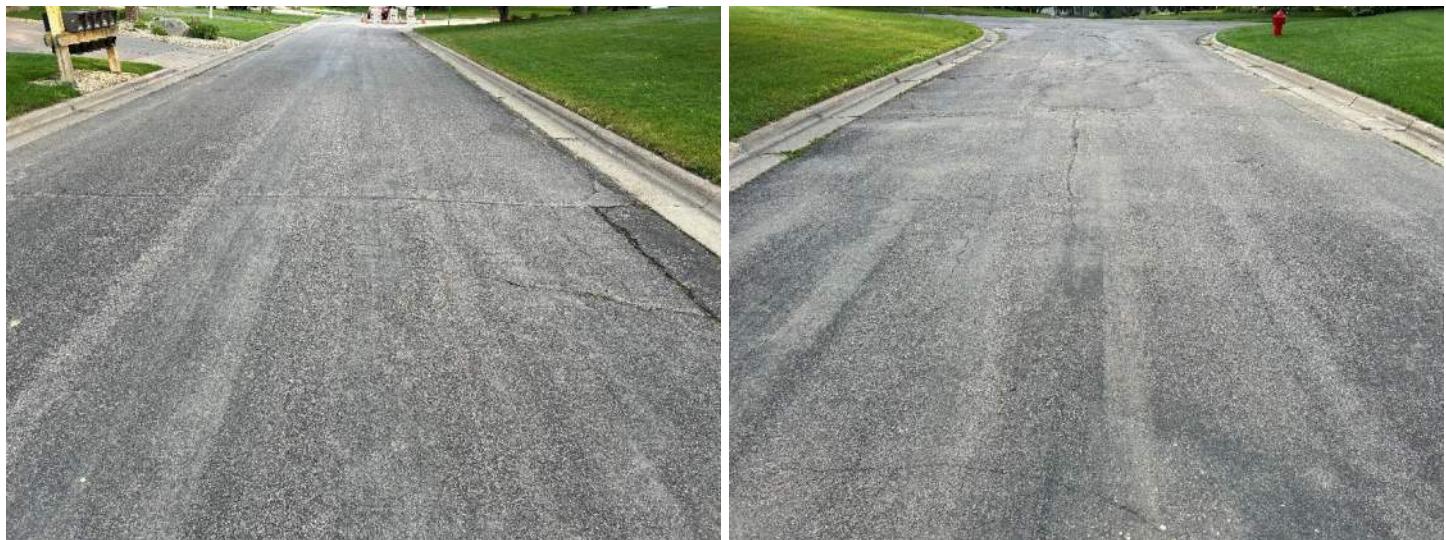
Core 17

Location	Number of Lanes	Roadway Width (ft)	Curb and Gutter	Surface Distresses
Pondview Ct	2	21	Yes	Surface stripping, Some alligator, transverse cracking

Bituminous Depth (in)	Lift Thickness and Condition	Base Depth and Description	Subbase or Subgrade Description
5	2.5" - Wear 2.5" - Base Poor - Base layer raveling	4" - Gravel, light brown	Clayey Sand, Light brown

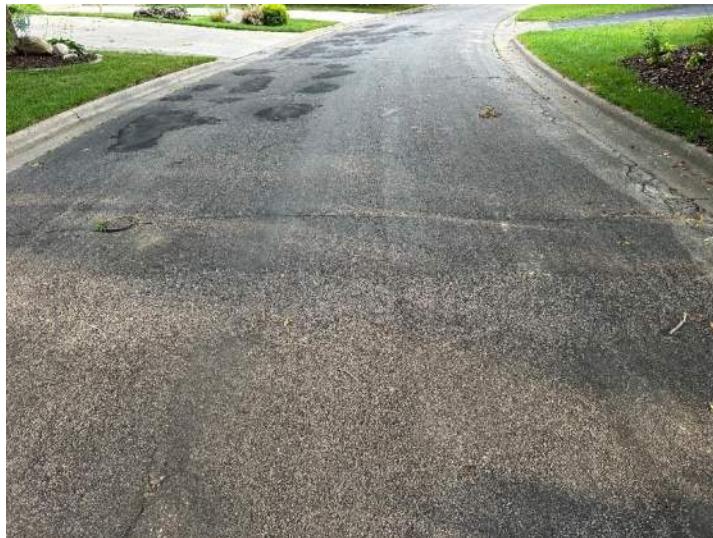
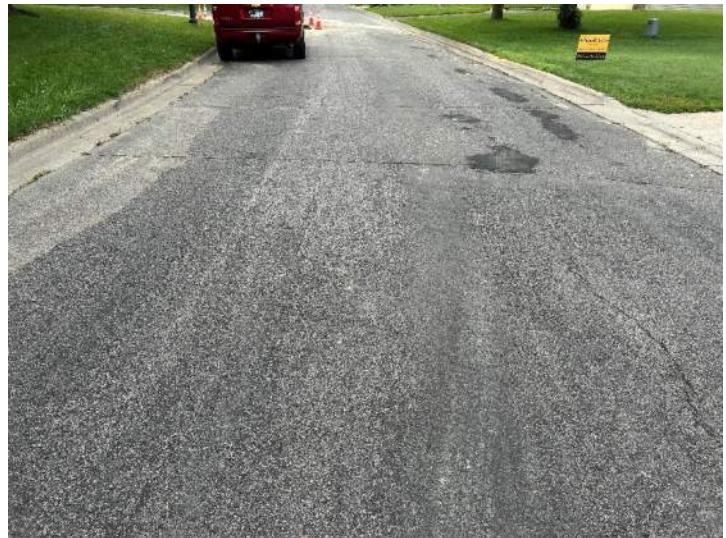
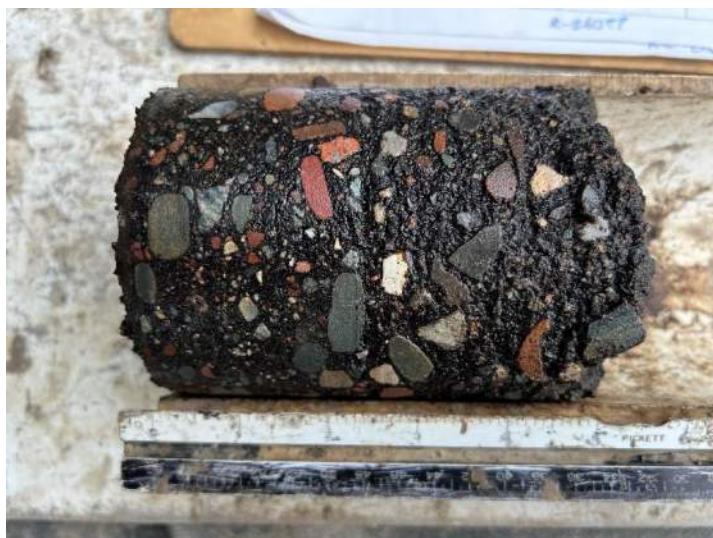
Core 18

Location	Number of Lanes	Roadway Width (ft)	Curb and Gutter	Surface Distresses
Pondview Ct	2	24	Yes	Surface stripping, patching, transverse cracking

Bituminous Depth (in)	Lift Thickness and Condition	Base Depth and Description	Subbase or Subgrade Description
5	2.5" - Wear 2.5" - Base Poor - Raveling	7" - Gravel, Light brown	Clay, brown

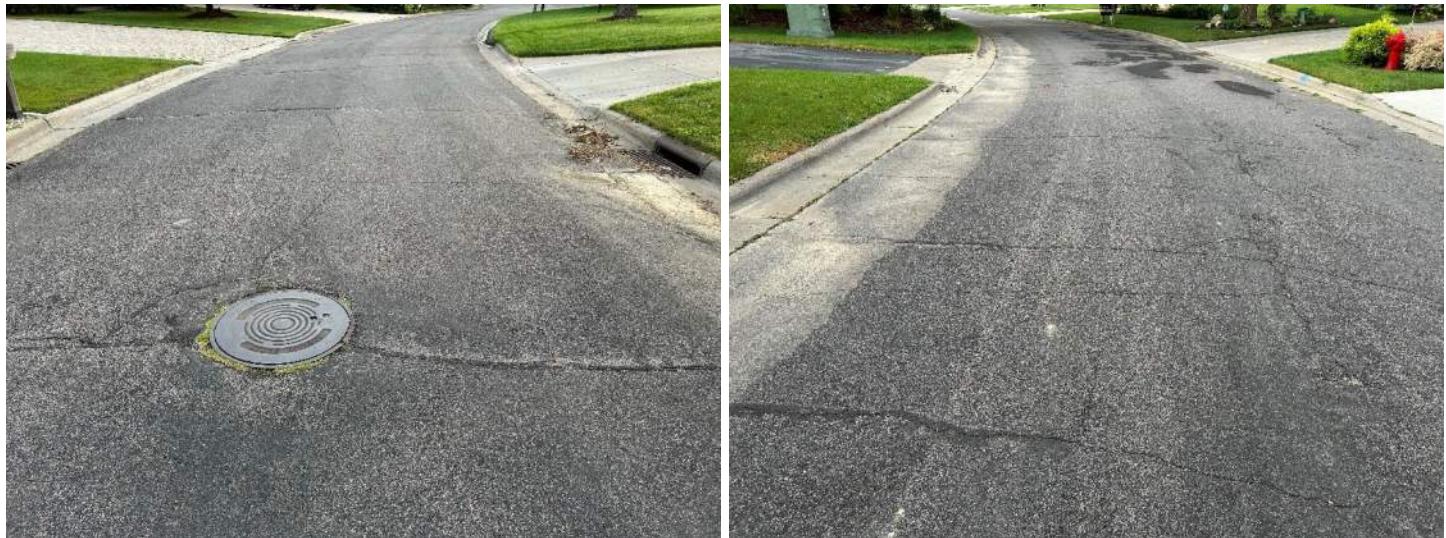
Core 19

Location	Number of Lanes	Roadway Width (ft)	Curb and Gutter	Surface Distresses
Pondview Ct	2	24	Yes	Surface stripping, transverse, longitudinal cracking

Bituminous Depth (in)	Lift Thickness and Condition	Base Depth and Description	Subbase or Subgrade Description
5	2.25" - Wear 2.75" - Base Fair - Some base layer raveling	8.5" - Sand with gravel, light brown	Clay, brown

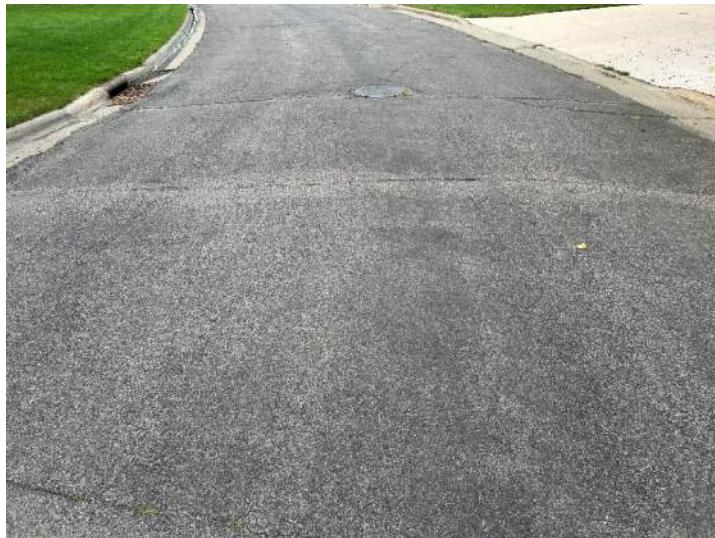
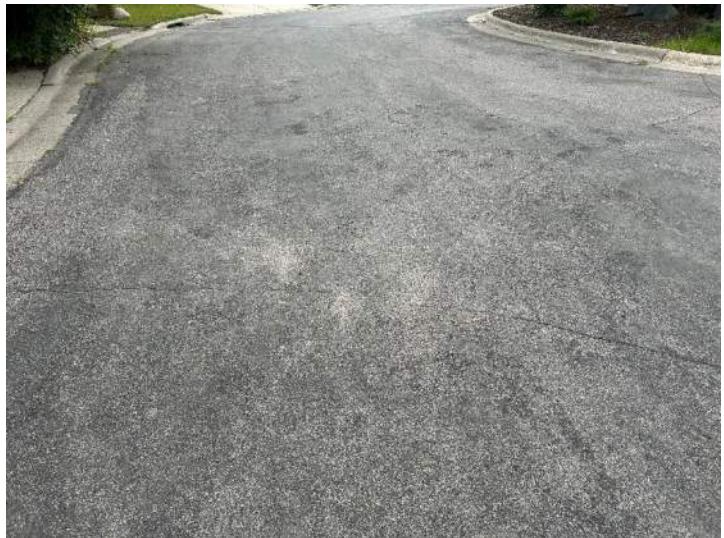
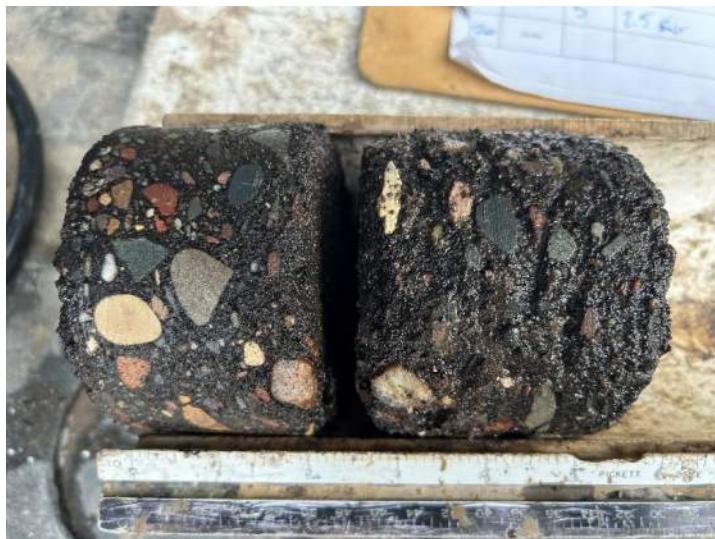
Core 20

Location	Number of Lanes	Roadway Width (ft)	Curb and Gutter	Surface Distresses
Pondview Ct	2	24	Yes	Surface stripping, Some transverse cracking

Bituminous Depth (in)	Lift Thickness and Condition	Base Depth and Description	Subbase or Subgrade Description
5	2.5" - Wear 2.5" - Base Poor - Raveling	5" - Sand with gravel, light brown	Clay, brown
