FEASIBILITY REPORT

GOOSE LAKE PARKWAY AND ELM CREEK TRAIL AREA PROJECT

CHAMPLIN | HENNEPIN COUNTY | MINNESOTA

CITY PROJECT NO. 22502
SAP 193-121-001
WSB PROJECT NO. 026077-000

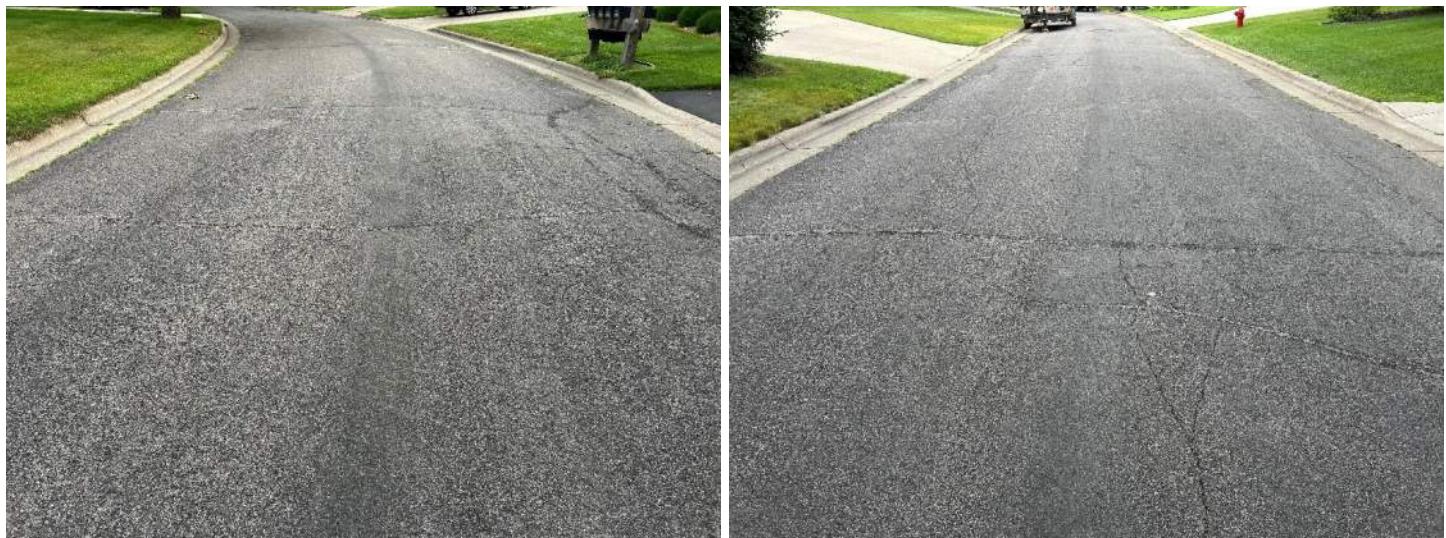
Core 21

Location	Number of Lanes	Roadway Width (ft)	Curb and Gutter	Surface Distresses
Oakview Ct	2	22	Yes	Surface stripping, transverse cracking

Bituminous Depth (in)	Lift Thickness and Condition	Base Depth and Description	Subbase or Subgrade Description
4	1.75" - Wear 2.25" - Base Poor - Raveling	6" - Sand with gravel, light brown	Clayey Sand, brown

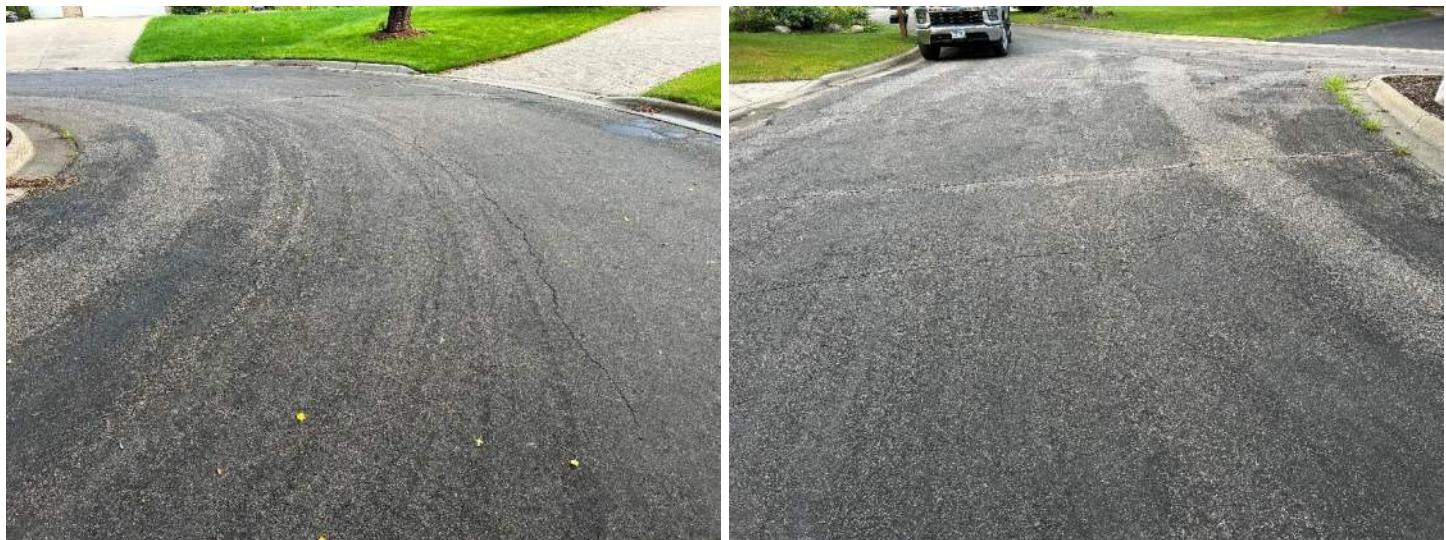
Core 22

Location	Number of Lanes	Roadway Width (ft)	Curb and Gutter	Surface Distresses
Oakview Ct	2	24	Yes	Surface stripping, transverse cracking

Bituminous Depth (in)	Lift Thickness and Condition	Base Depth and Description	Subbase or Subgrade Description
5.5	2.5" - Wear 3" - Base Poor - Raveling	5" - Sand with gravel, light brown	Clayey Sand, brown

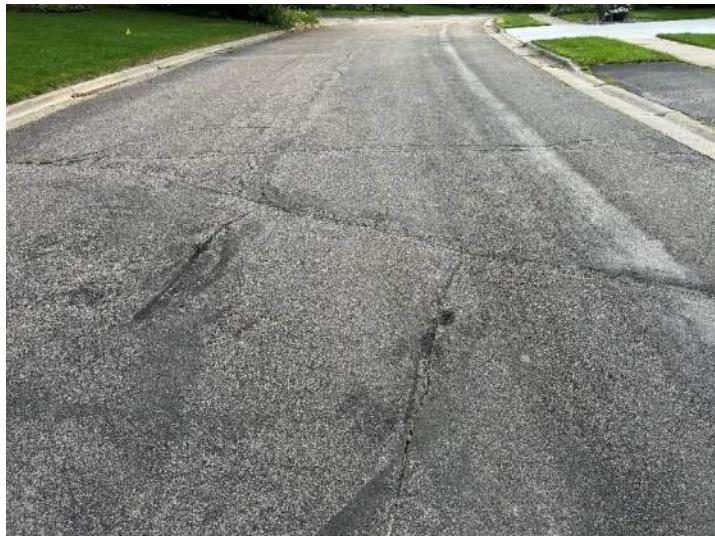
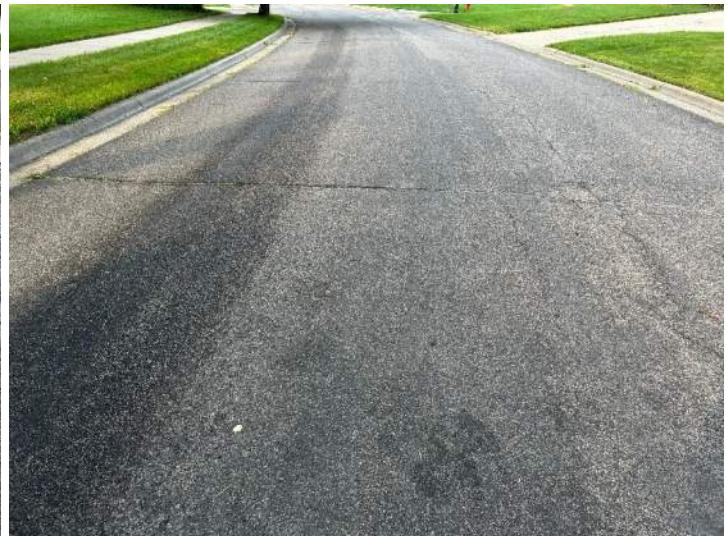
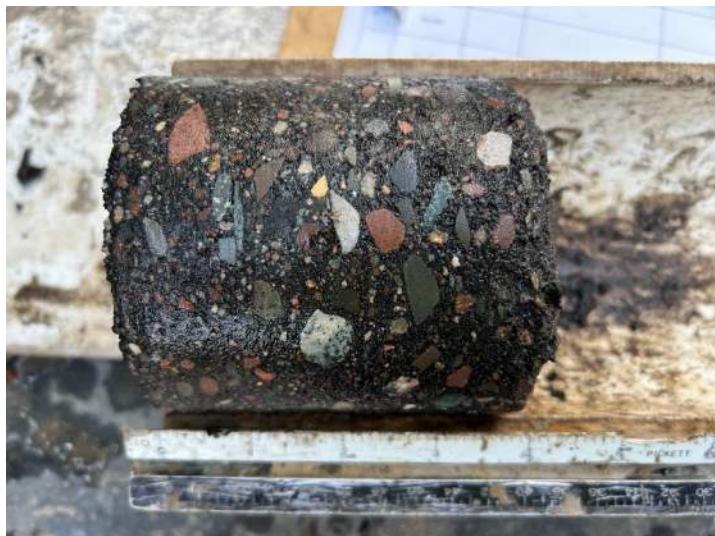
Core 23

Location	Number of Lanes	Roadway Width (ft)	Curb and Gutter	Surface Distresses
Elm Creek Trail	2	24	Yes	Surface stripping, transverse, longitudinal cracking

Bituminous Depth (in)	Lift Thickness and Condition	Base Depth and Description	Subbase or Subgrade Description
4	2.25" - Wear 1.75" - Base Fair - Some base layer raveling	4" - Sand trace gravel, brown	f-m Sand, brown

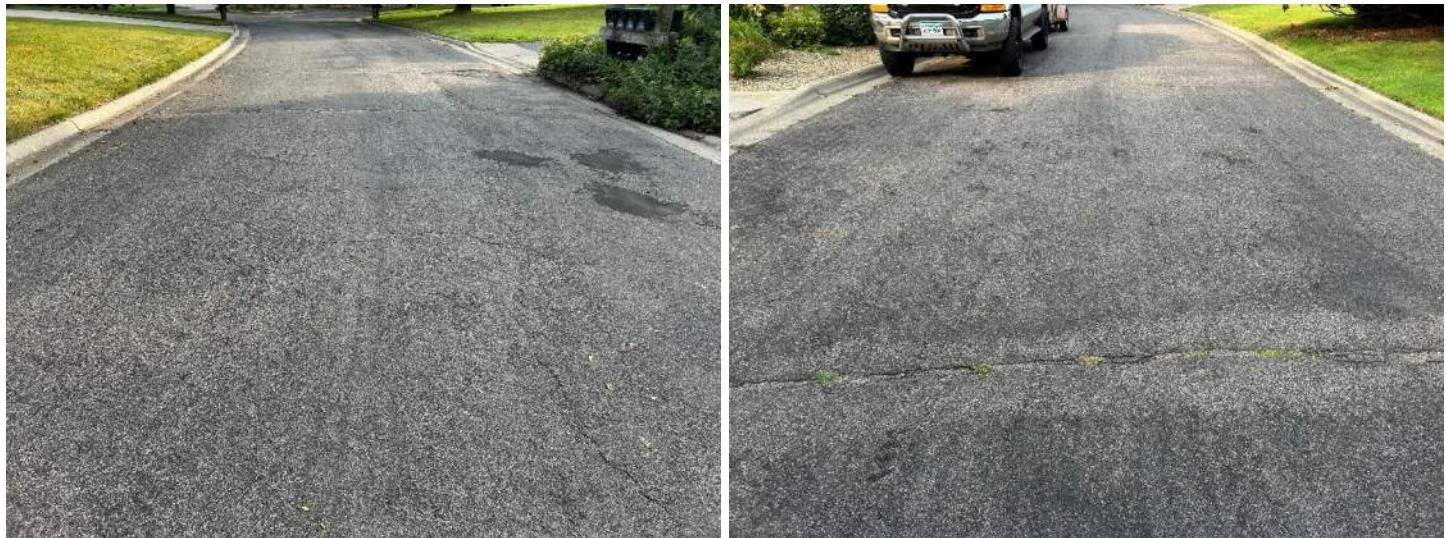
Core 24

Location	Number of Lanes	Roadway Width (ft)	Curb and Gutter	Surface Distresses
Norway Ct	2	24	Yes	Surface stripping, transverse cracking

Bituminous Depth (in)	Lift Thickness and Condition	Base Depth and Description	Subbase or Subgrade Description
3.5	2" - Wear 1.5" - Base Good Condition	4" - Sand trace gravel, brown	f-m Sand, brown

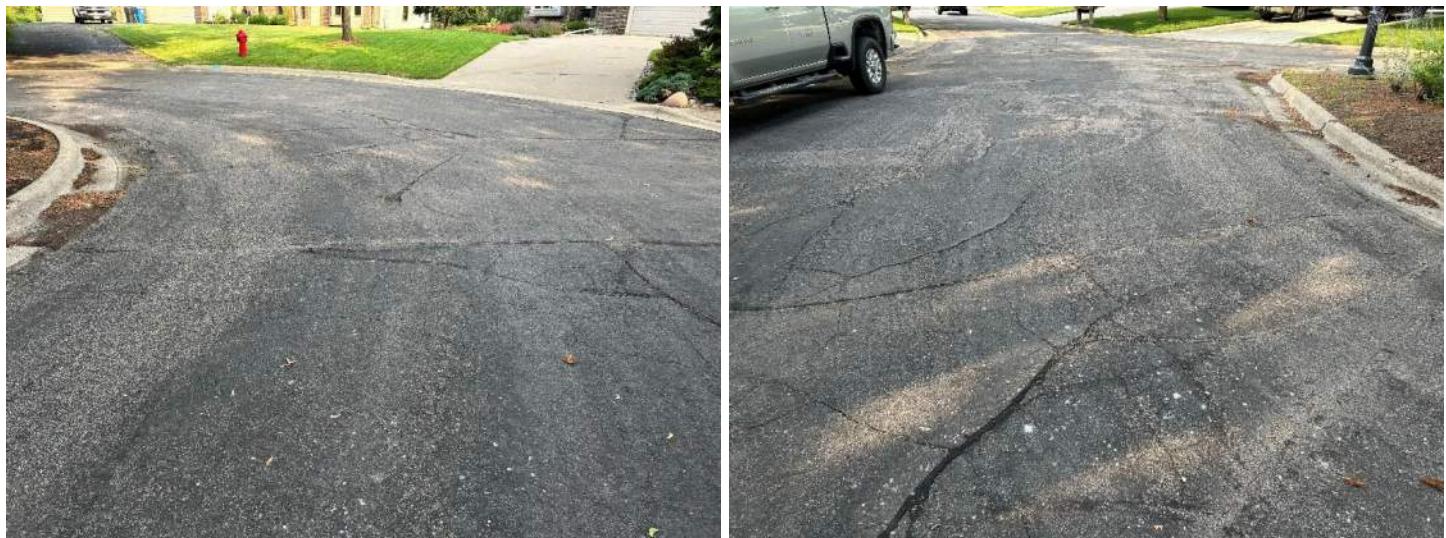
Core 25

Location	Number of Lanes	Roadway Width (ft)	Curb and Gutter	Surface Distresses
Norway Ct	2	24	Yes	Surface stripping, alligator, transverse cracking

Bituminous Depth (in)	Lift Thickness and Condition	Base Depth and Description	Subbase or Subgrade Description
3.5	1.75" - Wear 1.75" - Base Poor - Raveling	4" - Sand trace gravel, brown	f-m Sand, brown

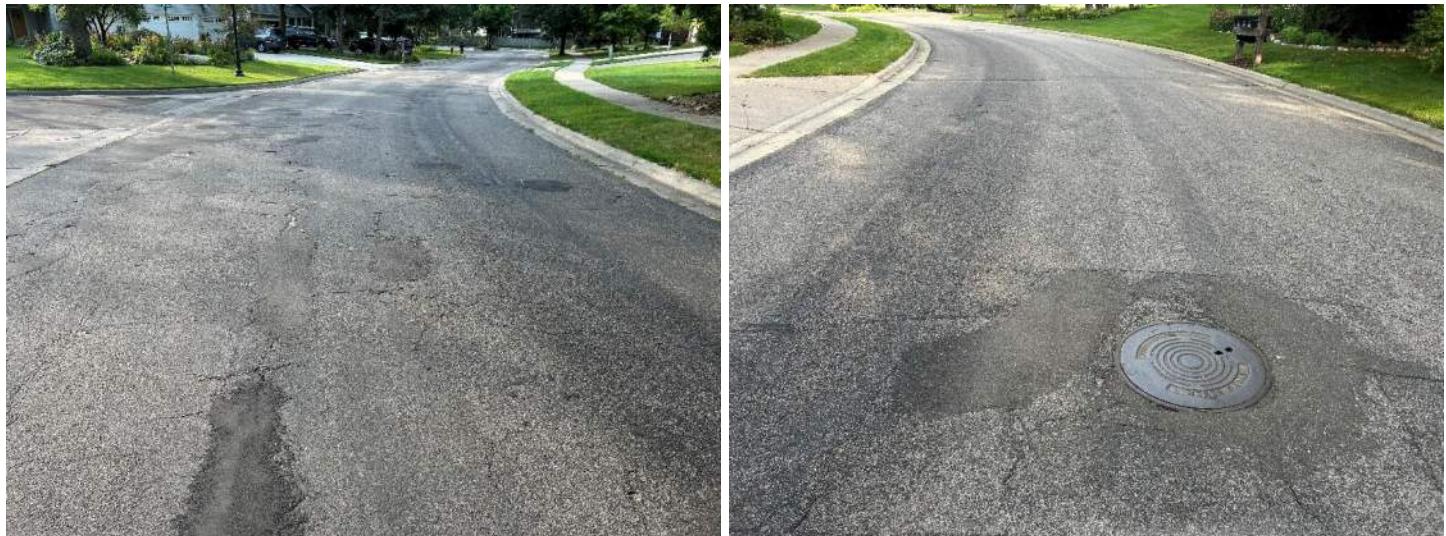
Core 26

Location	Number of Lanes	Roadway Width (ft)	Curb and Gutter	Surface Distresses
Elm Creek Trail	2	24	Yes	Surface stripping, patching, transverse cracking

Bituminous Depth (in)	Lift Thickness and Condition	Base Depth and Description	Subbase or Subgrade Description
4	2.25" Wear 1.75" - Base Fair - Some base layer raveling	4" - Sand trace gravel, brown	Sand trace gravel, brown

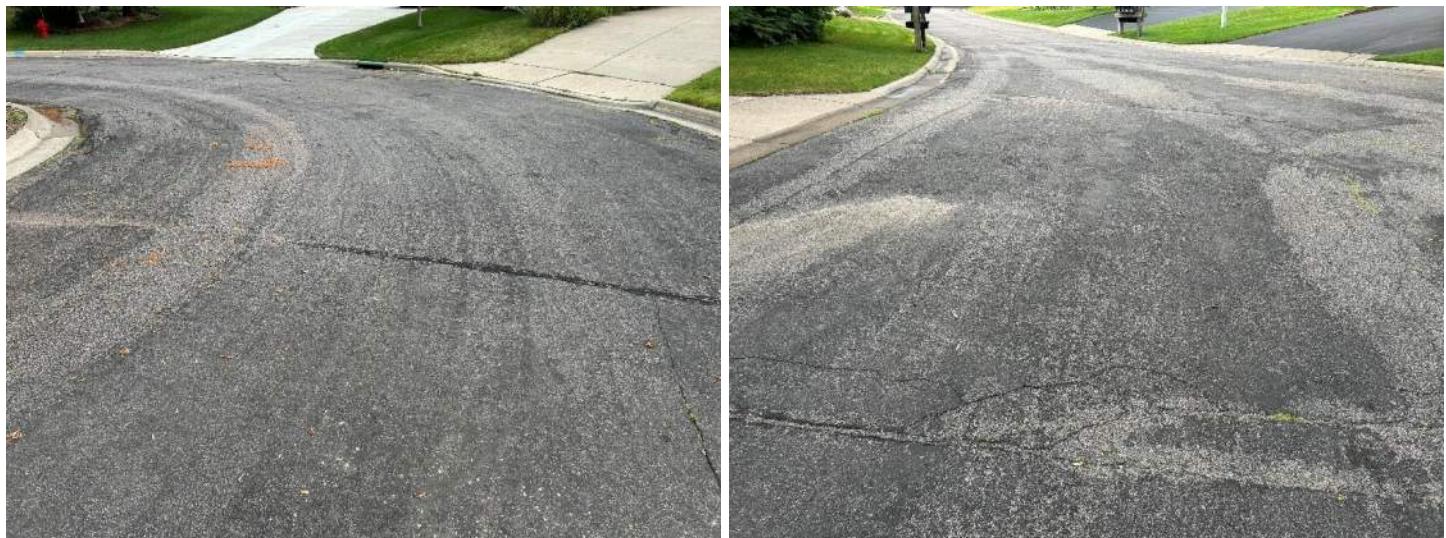
Core 27

Location	Number of Lanes	Roadway Width (ft)	Curb and Gutter	Surface Distresses
Magnolia Ct	2	24	Yes	Surface stripping, transverse cracking

Bituminous Depth (in)	Lift Thickness and Condition	Base Depth and Description	Subbase or Subgrade Description
3.25	2" - Wear 1.25" - Base Poor - Raveling	5" - Sand trace gravel, brown	f-m Sand, brown

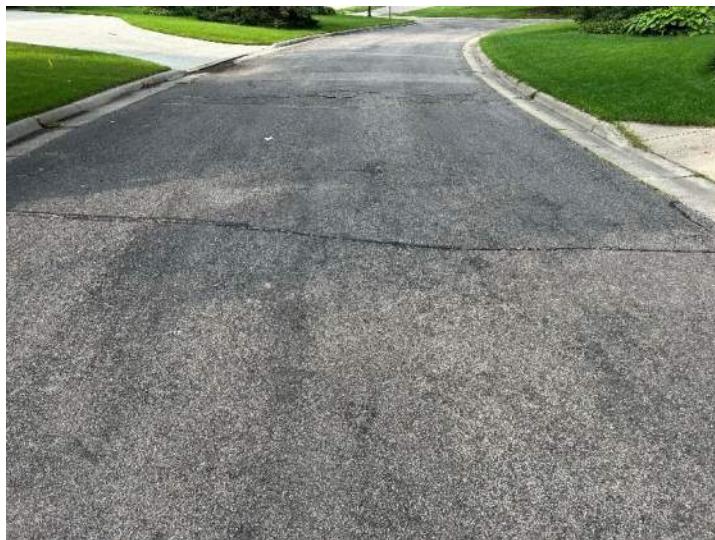
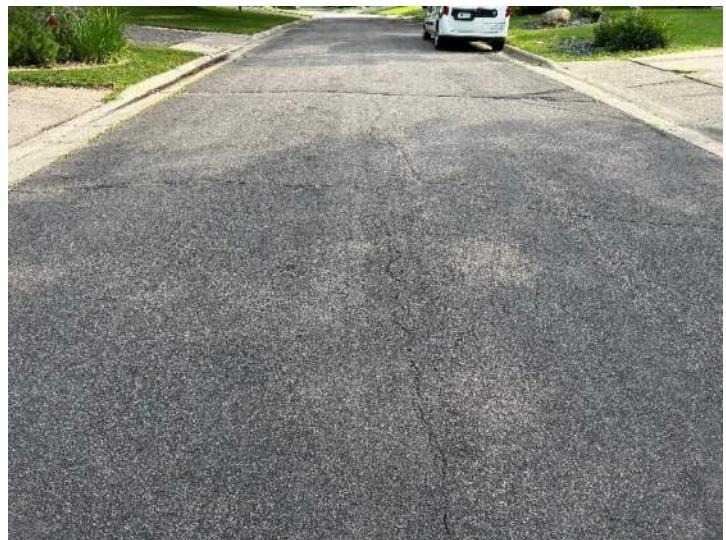
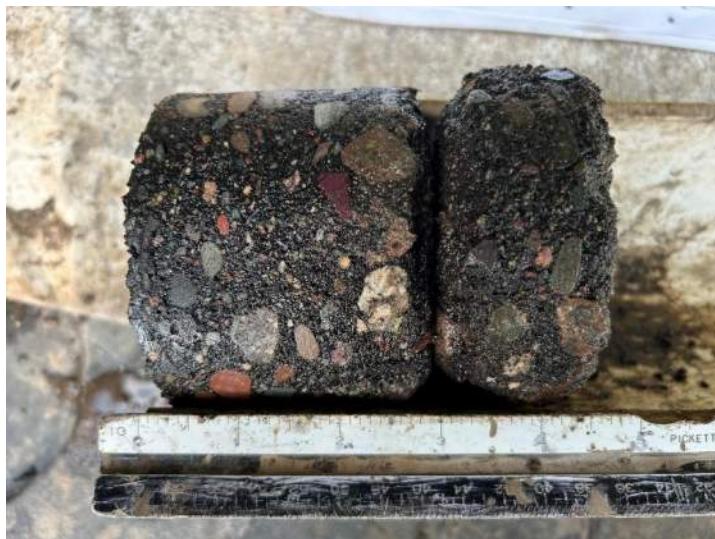
Core 28

Location	Number of Lanes	Roadway Width (ft)	Curb and Gutter	Surface Distresses
Magnolia Ct	2	24	Yes	Surface stripping, transverse cracking

Bituminous Depth (in)	Lift Thickness and Condition	Base Depth and Description	Subbase or Subgrade Description
4.5	3" - Wear 1.5" - Base Poor - Raveling	4" - Sand trace gravel, brown	f-m Sand, brown

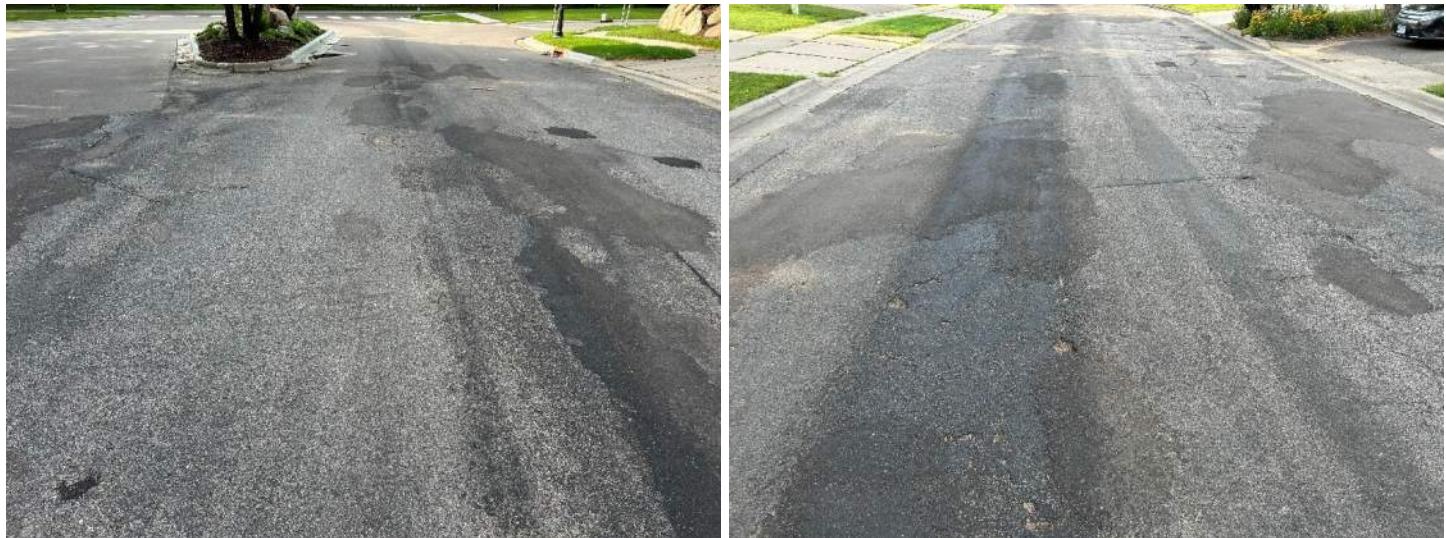
Core 29

Location	Number of Lanes	Roadway Width (ft)	Curb and Gutter	Surface Distresses
Elm Creek Trail	2	28	Yes	Surface stripping, patching, transverse cracking

Bituminous Depth (in)	Lift Thickness and Condition	Base Depth and Description	Subbase or Subgrade Description
6.25	2.25" - Wear (3+ Lifts of material) Poor - Base layer raveling	4" - Sand trace gravel, brown	f-m Sand, brown
